Florence, Italy
30th September – 2nd October 2019

Condition monitoring of excavated CIPP-liners to ensure lifespan

Love Pallon¹, Olle Persson¹, Erik Marklund¹, Annika Malm¹ and Thomas Johansson²

¹ RISE Research Institutes of Sweden, Göteborg, Sweden

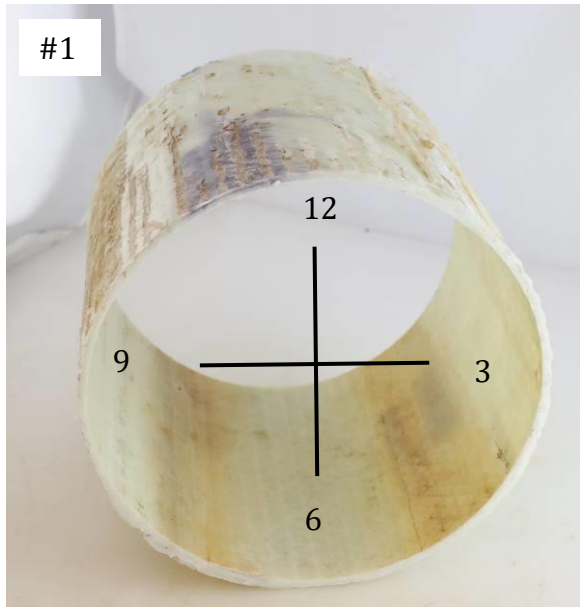
Figure 1. FRP CIPP-liner installed 2003, with upper point defined at 12 and bottom at 6.

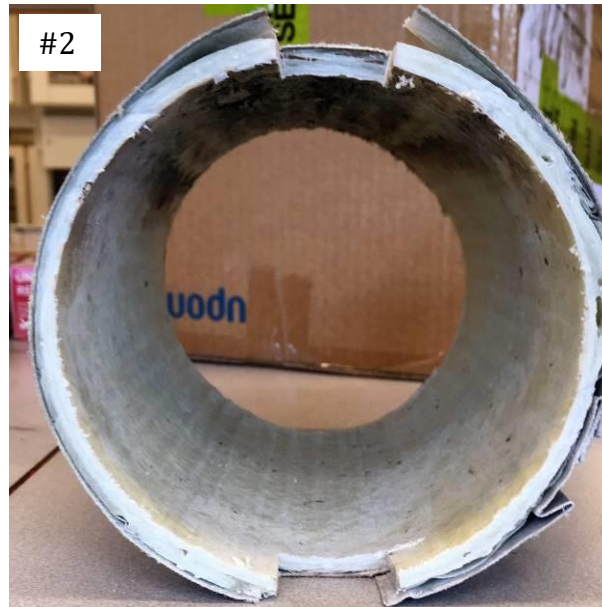
Figure 2. FRP CIPP-liner installed at 2007.

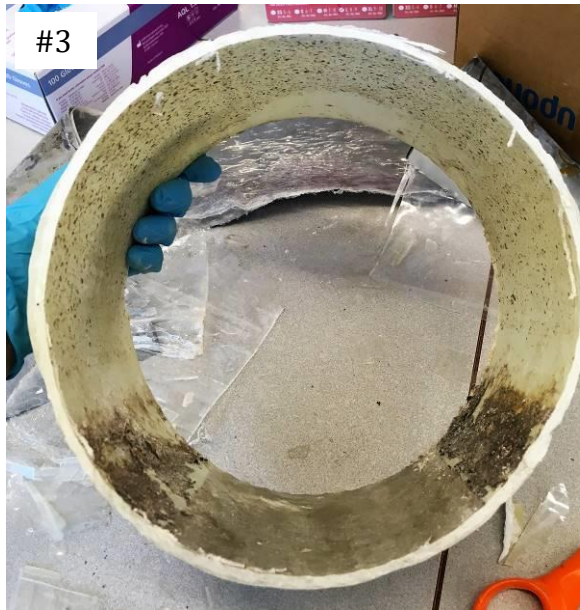
Figure 3. FRP CIPP-liner installed at 2010.

Sample #3 was of the same liner model as Sample #2 but installed 2010, but it showed no sign of holes (Figure 3). If it relates to an improved control of the product, the probability of assessing a defect region or a better installation is difficult to say.

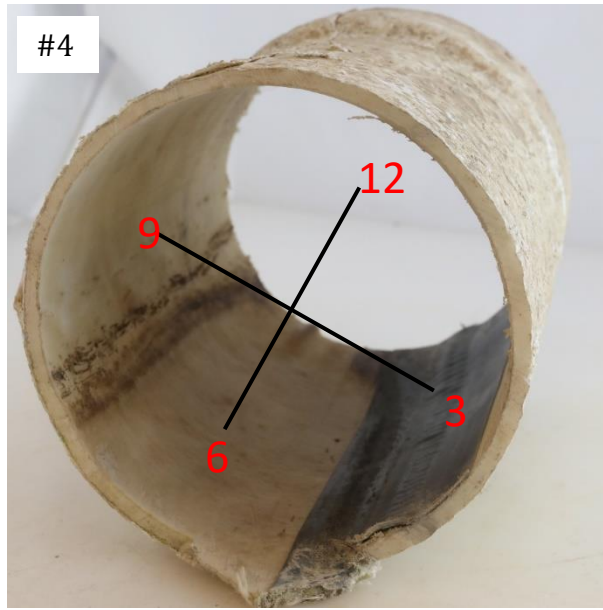
Figure 4. Needle felt CIPP-liner installed at 2006.

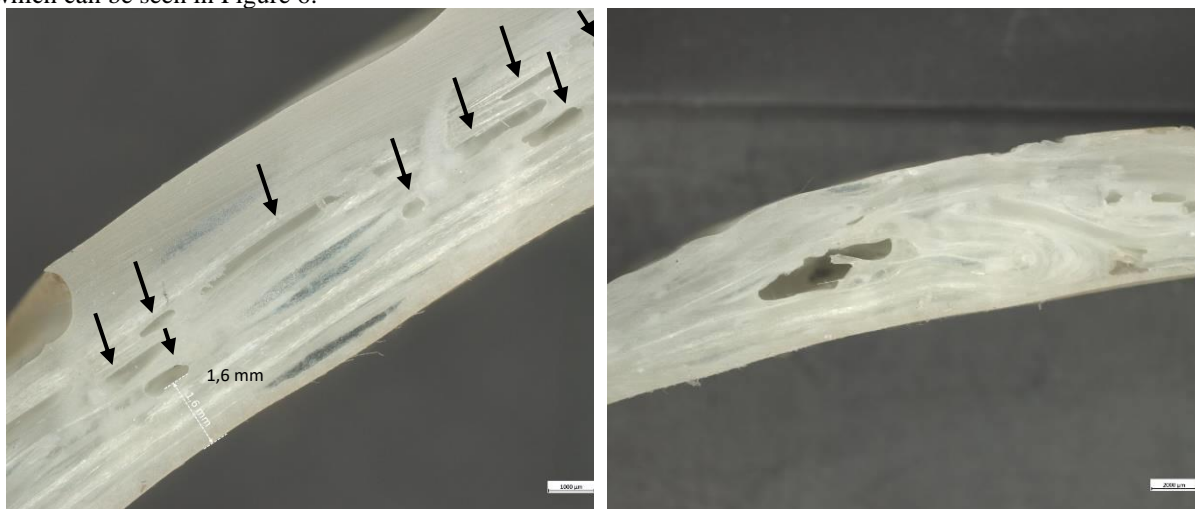
From the visual inspection of the pipe wall cross section of Sample #1 the most noticeably was the great number of voids in the wall. The holes were distributed all around the circumvent and at different depth of the pipe wall. In Figure 5-9 the cross section of Sample #1 is shown, here it can be seen that the holes are distributed across the wall thickness. The width of the holes, with a main extension in the tangential direction, varied from a centimeter and more to a few millimeters. The depth of the holes varied but the extension in axial direction was noticeable which can be seen in Figure 6.

Figure 5. Light optical microscopy of a cross section of pipe wall from a CIPP-liner installed at 2003. The black arrows indicated holes in the pipe wall. The white scale bar is 1 mm.

Figure 6. Light optical microscopy of a cross section of pipe wall from a CIPP-liner installed at 2003. The white scale bar is 1 mm.

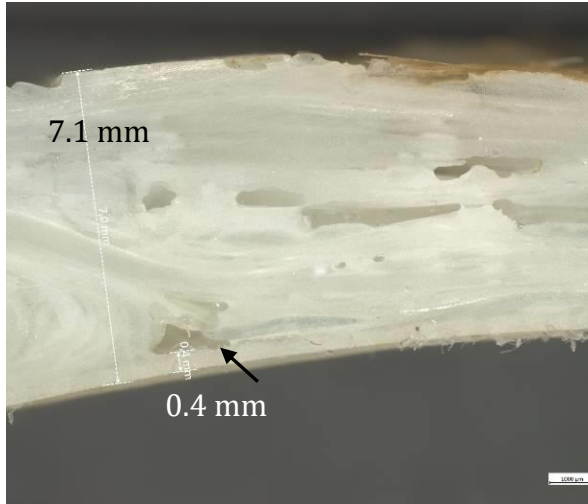
Figure 7. Light optical microscopy of a cross section of pipe wall with holes across the wall thickness. One hole was situated only 0.4 mm from the inside surface (black arrow). The white scale bar is 1 mm.

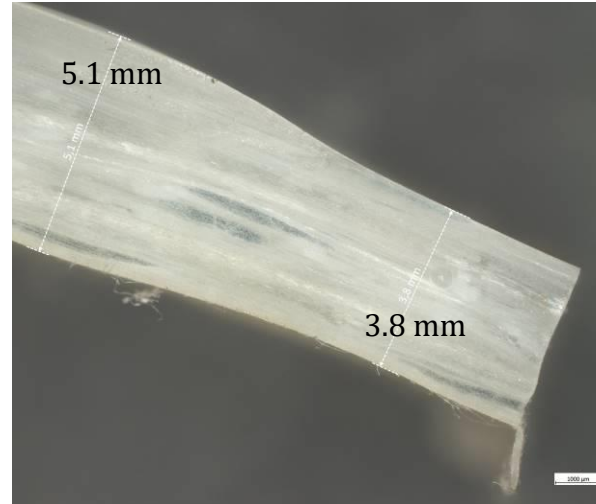
As can be seen in Figure 8 the thickness of the glass fiber reinforced part varies also between points close to each other, here going from 3.8 mm to 5.1 mm over a distance of 10 mm. At the thickest point (considering the fiber reinforced part) the wall was 7.1 mm, compared to the designed 4 mm. Outside the glass fibers a surplus of resin was also visible.

Figure 8. Light optical microscopy of a cross section of pipe wall shows how the thickness varies over short distances, also when only measuring the thickness of the glass fibers. The white scale bar is 1 mm.

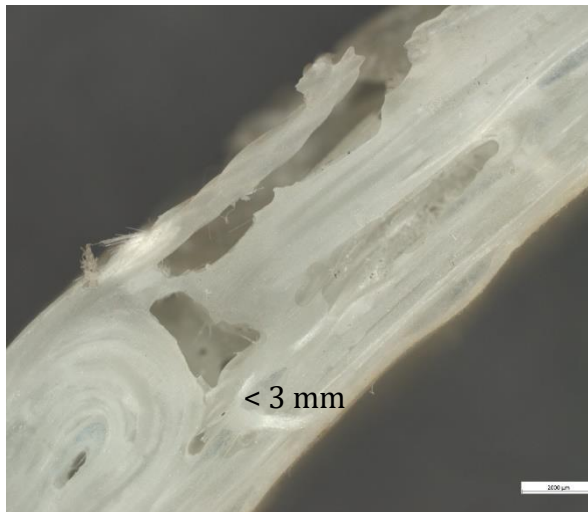
Figure 9. Light optical microscopy of a cross section of pipe wall shows that due to uneven distribution of resins the real thickness is lower than then designed value. The white scalebar is 2 mm.

In Figure 9 the disruption of glass fiber combined with an uneven distribution of resin leads the formation of large voids which reduces the actual thickness of the wall pipe. It is unclear how the holes are distributed in the depth, but based on the cross section of Figure 9 it is clear that installed product is not formed in the desired way upon installation. At the point in Figure 9 the efficient thickness is less 3 mm. The inside surface on the other hand shows good condition with only surface cracks visible (Figure 10).

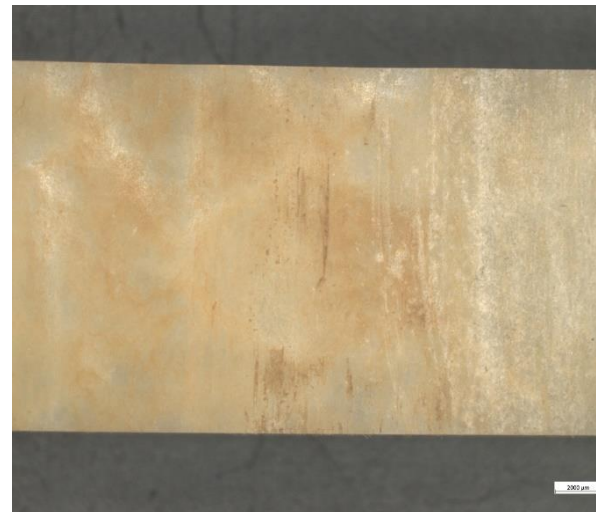
Figure 10. The inside surface of the sample showed good conditions with only surface cracks. The white scalebar is 2 mm.

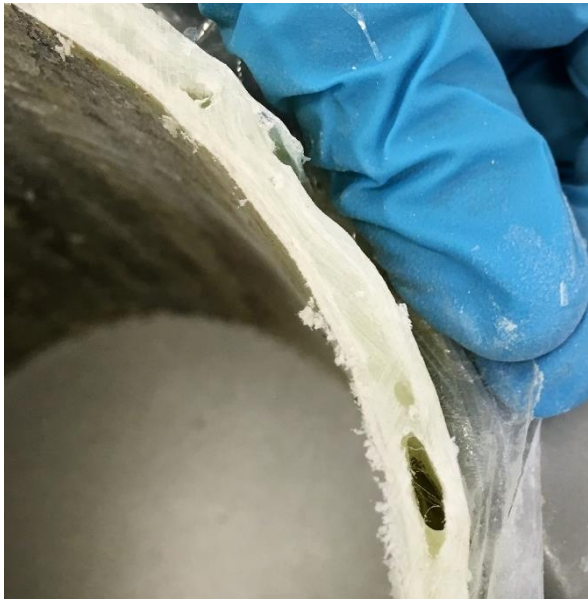
When examine Sample #2 from 2007, produced by the same manufacture but a different liner, it shows to have the same problem with holes in the cross section. In Figure 11 a part of the pipe is seen, with a large hole in the middle of the wall. The hole is 1 cm wide, 3 mm thick and several cm deep. The hole in Figure 11 shows one of many holes that form defects in the pipe wall.

Figure 11. A defect seen in the pipe wall in between the reinforcing fibers for the CIPP-liner installed in 2007 (Sample #2).

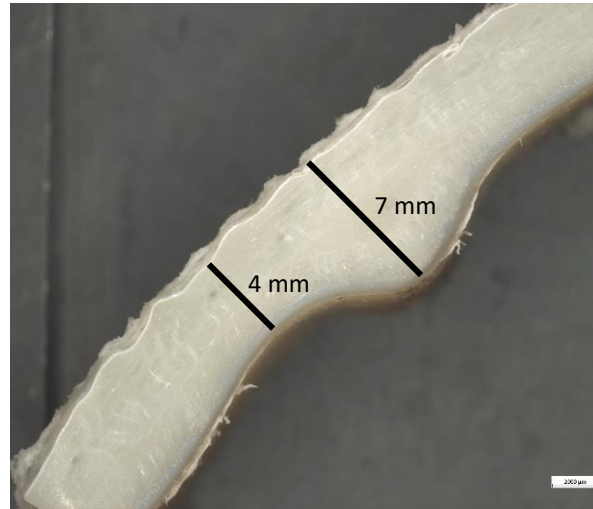
Figure 12. Light optical microscopy shows thickness variation in the needle-felt liner installed in 2006 (Sample #4). The white scale bar is 2 mm.

Figure 12 shows the cross section of the needle felt liner. From the LOM-evaluation it showed homogeneity with only smaller porous visible. The thickness on the other hand varied a lot between different positions, shown clearly in Figure 12 where the thickness varies between 4 and 7 mm within 1 cm of the circumvent. The uneven thickness may create folds that can reduce flow capacity and enhance deposit of solid material.

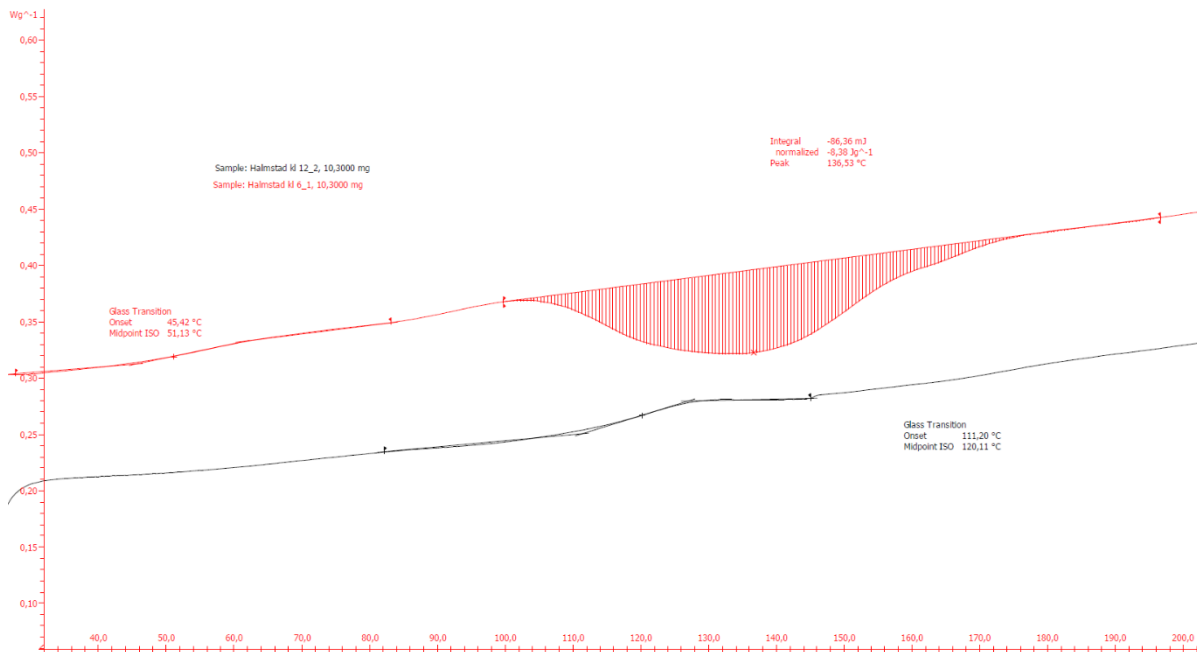
Thermal analysis by DSC showed for Sample #1 a difference in degree of curing for the bottom part (at 6 o'clock) compared to the upper part (at 12 o'clock). Figure 13 shows the DSC curves for the first heating of a samples taken at 6 (red) and 12 (black). The red curves show an exotherm peak during heating that is related to curing of non cross-linked resin. Such reaction cannot be seen for samples taken at 12 or during the second heating at any of the positions. The difference in degree of curing might be related to the effect of steam curing during installation, where condense water form in the bottom of the liner and cools down the curing. In this case the degree of curing was calculated to 92%, taking a glass content of 53 % in account (determined by burning of the resin). The same behavior was seen for Sample #2, with a curing during the first heating for the samples taken at 6 o'clock. This was not experienced for samples taken at position 12 o'clock.

Figure 13. DSC of Sample #1, with pieces taken from 6 o'clock (red) and 12 o'clock (black), shows an exothermic peak for the bottom part of the liner. Indicating that there exists non-reacted resin to an extent it does not in the upper part of the liner.

Another interesting observation is the difference in degree of curing at different positions for steam generated curing. A lower degree of curing will in the end deteriorate the mechanical properties and chemical stability of the material. In this initially study the influence of a lower curing at the bottom part was not seen, but on the other hand no designated measurements were performed to detect it.

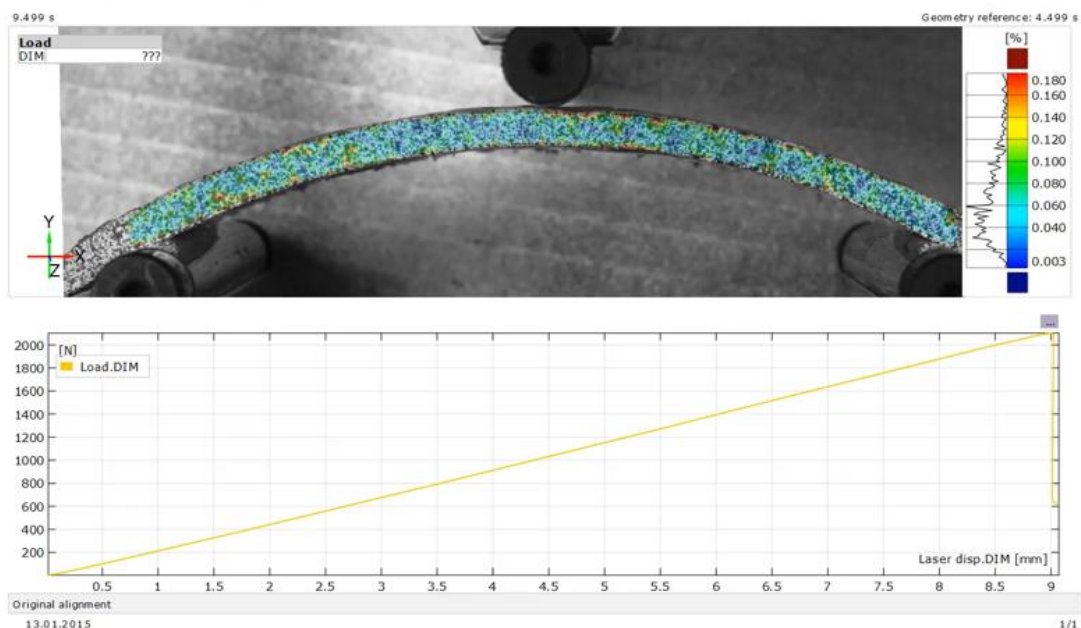
Specimen 37B (Equivalent Mises Strain field)

Mechanical analysis of Sample #1 gave an average ring stiffness of 10.67 kN/m² (kN/m² corresponding to SN) for the two test pieces and an apparent modulus of 9512 MPa (N/mm²). The average thickness was determined to 5.35 mm. The bending modulus as measured from three-point bending was measured to 9880 MPa. Corrected for the curvature of the test pieces the bending modulus was calculated to 12831 MPa. The test report for the installation determine the short-term E-modulus to 12000 MPa (N/mm²). The short-term E-modulus is within the same values as determined in the laboratory, but at this stage the author do not for sure know how the E-modulus was determined after installation and at this stage no further conclusion can be drawn. A rather large scatter was seen for the stress-strain curves of the three-point bending. It is possible that this could be influenced by the defects in the pipe wall. For the time of testing no considerations was taken to possible defects in the pipe wall.

Figure 14. Three point bending in combination with Digital Image Correlation of Sample #1. The colored bar at the right gives the values of the strain field and the plot beneath gives the load (N) as a function of displacement (mm).
