Optimal Maintenance of Hot Dip Galvanized Steel

Björn Tidbeck, RISE
Björn Stam, St Control
Bror Sederholm, RISE
RISE Report 2023:62

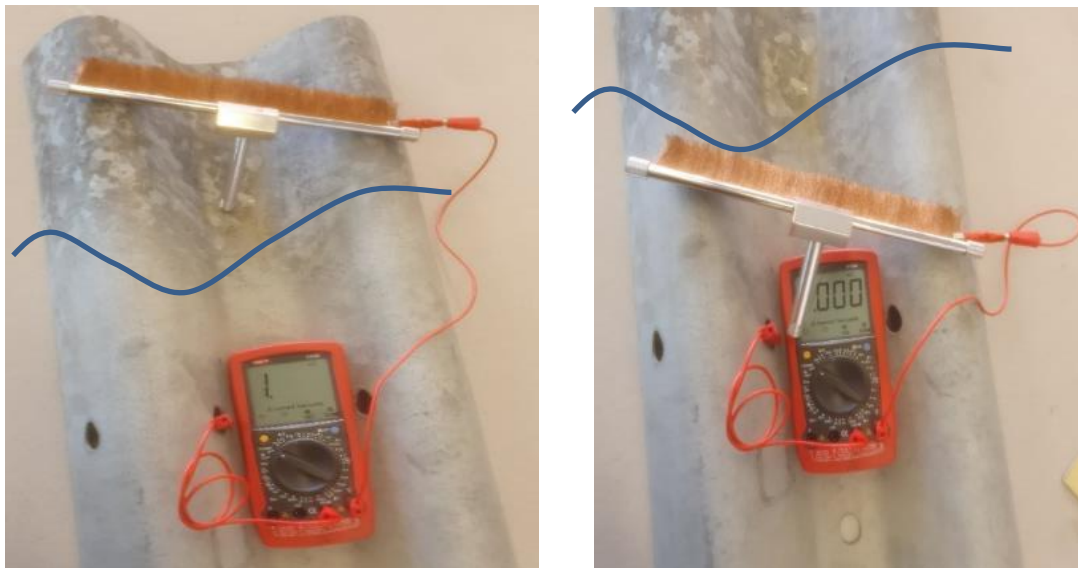
Figure 5. A HDG steel sheet that has been exposed along a road, the lower part of the sheet, (below the blue line) has been cleaned and pretreated by slurry blasting. The part above the blue line has been washed with fresh water. To the left: no electrical contact with the substrate, (resistance in $k\Omega$ - range). To the right: electric contact with the substrate, (resistance in Ω - range).

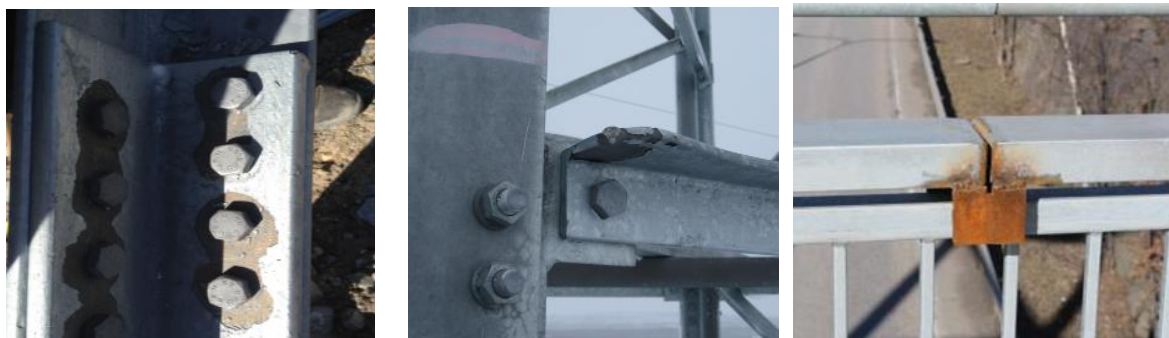
Figure 6. *To the left: damage from assembly and inferior zinc adhesion to the steel, the damage may have been avoided with use of proper washers. In the middle: damage from transport, can be avoided with adequate care during handling. To the right: a damage from welding after the galvanization process.*

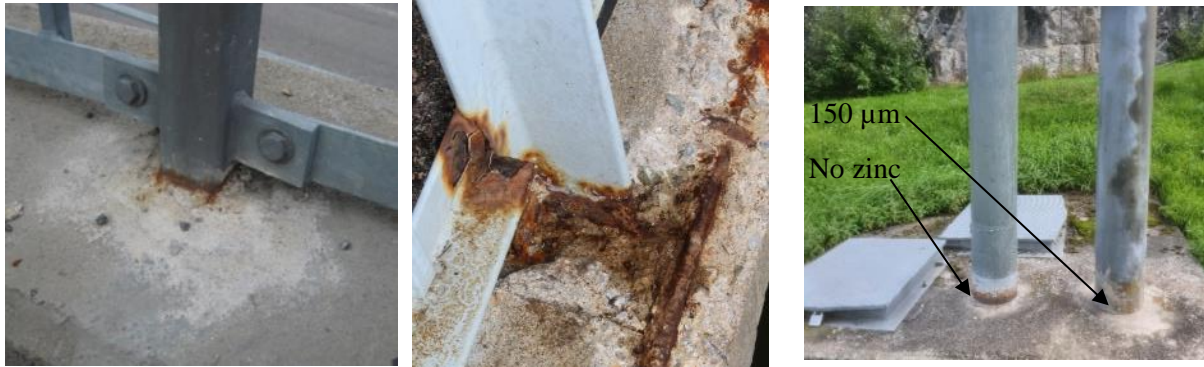
Figure 7. To the left: a HDG railing post cast into concrete about two years after installation, the railing post was found to be in electrical contact with the cast-in rebars. In the middle: a painted railing post with galvanic corrosion between the post and the cast-in rebars. To the right. A concrete slab with two protruding ventilation pipes in HDG steel. The left pipe showed red rust at the interface between concrete and steel. The right pipe showed no corrosion at the concrete steel interface. It is probable that the left pipe is electrically connected to the rebars and the right pipe is not. Electrical contact measurement of this particular installation could have avoided this type of corrosion damage.

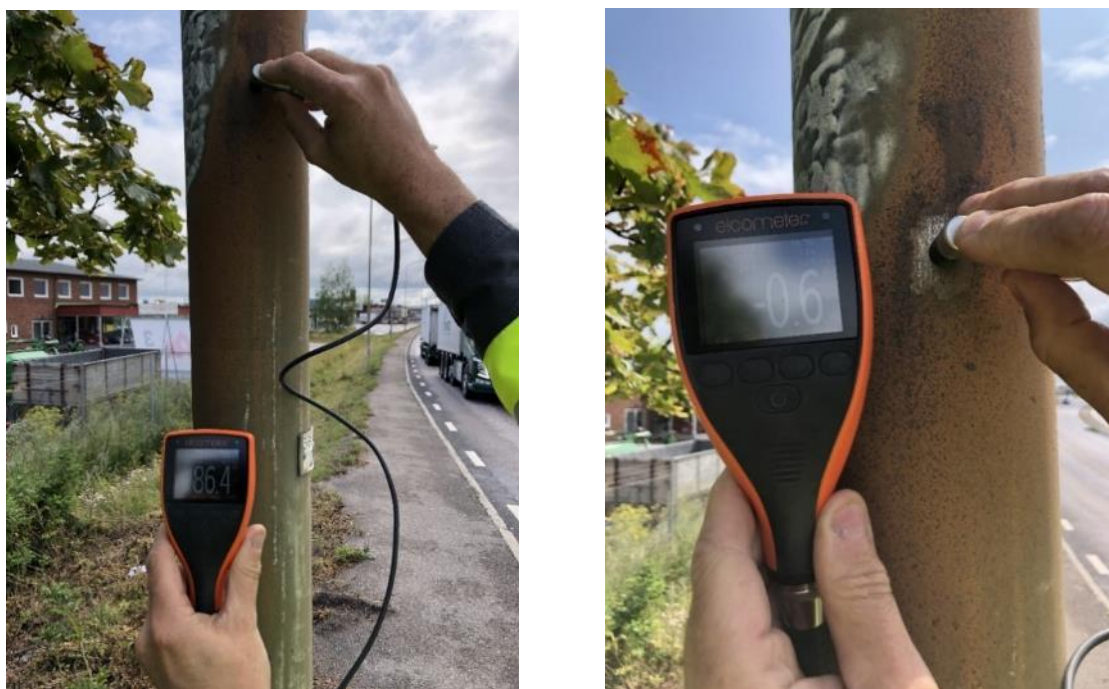
Figure 9. Coating thickness measurement on a lamppost, to the left, measurement as found indicate a thickness of 86 μm . To the right: measurement after scraping gently with a knife held at 90 degree angle, indicate a coating thickness of 0 μm , (the -0.6 μm reading is within the error margin of the instrument).

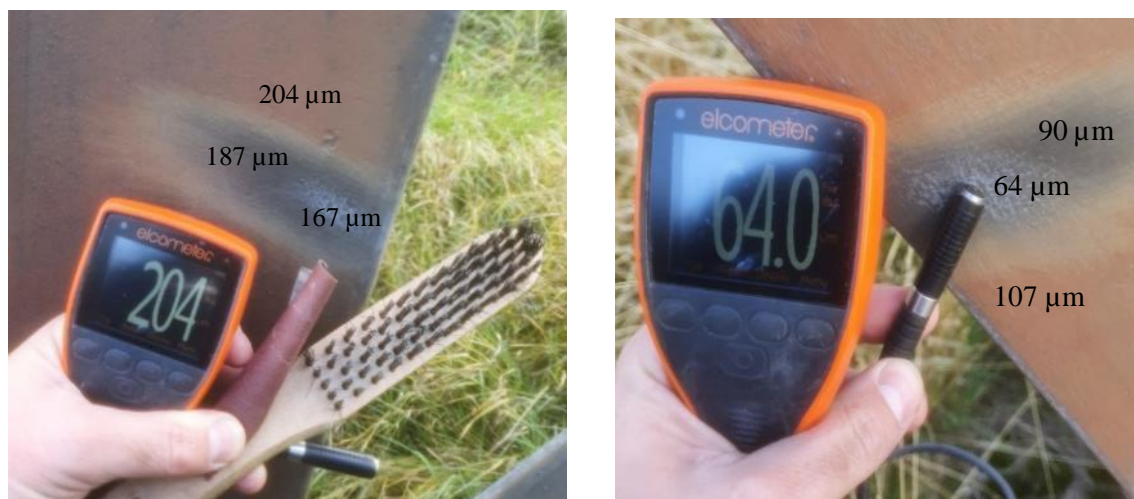
Figure 10. Coating thickness measurements of HDG steel of a 48 year old power pylon placed nearby the E4 freeway in the Stockholm area. To the left: leg furthest away from the traffic, To the right: leg closest to the traffic. Loose corrosion products were scraped using a steel wire brush to produce the blackish surface, further treatment with a 100 grit paper produced a surface with metallic sheen equivalent to a St 3 surface according to ISO 8501-1. Different treatments produce significantly different thickness measurements. It is also noteworthy that the thickness was almost double on the leg furthest to the freeway, in other words, film thickness can be very local. Varying film thickness can be differences from the HDG process or local variations in corrosivity.

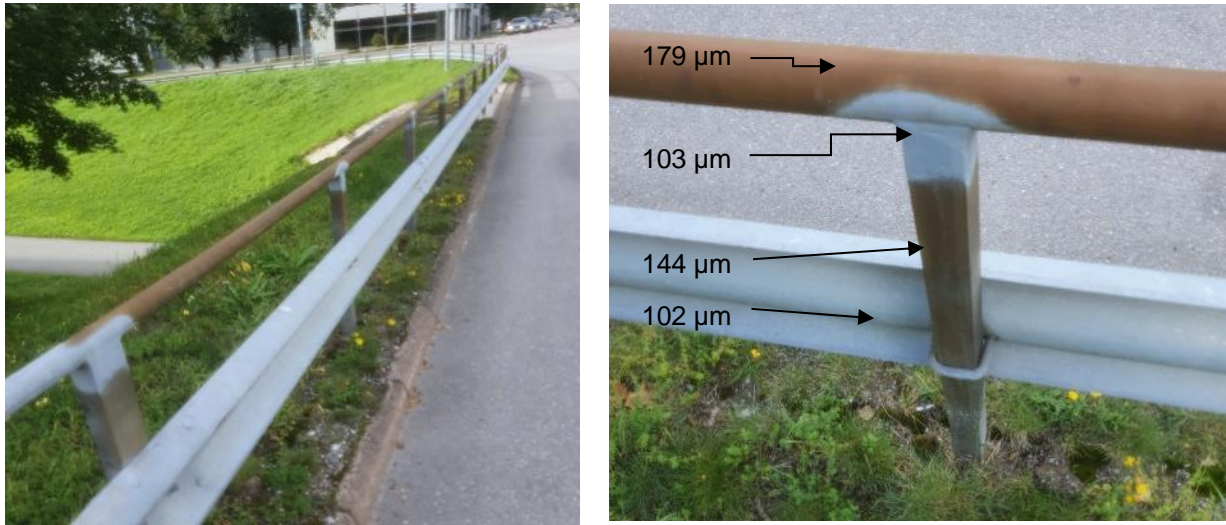
Figure 11. Coating thickness measurements of HDG and TSZ of a road fence with unknown service time. Note the alloy corrosion on the fence poles and the rail. Despite the rusty look of the alloy corrosion the coating thickness of the poles and the rail is thicker than the coating on the W-profile (102 µm) and the TSZ (103 µm). All measurements were taken after wire brushing a small area of the coating.

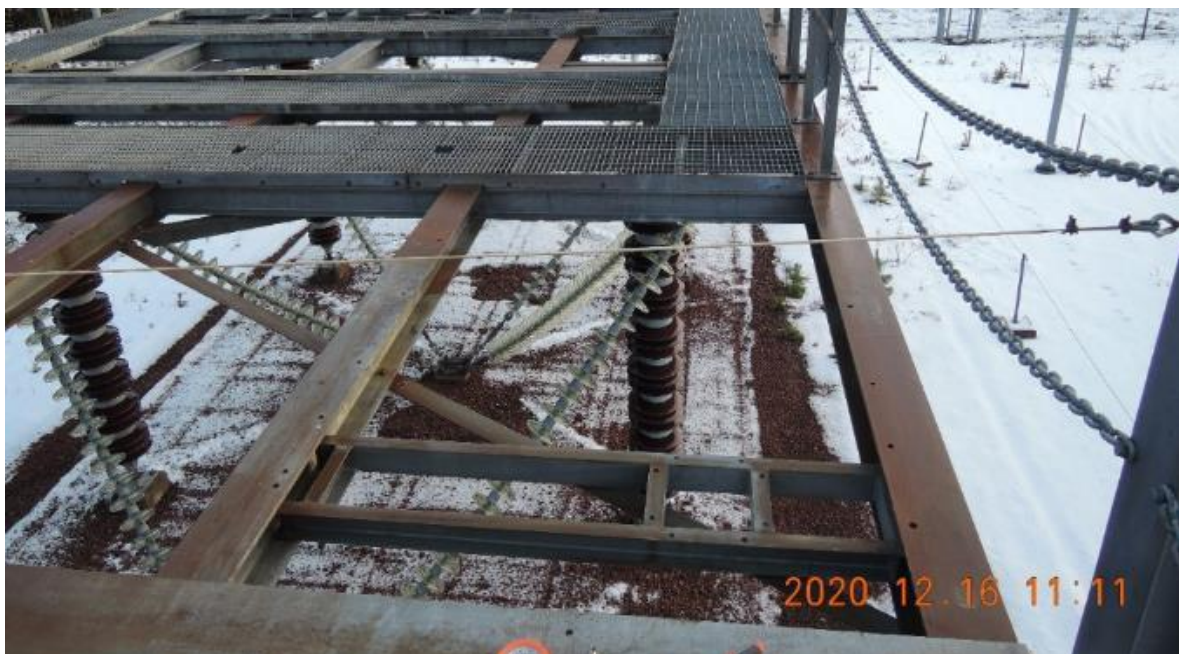
Figure 12. Overview of the transformer platform that was inspected. Generally no signs of critical corrosion damage were found. The main I-beams have developed alloy corrosion.

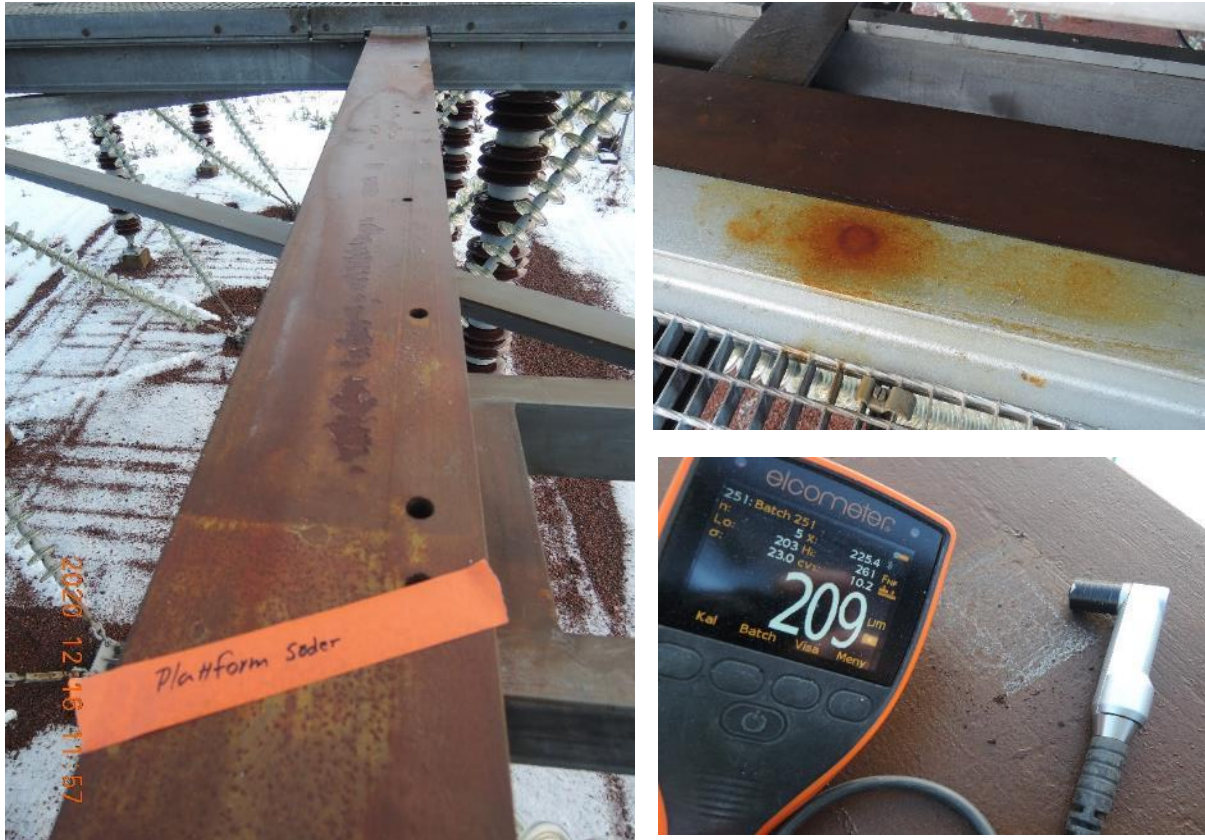
Figure 13. To the left: Main I-beam with alloy corrosion and corrosion hot-spots in damages of the HDG coating. The hot-spots may be the result of corrosion in a crevice where corrosion rates may be higher due to prolonged wet time. Top right: A HDG I-beam with alloy corrosion and an I-beam with discoloration from extraneous rust. Lower right: HDG coating thickness measurement. The HDG coating thickness was about 200 μm after scraping the superficial corrosion products.

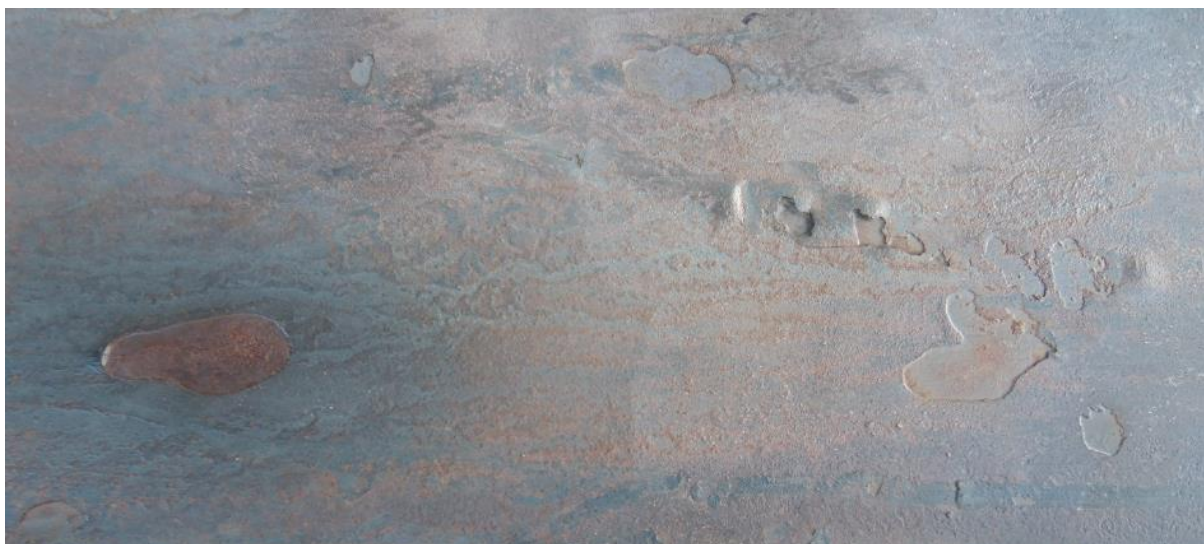
Figure 14. Spot-wise delamination and areas with low zinc thickness. This damage has probably come from the HDG process.

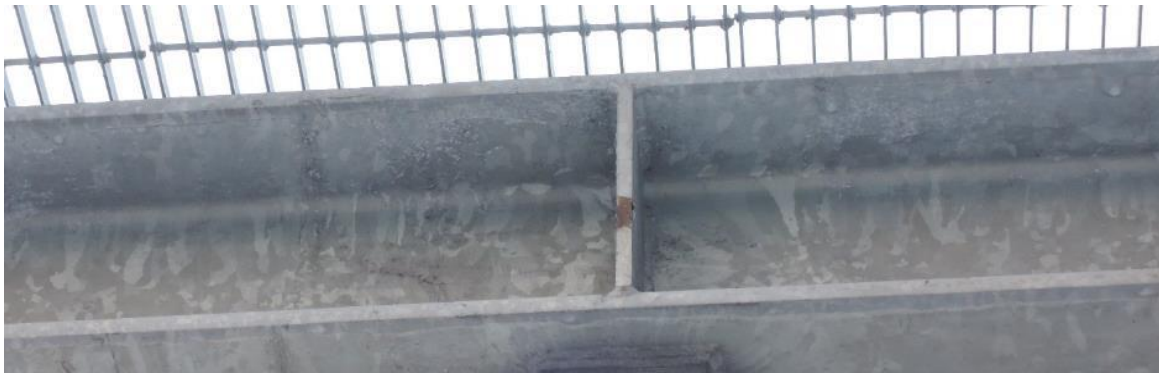
Figure 15. Damage in the HDG coating down to the steel substrate. The damage was located in a position that makes the cause likely to be flaking due to mechanical damage during transportation or structure assembly.

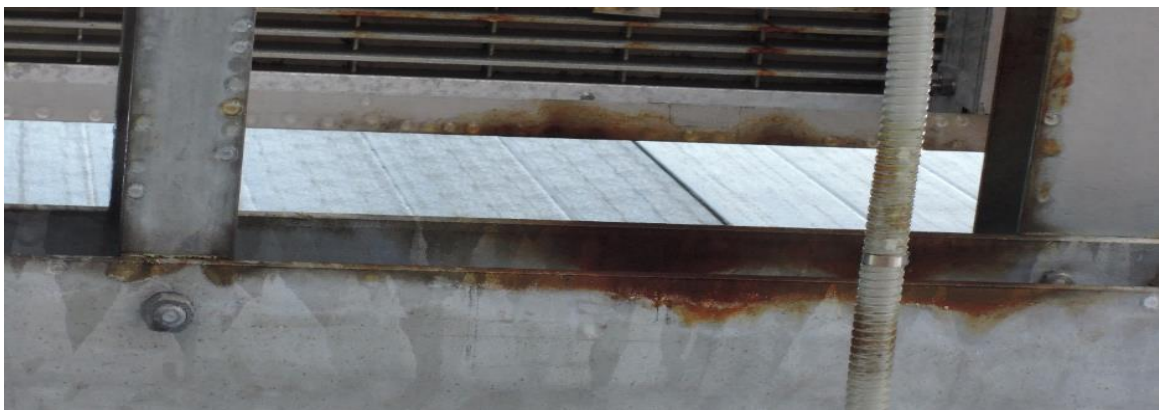
Figure 16. Discoloration from extraneous rust.

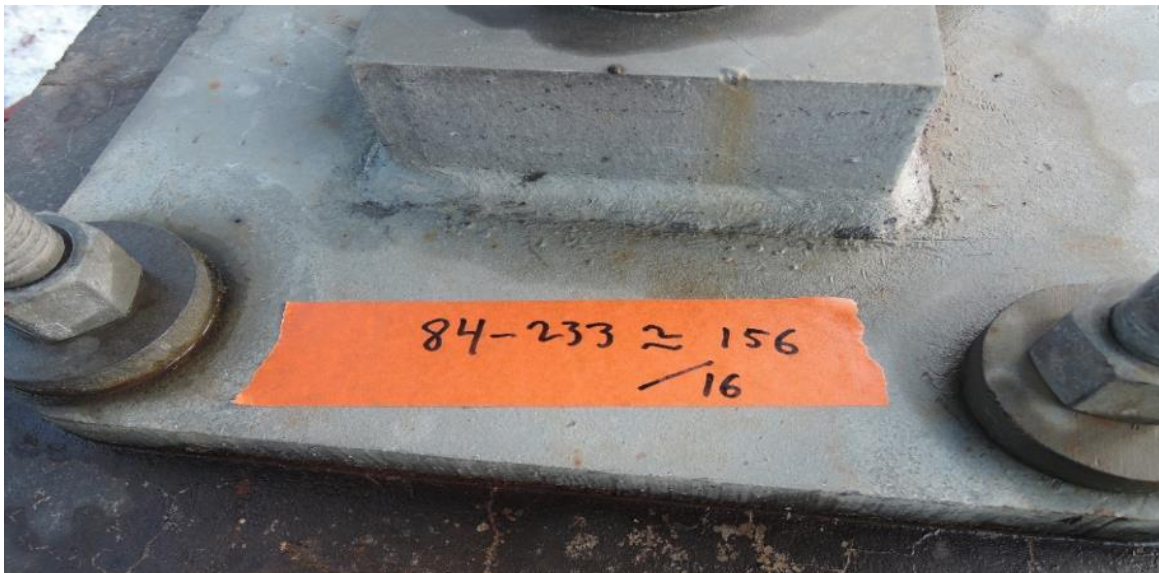
Figure 17. Sharp edges of HDG steel. If the HDG has adequate adhesion to the steel, sharp edges often not a problem with regards to corrosion. Rounded edges may however be motivated if the steel shall be coated with paint products to obtain a duplex coating, or if wear or impacts is anticipated during shipping, handling or service of the steel members. Thermally cut edges may produce a HDG coating with insufficient coating thickness and adhesion to the steel.

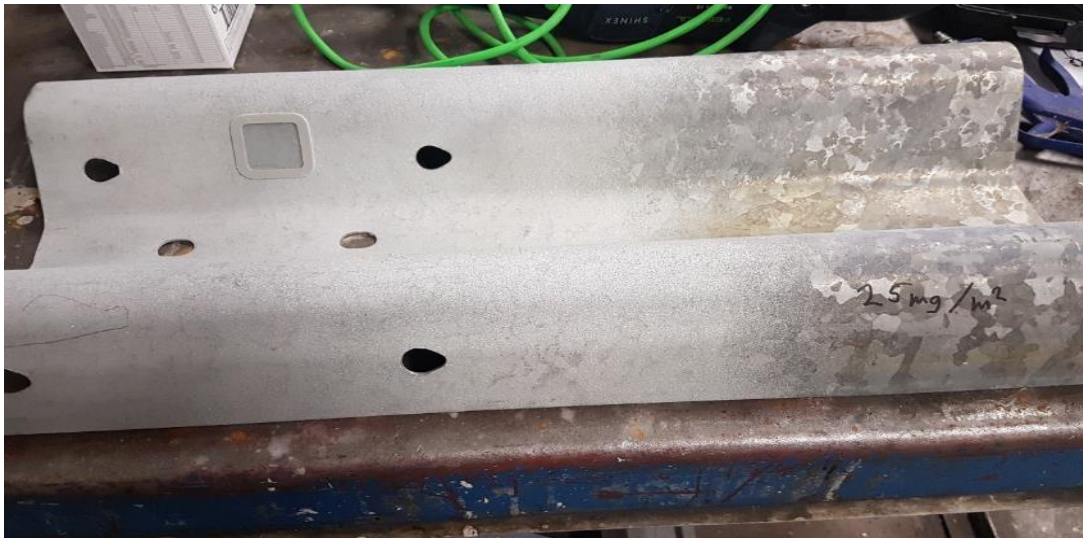
Figure 20. Road fencing that has been partly blasted with slurry blasting. One of the advantages with slurry blasting is that it is relatively easy to wash the surface before blasting, as well as during blasting. Bresle measurements after slurry blasting showed a low salt content on the surface, 25 mg/m².
