Inspection of reference objects coated with various zinc rich coatings

Björn Tidbeck, Bror Sederholm

Report number. 15660-1

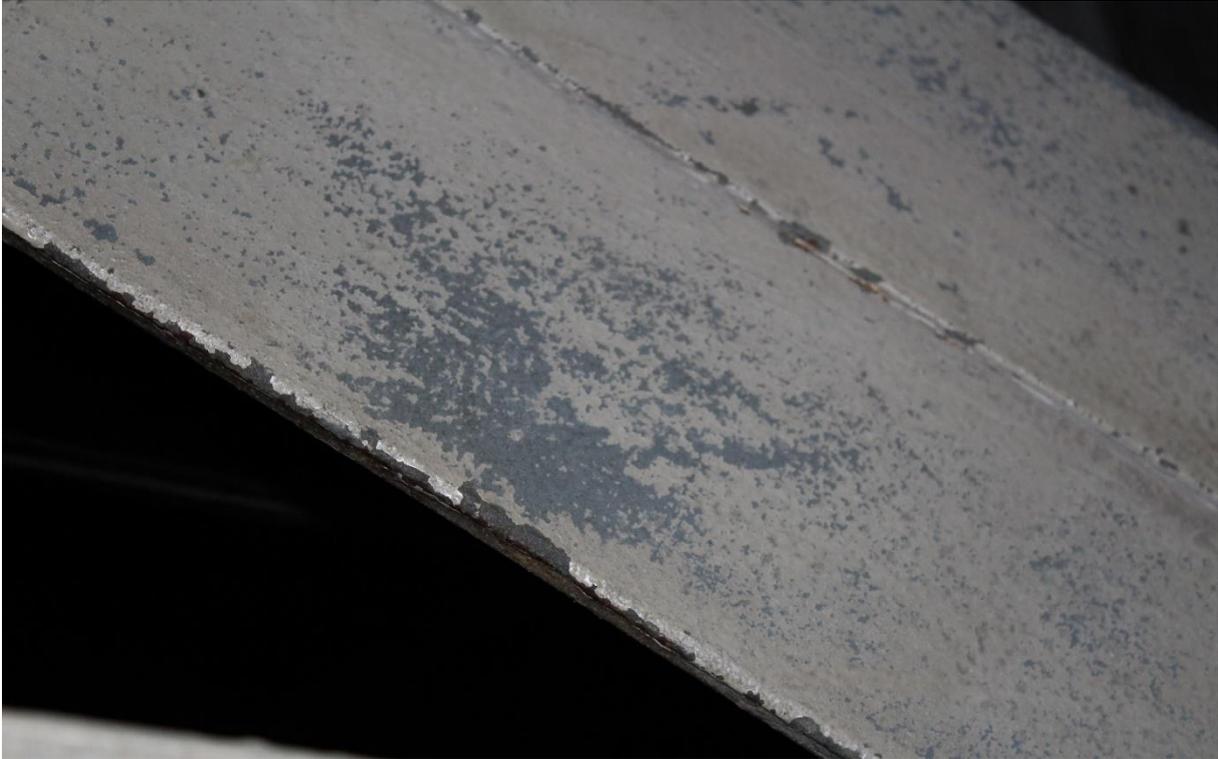
Figure 4. A steel beam in the supporting structure that had been subjected to wear from bypassing visitors. The coating on the edge of the steel beam had been scraped off leaving the underlying steel exposed to the air.

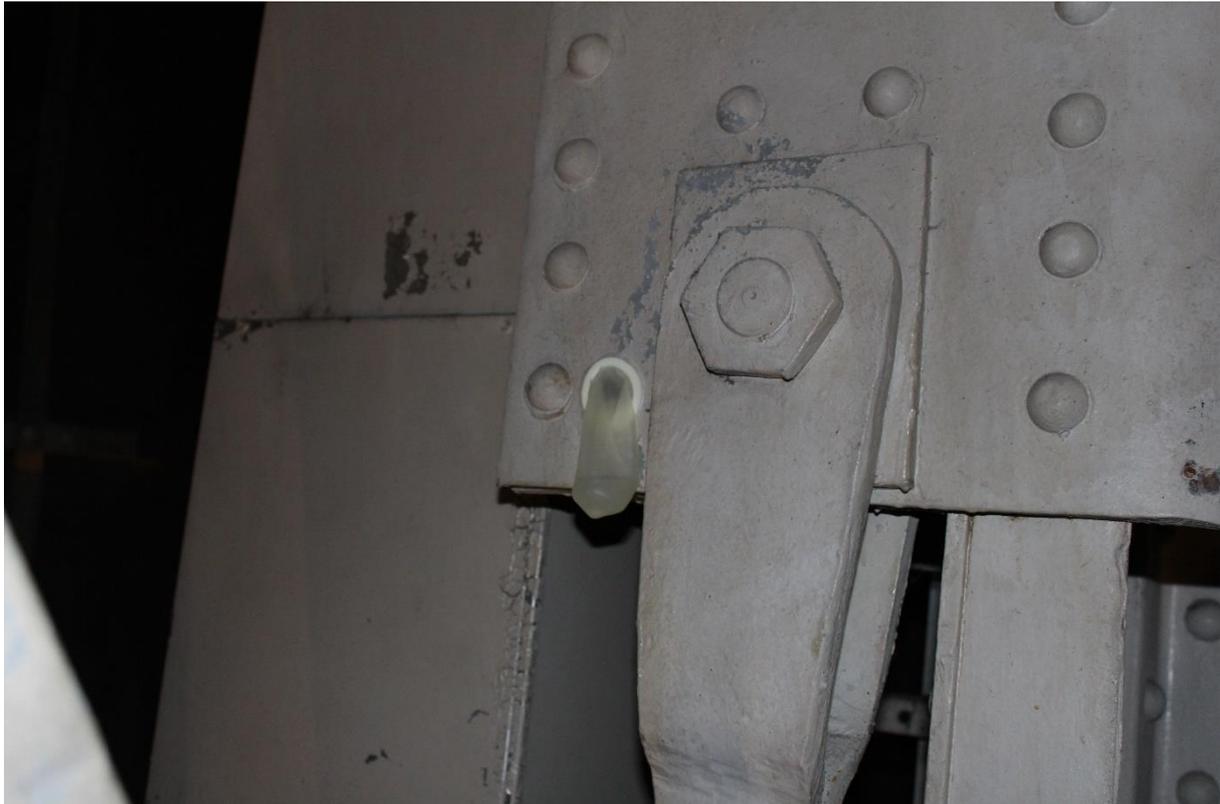
Figure 6. Two Bresle tests were carried out, the amount of soluble salts was equivalent to about 600-800 mg Cl/m². According to the warden of the statue, there had previously been quite a lot of holes in the copper cladding and the high salt content could be a result of rainwater seeping through the cladding. The high salt content on the surfaces could also have been obscured by zinc salts and hydroxides from the silicate coating.

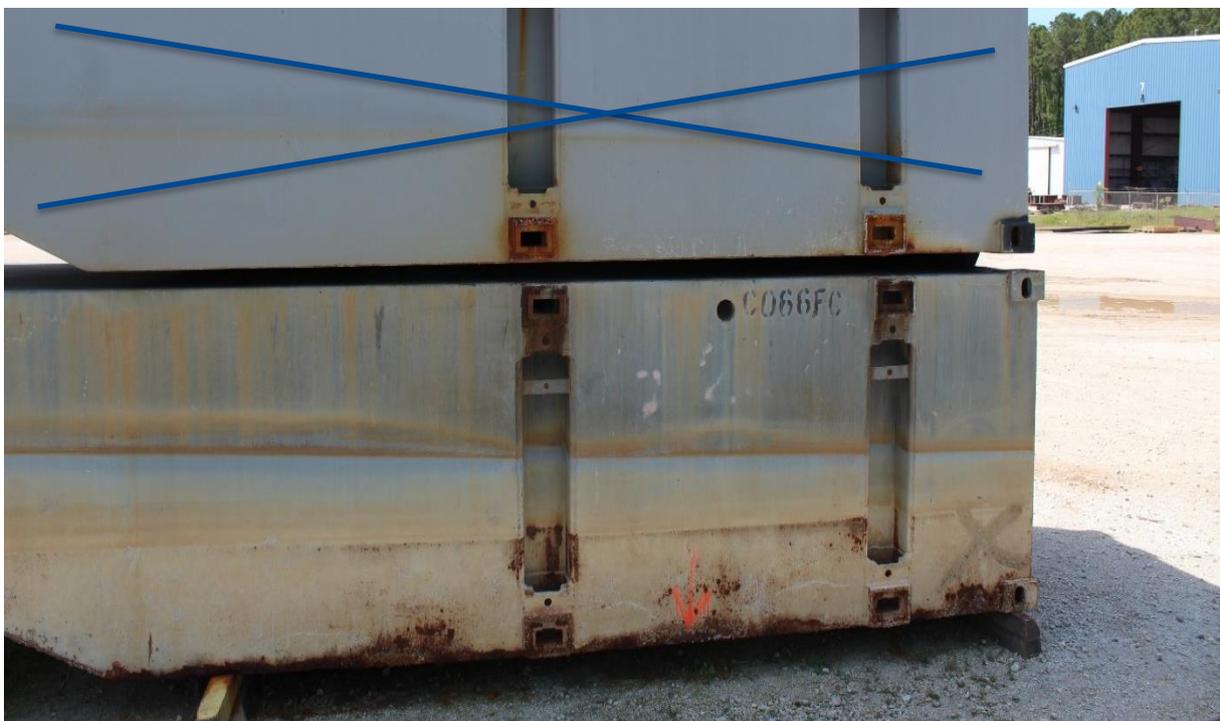
Figure 10. Unit C066FC, probably manufactured during early 1990. The DFT above the 1st waterline was about 180 μm , between water lines about 90 μm , below the 2nd water line 30 μm . Below the 2nd waterline rust and barnacles were found.

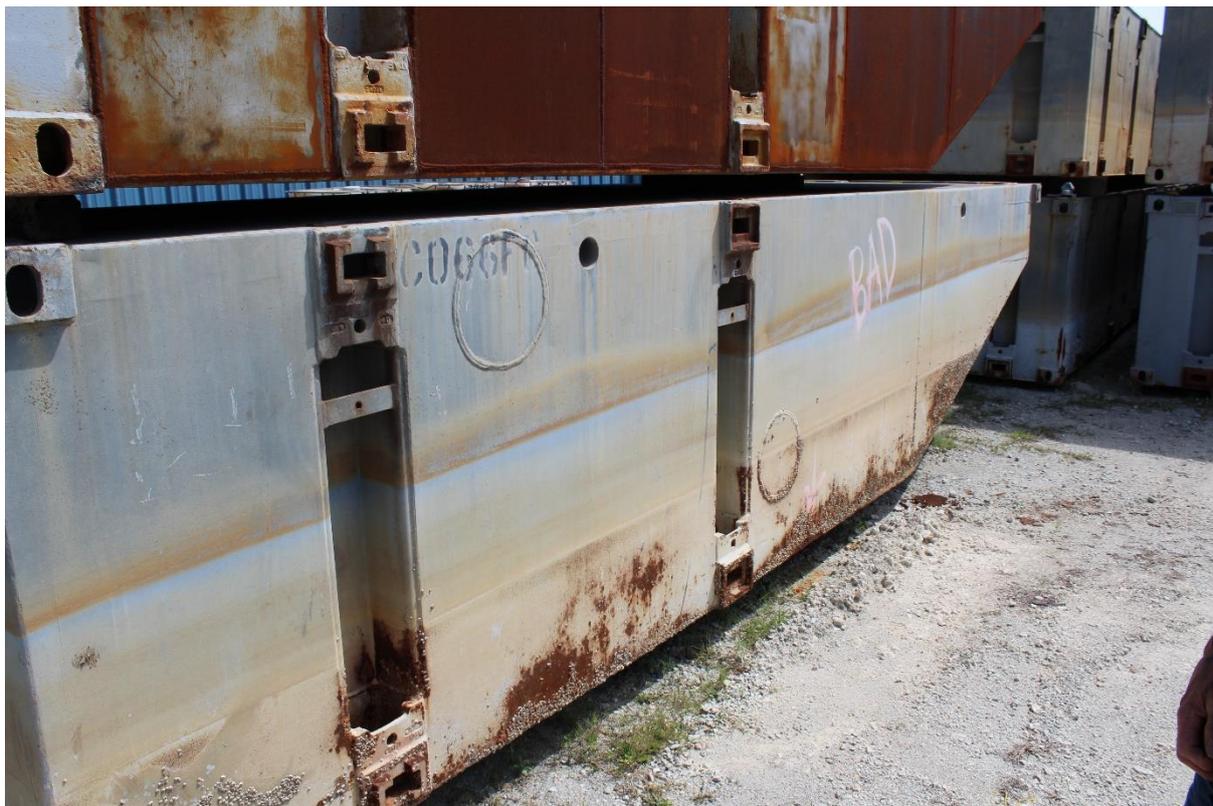
Figure 11. Unit C066FC, the presence of barnacles below the second waterline could be an indication that all zinc has been consumed and as a result, the barnacles can start to grow.

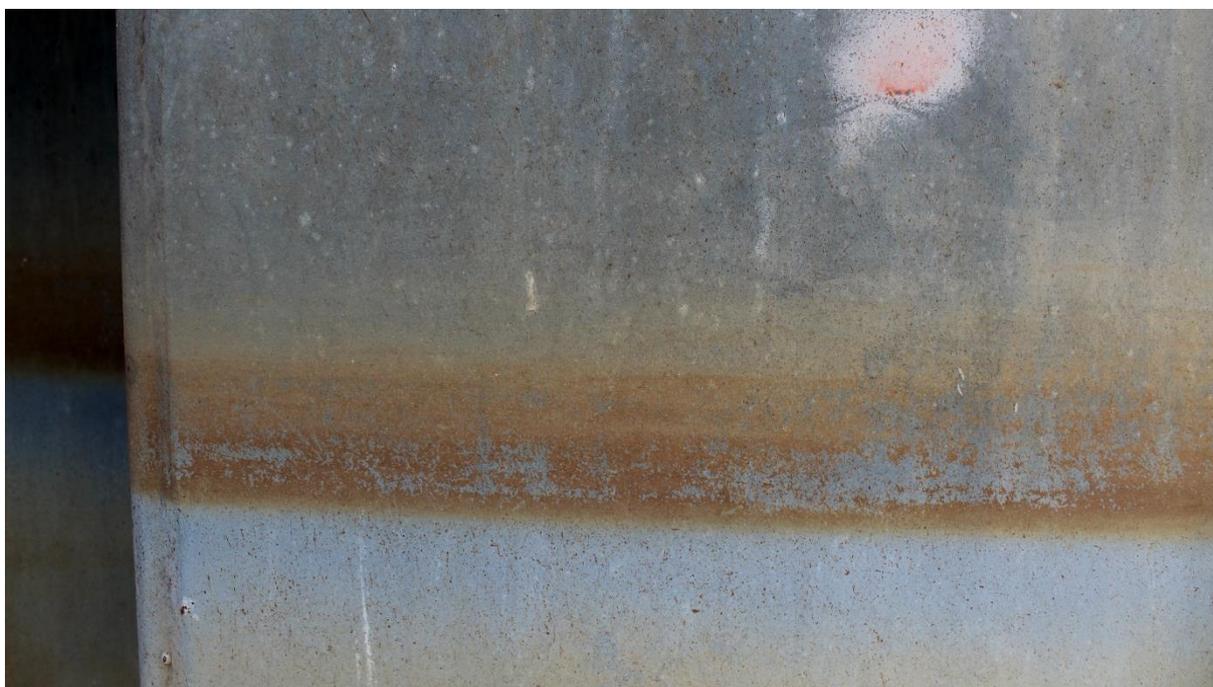
Figure 12. Unit C066FC Closeup picture of the waterline.

Around the splash zone of the 1st waterline of unit C066FC some small rust spots could be seen. Probably these spots were due to micro-cracking or small imperfections in the coating during its early exposure. This behavior has been demonstrated by accelerated corrosion testing at the RISE KIMAB corrosion lab. The micro-cracks are not visible to the naked eye, but since the coating is porous, the surface can easily become discolored by the rust that forms in the cracks, and the surface appears as though it is rusting. It appears as though the coating has an ability to self-heal when it is exposed further. One explanation for this behavior could be that the micro-cracks seal by the formation of insoluble zinc salts from the coating. It is likely that these type of rust spots are mostly an aesthetical problem. In cooperation with Tikkurila Sweden, we have seen that the coating shows some tendency to form micro-cracks if the coating is applied at a too low relative humidity, (about 30%) or if the coating is applied at a too long spraying distance. These findings are also supported by research reports from NASA [9].

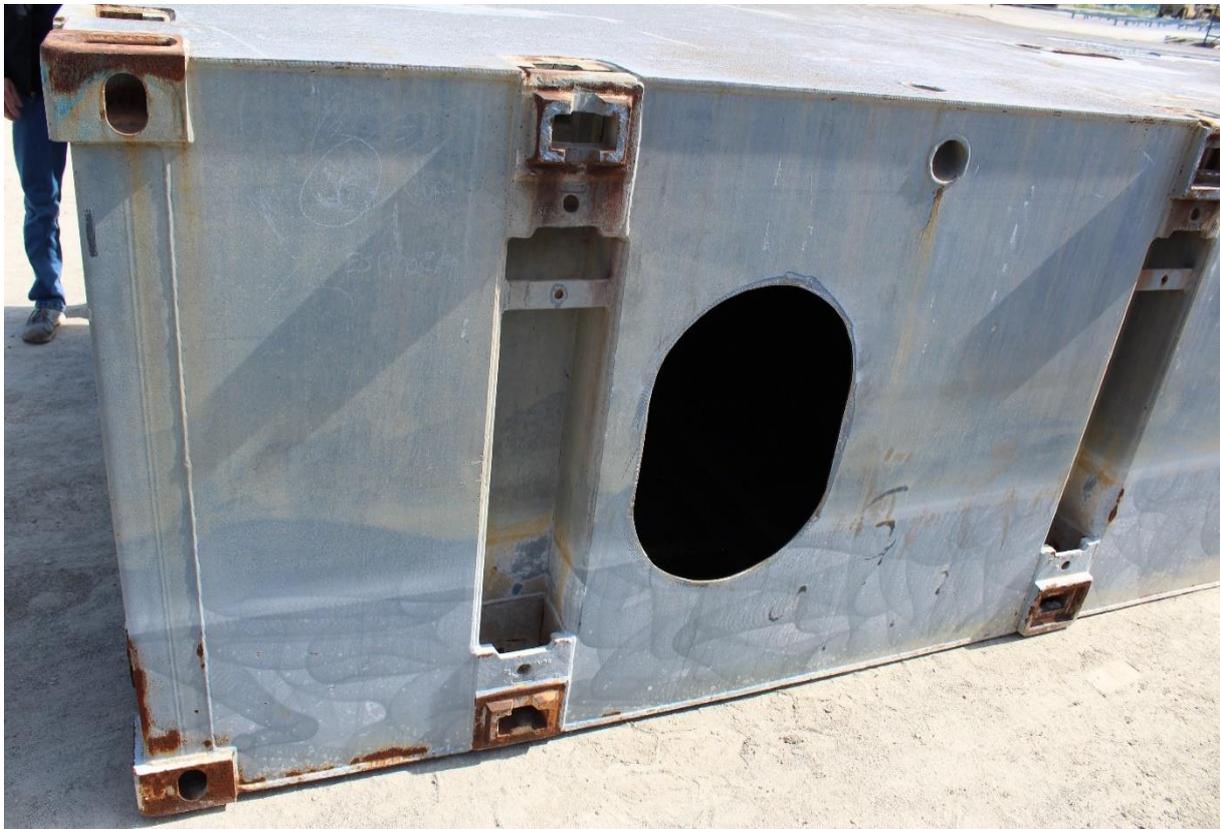
Figure 13. Unit L0 200, manufactured 18 years ago. This unit had been washed with a rotating high-pressure equipment, probably to remove barnacles. Most surfaces, edges and welds were essentially free from corrosion. The joints where the units are linked together have started to rust, these areas are however subjected to high mechanical wear.

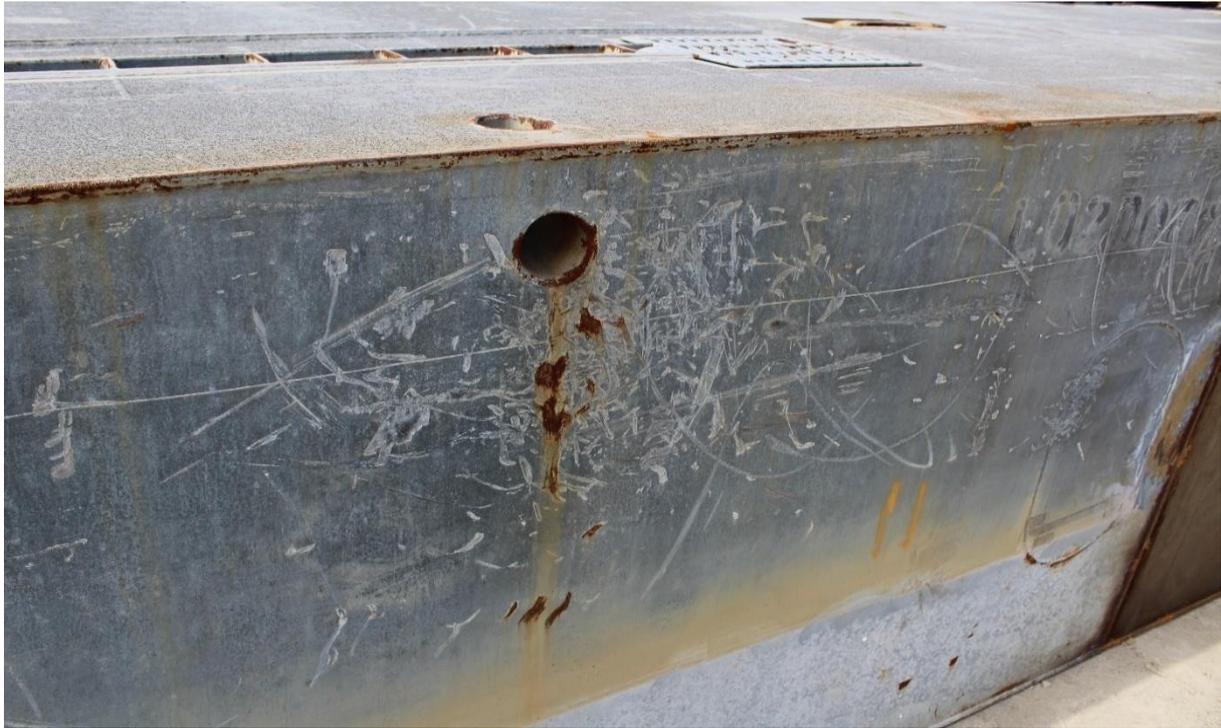
Figure 14. Unit L0 200, a surface subjected to mechanical damage. The coating is relatively resilient towards impact and there was no chipping or flaking around the damaged areas. DFT in the scratches without rust was about 30 μm .

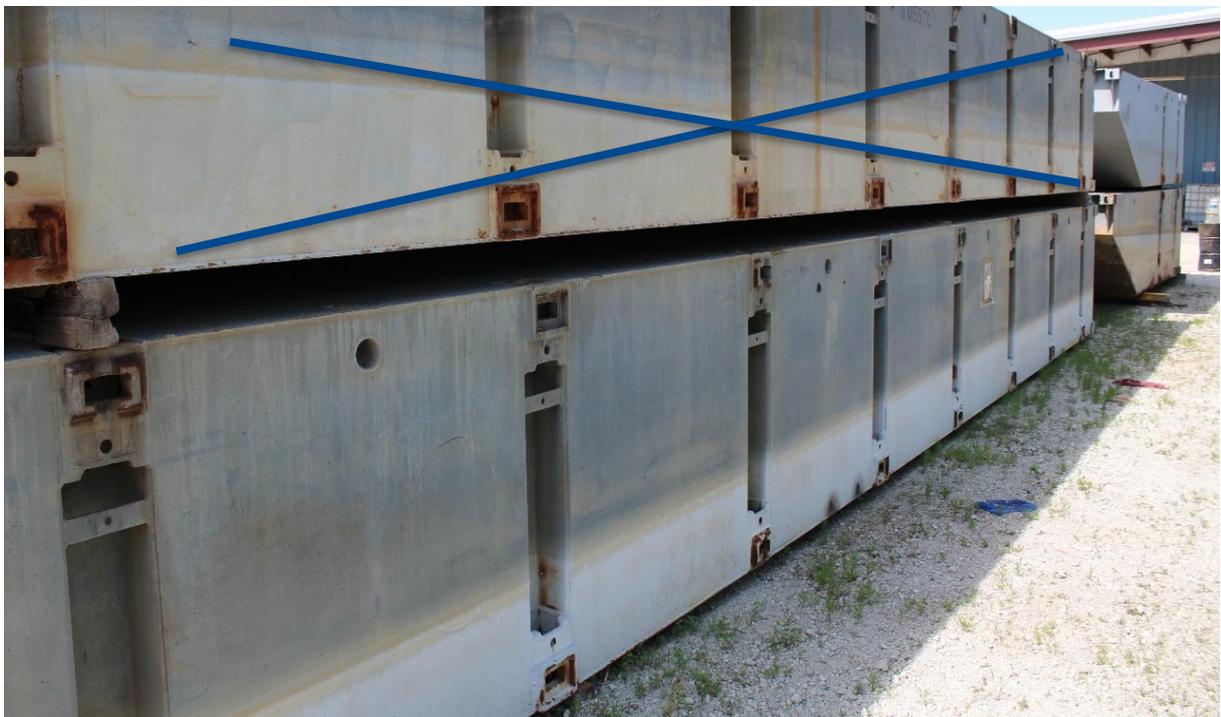
Figure 15. Unit P40 552, manufactured 13 years ago. This module was coated with a mean DFT of more than 400 μm without any visible mudcracking.

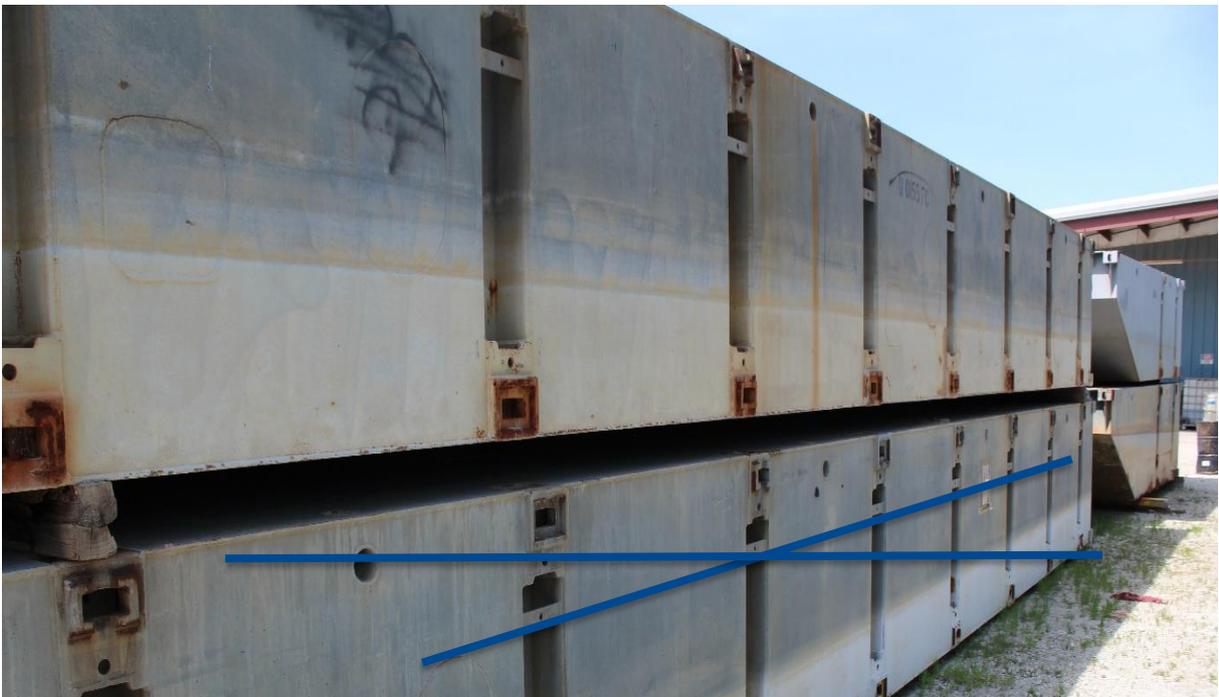
Figure 17. Unit Q155FC, probably manufactured during mid-1990. DFT about 350 μ m above the waterline and about 260 μ m below water line, no mudcracking could be found.

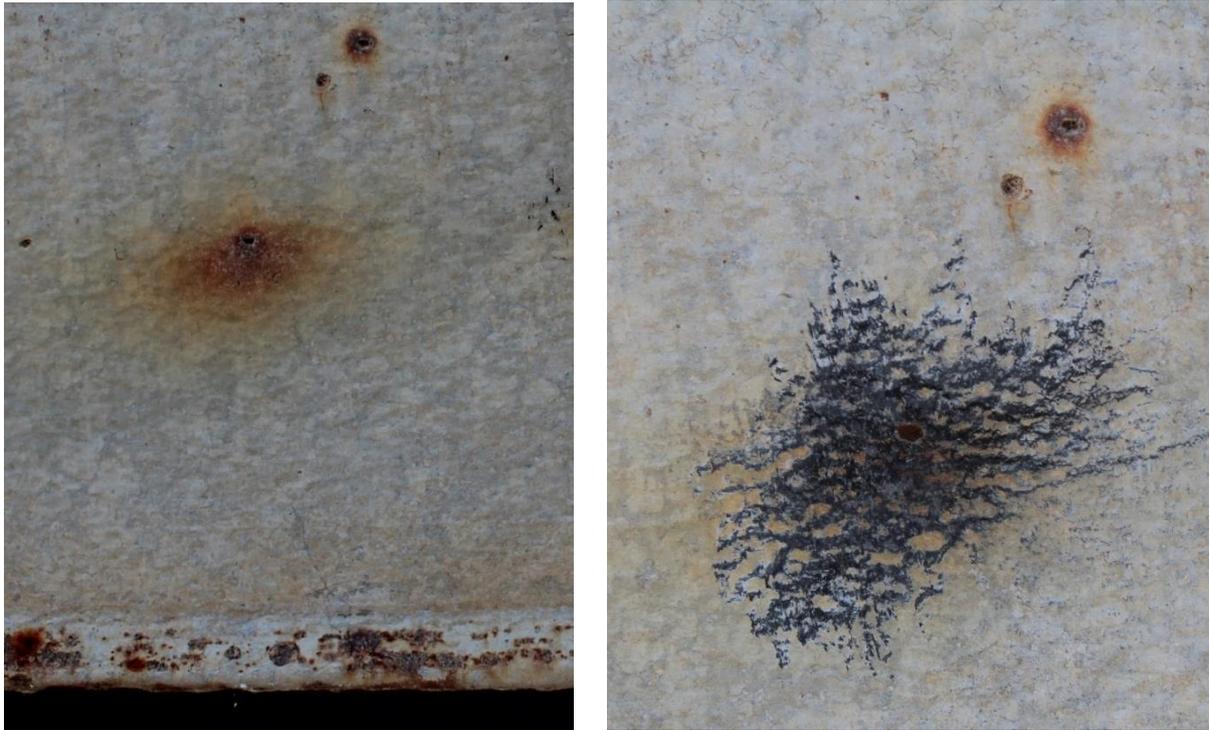
Figure 18. Unit Q155FC, to the left: pinholes and rust discoloration. To the right: The pinhole was abraded with a knife held at 90 degrees to the surface. There was no lateral rust creep from the pinholes, but intact zinc coating was found underneath the discoloration. The pit depth was approximately 2-3 mm.

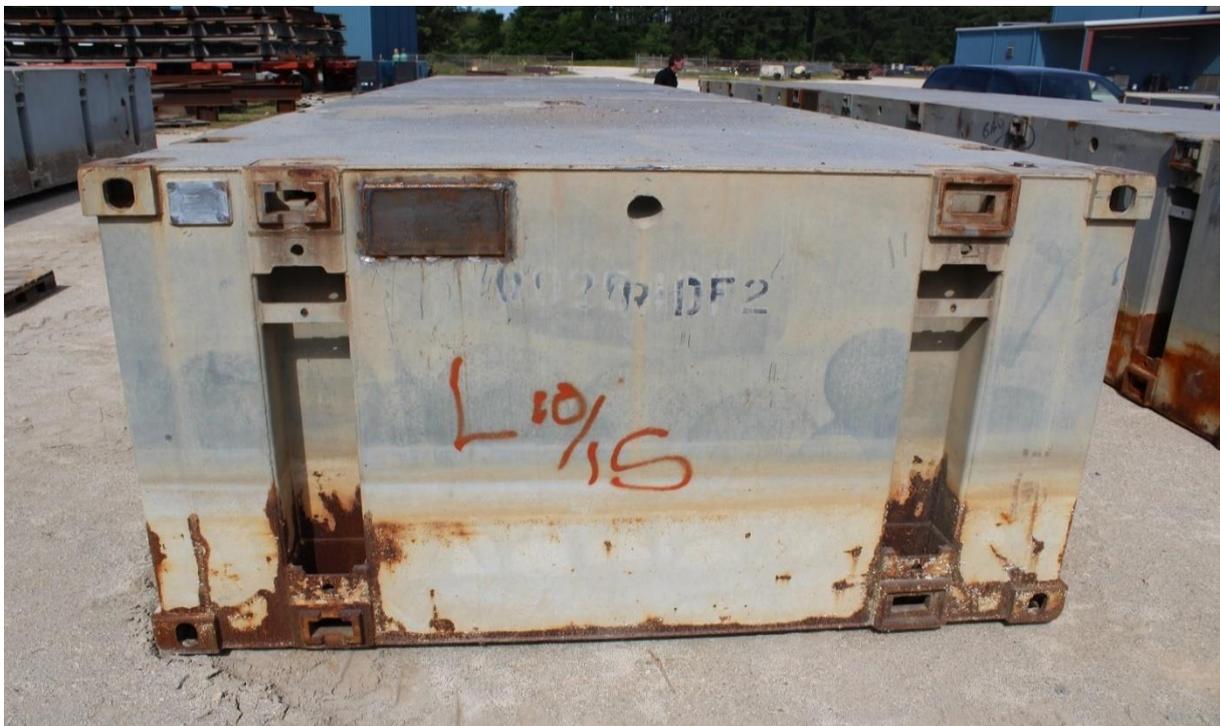
Figure 19. Unit Q0254, probably manufactured during early 2000. The zinc pigment appears to be consumed under the water line and as a result the steel has started rusting, some barnacles were visible. It appears that the coating deteriorates by gradual erosion from the outside and in rather than via flaking and under rusting.

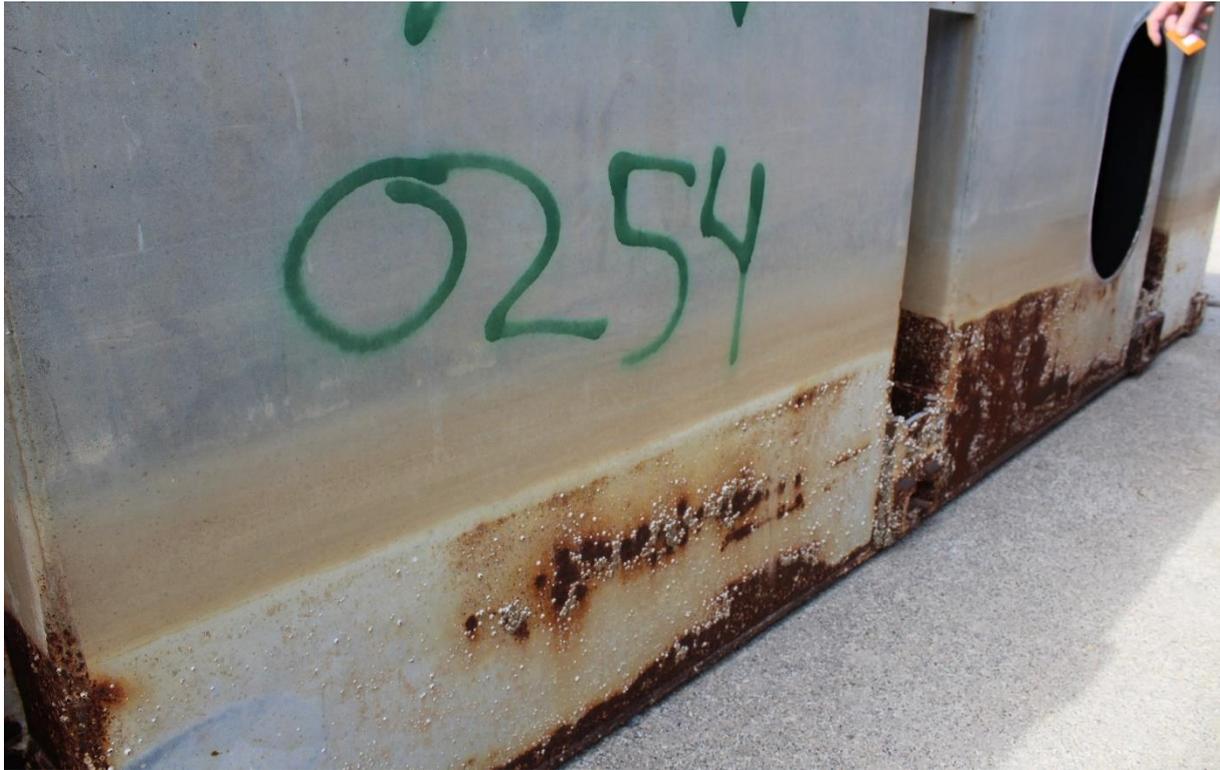
Figure 20. Unit Q0254 Barnacles under the waterline. Intact coating above the waterline

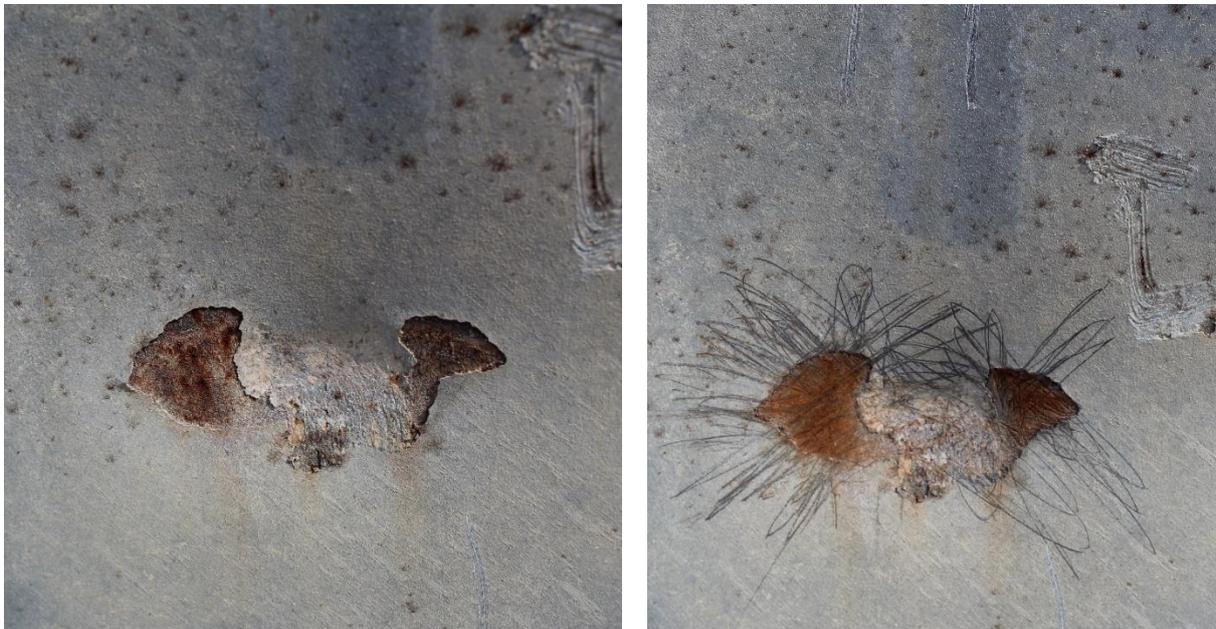
Figure 21. Unit Q0254 to the left: damage after impact. To the right: loose coating was removed with a screwdriver, no rust creep under the intact coating was observed.

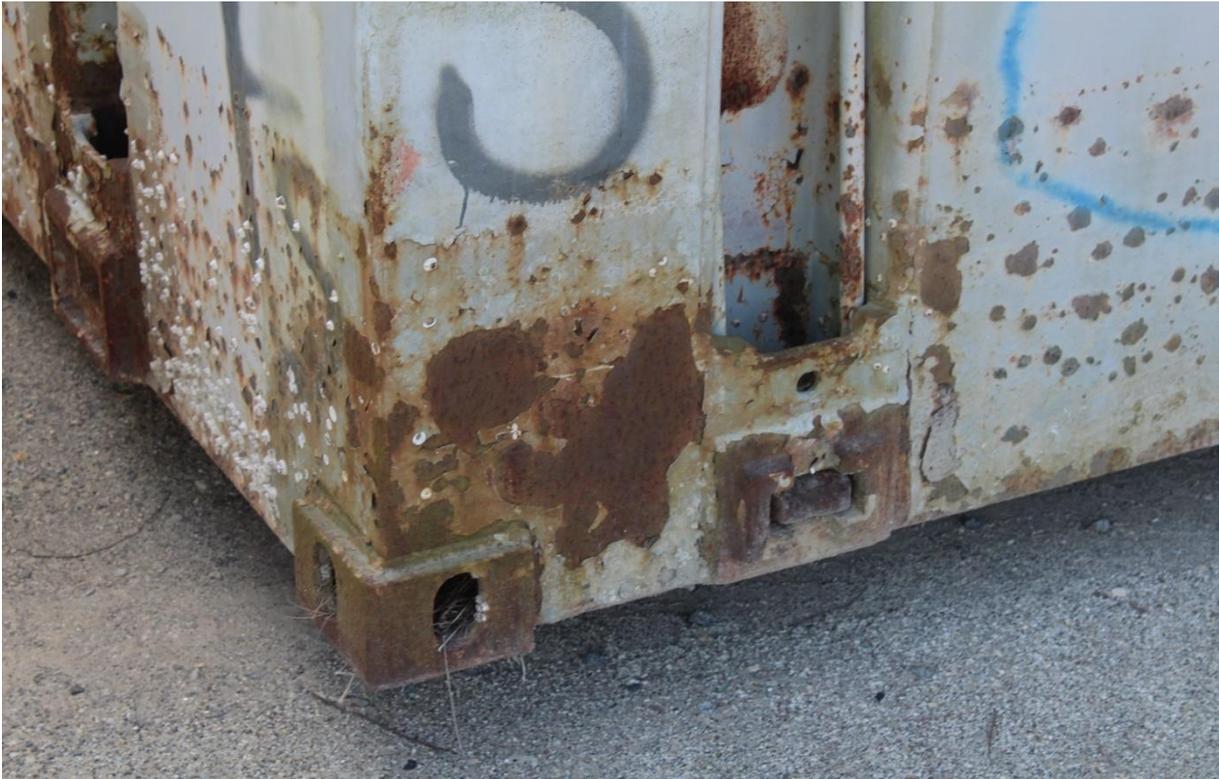
Figure 22. Reference units coated with 400 μ m epoxy. The coating had started to break down under the waterline.

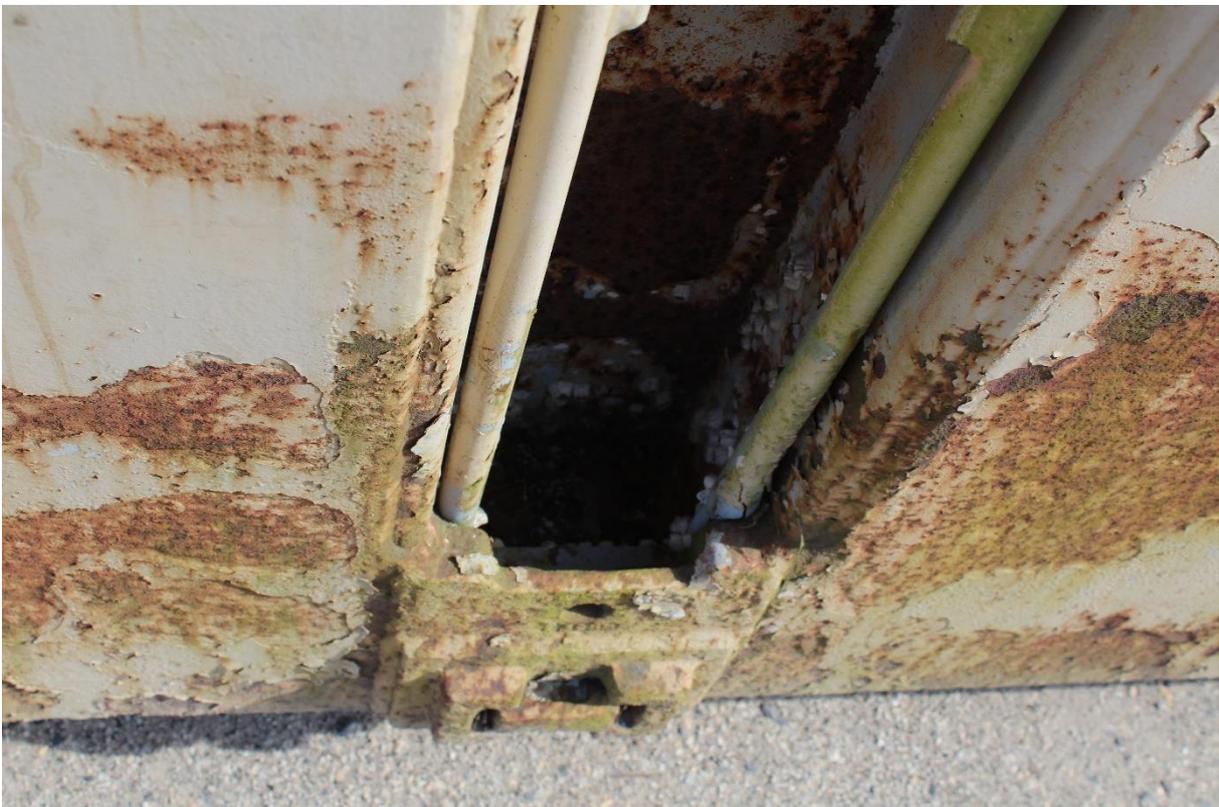
Figure 23. Reference unit coated with 400 μ m epoxy. Under rusting and flaking was found beneath the waterline.

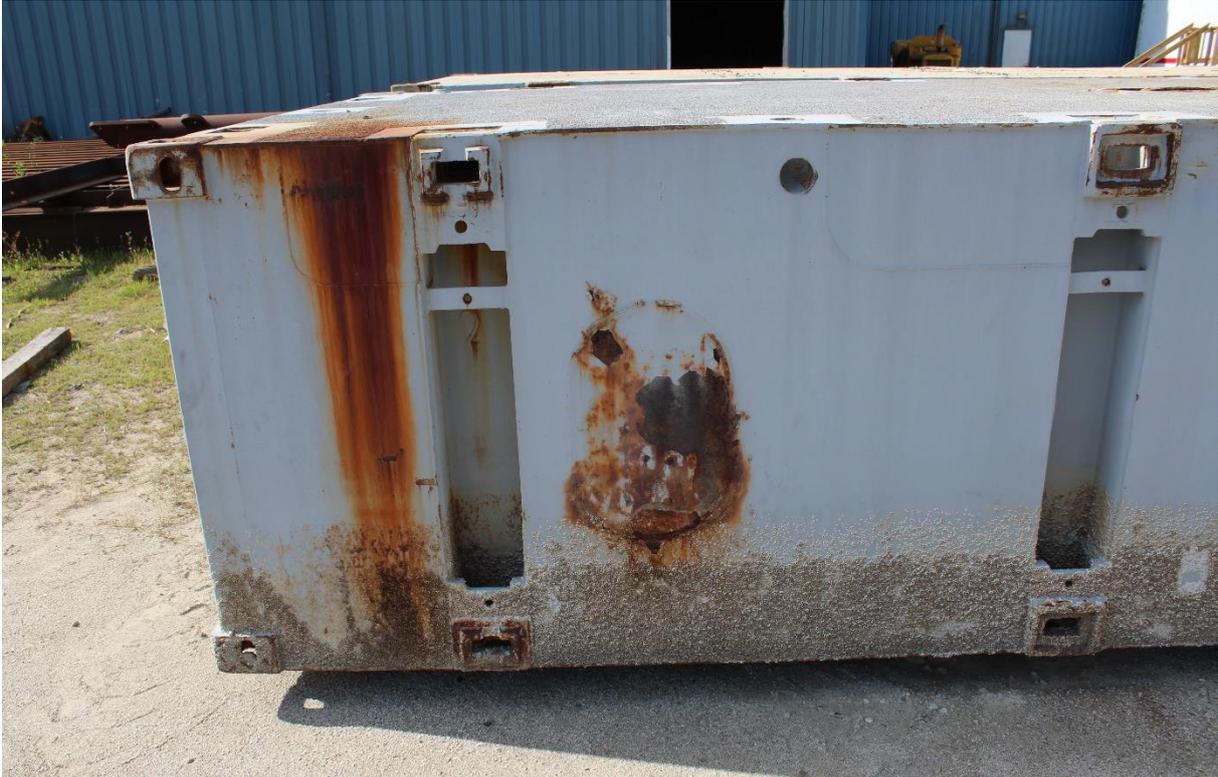
Figure 24. Reference unit coated with epoxy. Corrosion on welds around manhole. Significant growth of barnacles under the waterline.

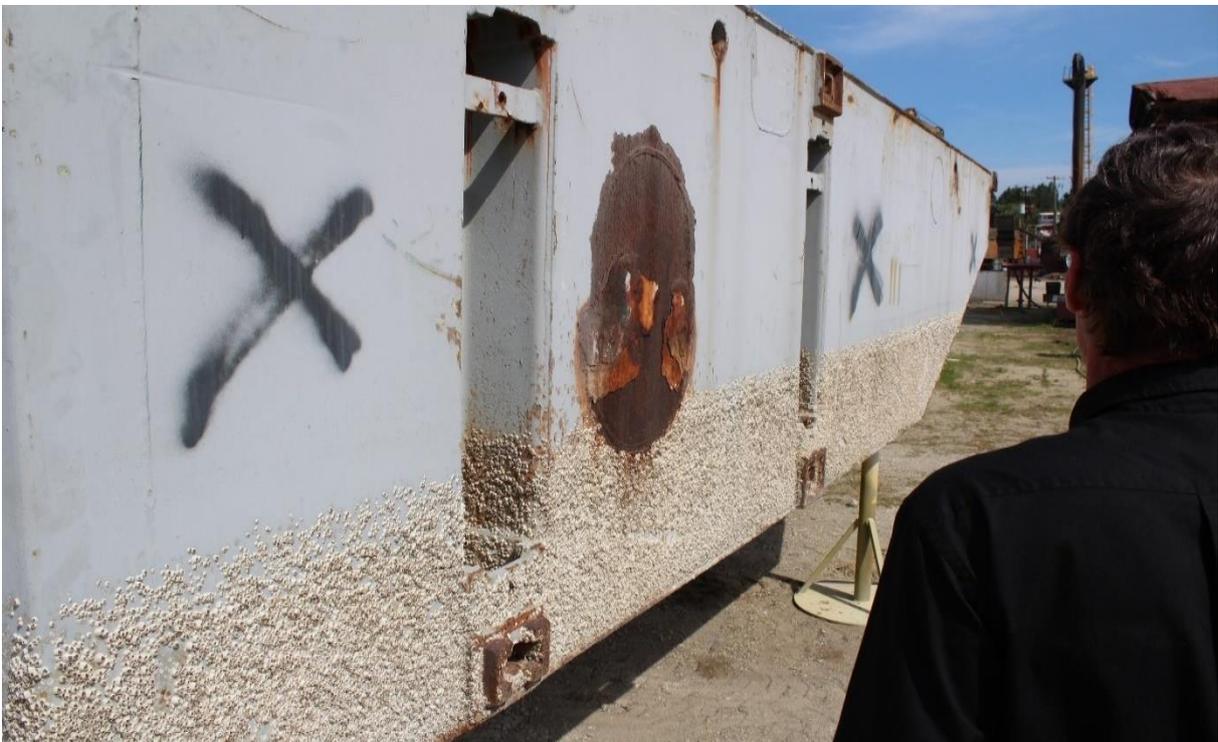
Figure 25. Reference unit coated with 400 μm epoxy. Barnacle growth under the waterline. Welds with insufficient pretreatment around the manhole had begun to rust and the coating had started to under rust.

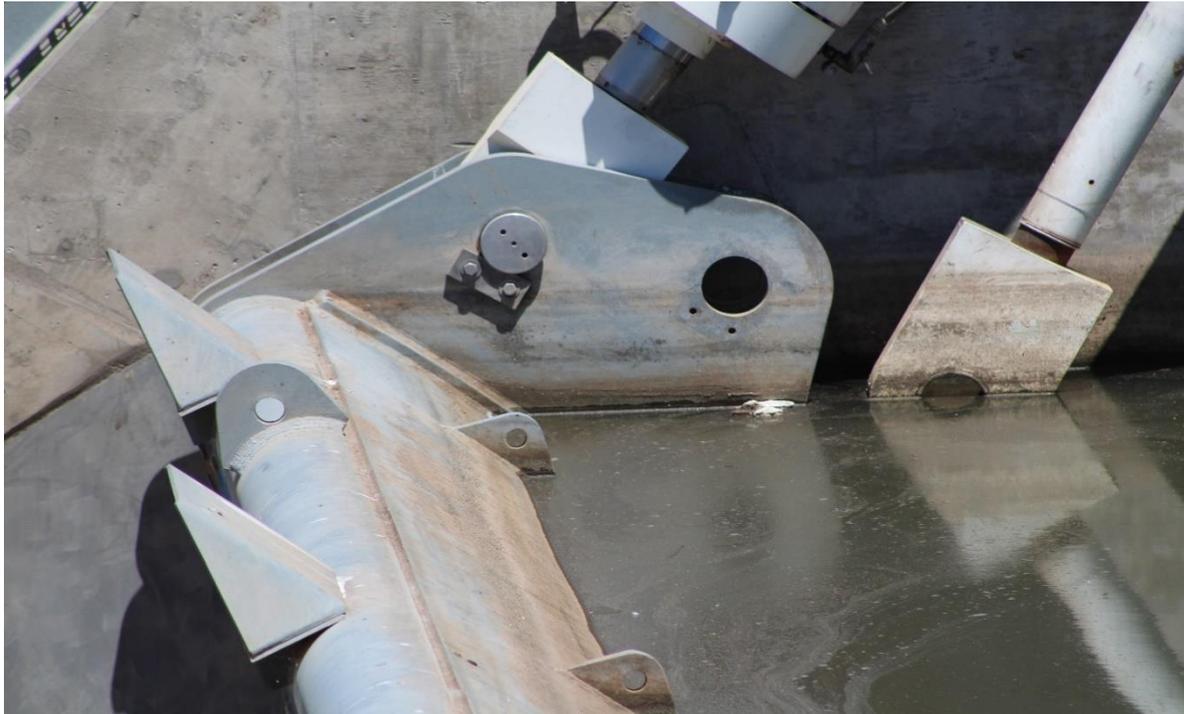
Figure 28. A picture of the wet side of a dam gate, notice the absence of corrosion around the hydraulic cylinder attachment points.

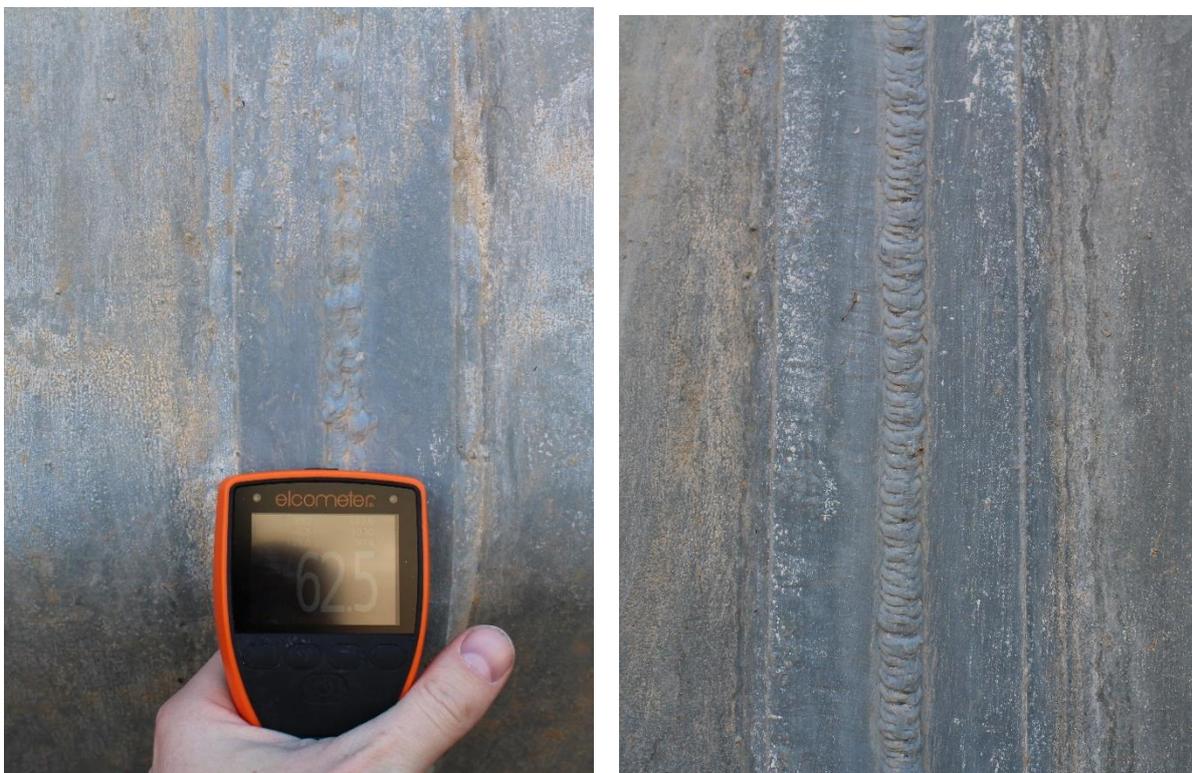
Figure 29. Welds between the two halves of dam gates. No signs of corrosion despite apparent poor pretreatment and low DFT. According to Earl Ramlow who was inspecting the installation of the dam gates, the weld has been laid through the coating and the resulting weld has been ground with a flap disc and painted with a brush to a DFT of about 60µm

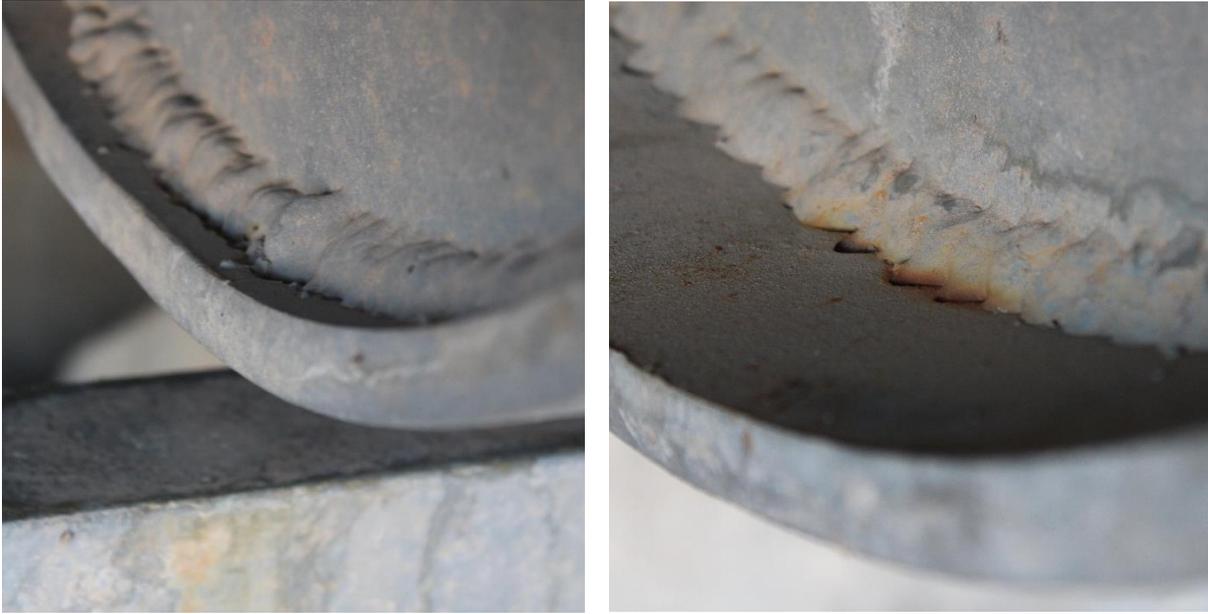
Figure 30. Irregular weld profiles with deep undercuts. To the left: generally, this type of weld was free from corrosion. To the right: a few poor welds had started to rust.

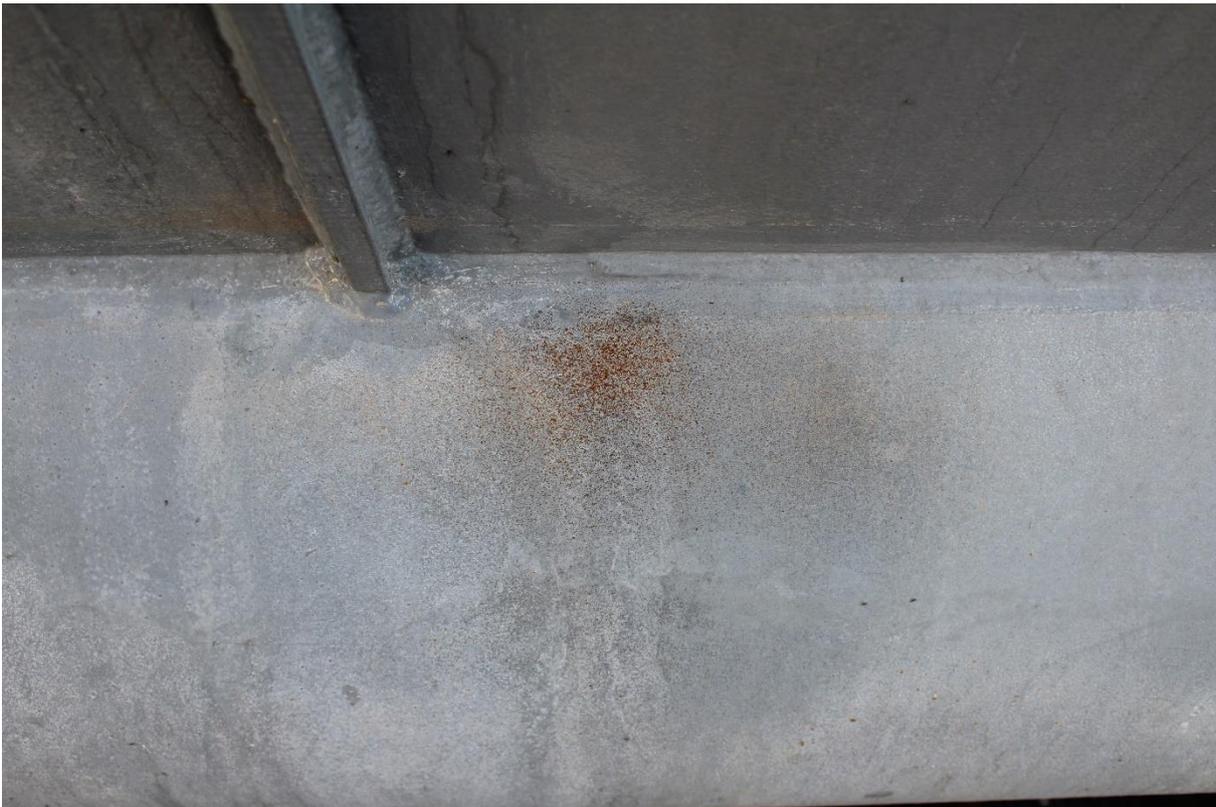
Figure 31. An area with rust spots. This could be a result of poor coverage or dry spray. Or it could be foreign matter from a disc grinder.

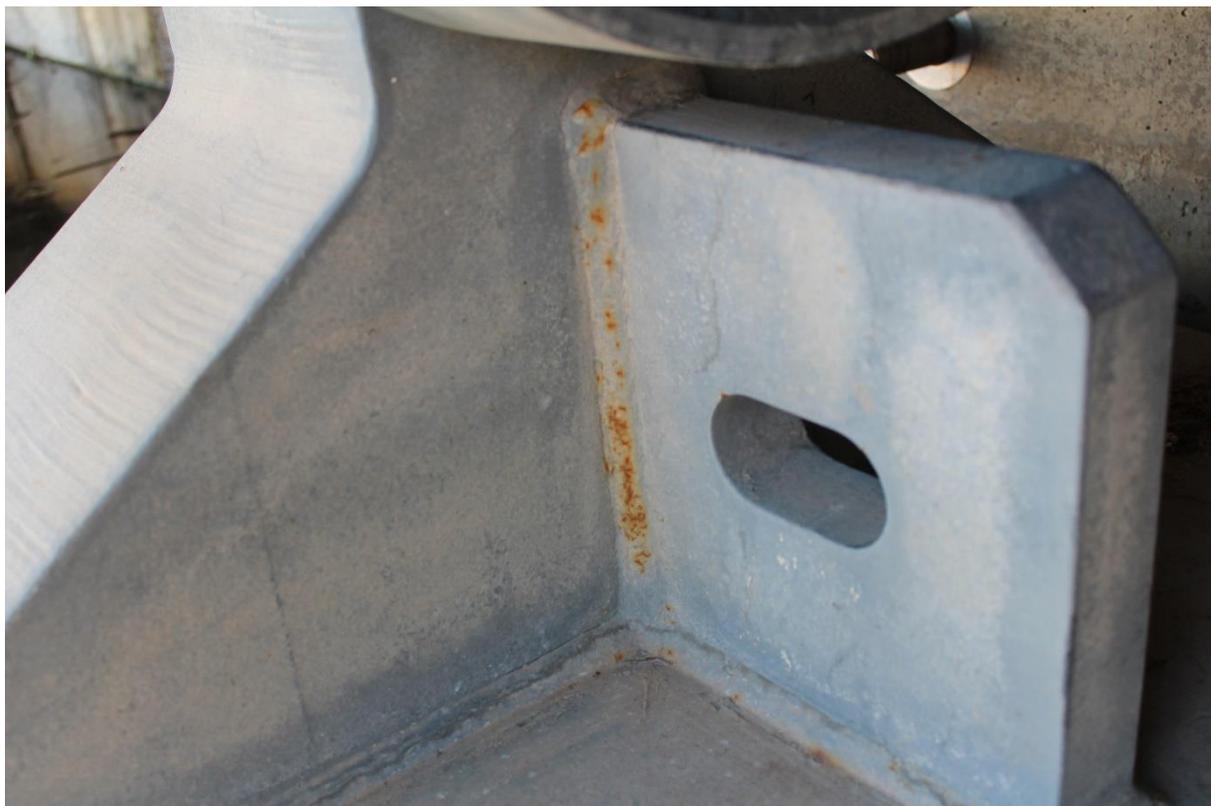
Figure 32. Rust on a weld with adequate smoothness. The premature coating failure on this weld is probably due to an inadequate blasting profile on the weld, which in turn had led to loss of adhesion.

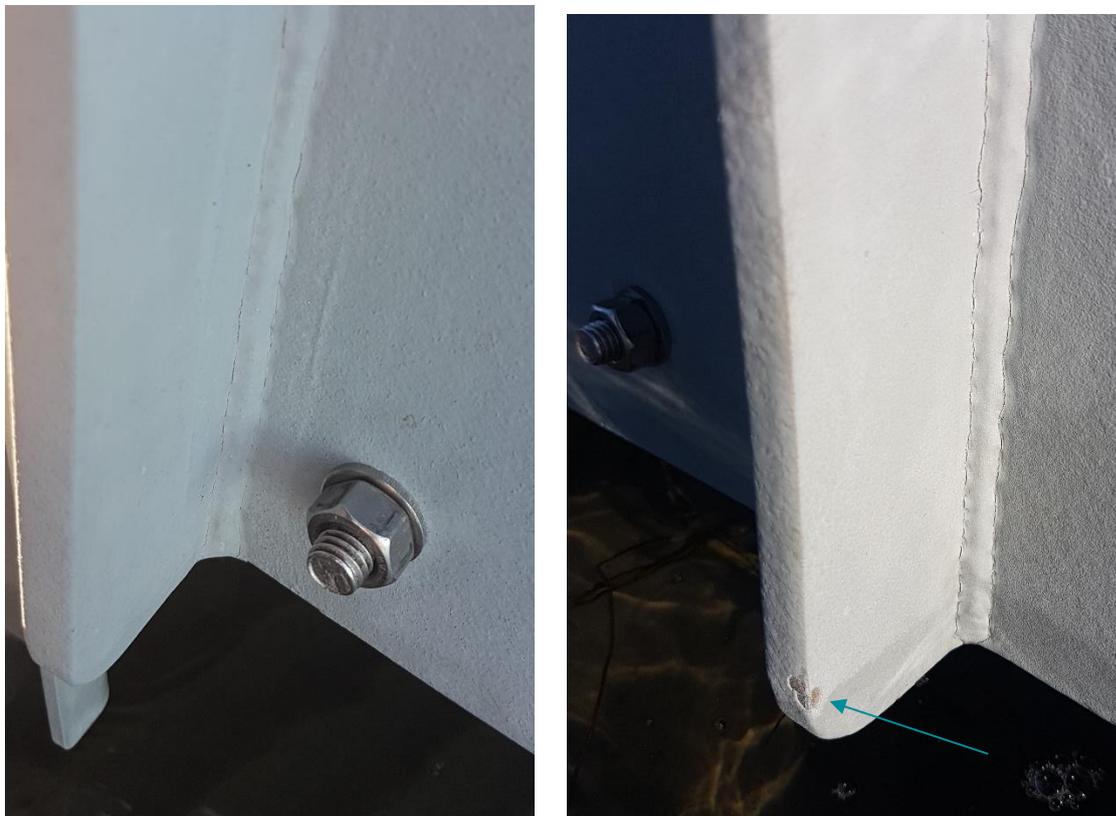
Figure 38. Cracks in the coating along an involute weld seem. It is likely that the cracks penetrate through the first coat but not the coating layer closest to the steel. To the right: A damage in the coating, no corrosion.
