Inspection of reference objects coated with various zinc rich coatings

Björn Tidbeck, Bror Sederholm

Report number. 15660-1

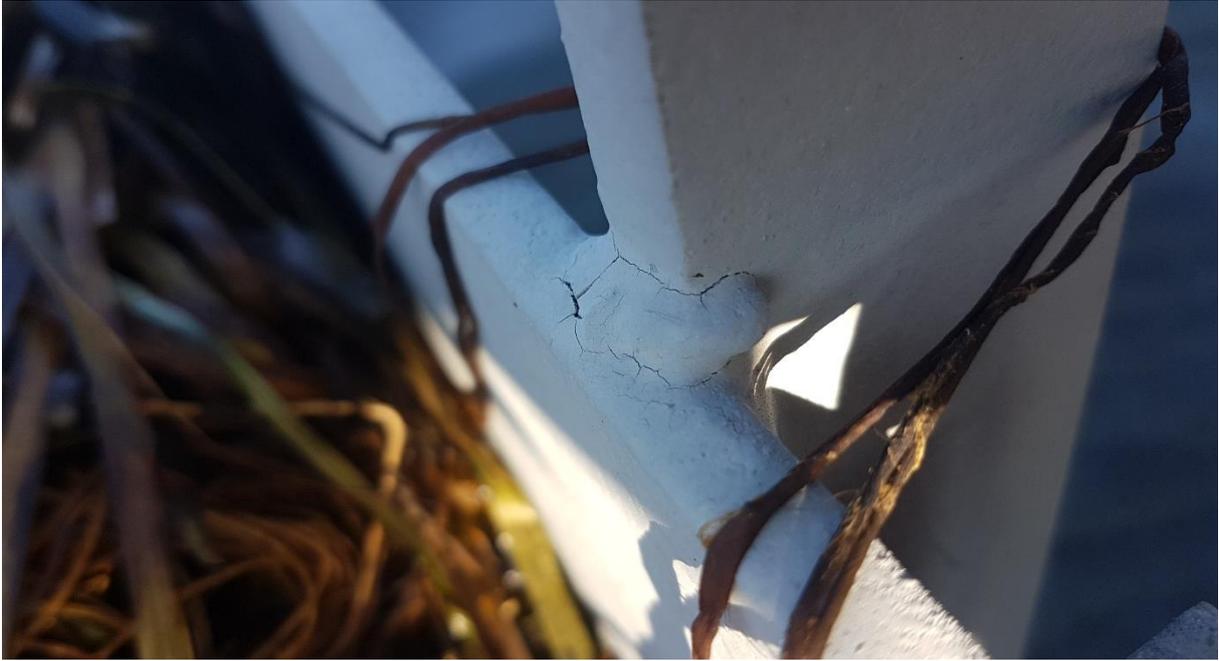
Figure 39. Mudcracking around a weld joining the girder of the ramp with one of the fencing poles.

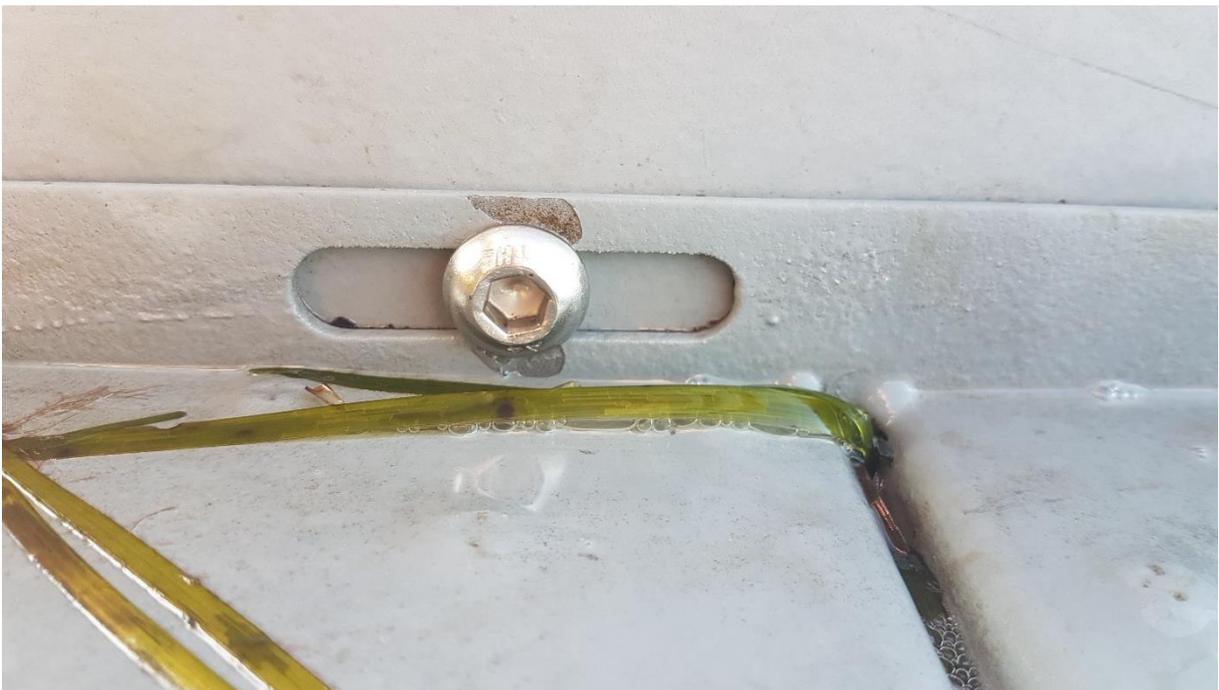
Figure 40. The coating had chipped around this stainless allen bolt. There was however little or no corrosion. One reason for this could be that the silicate binder creates a passivating silicate layer on the steel. Another explanation could be that the coating is protecting the steel cathodically.

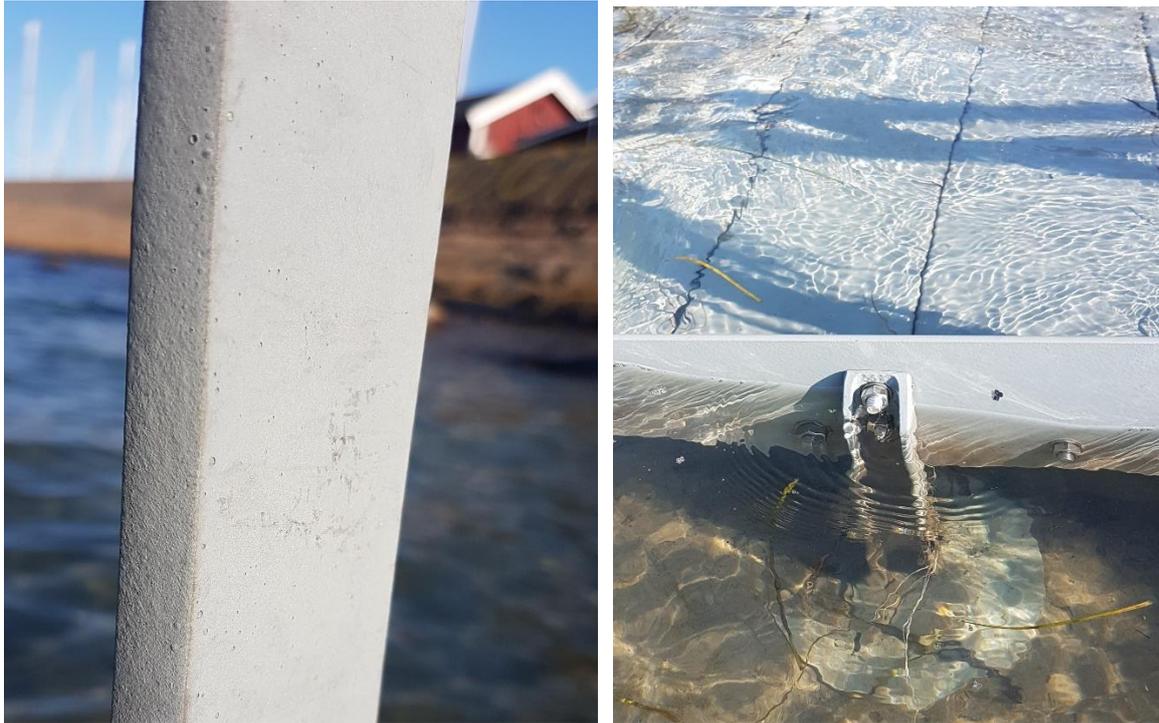
Figure 41. To the left: some craters on a pile for the fencing. To the right: support leg bolted in the girder of the ramp.

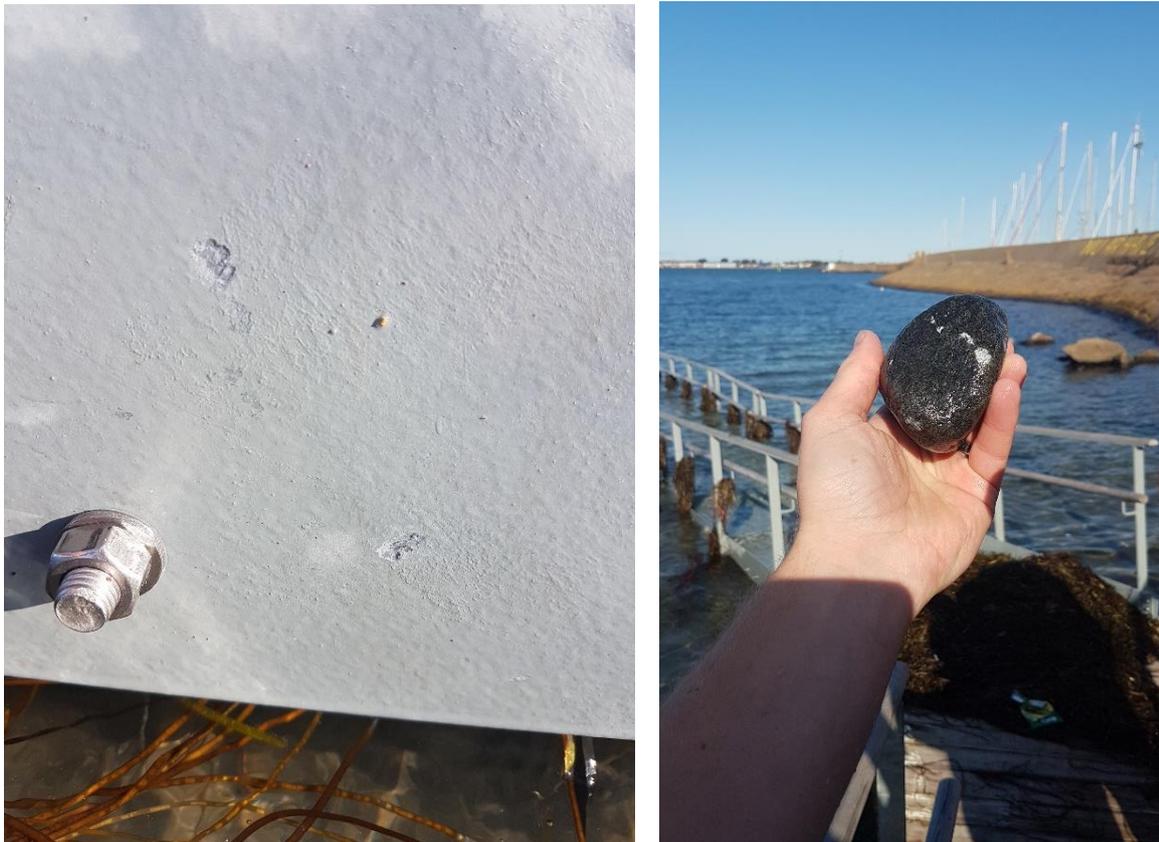
Figure 42. A damage in the coating was introduced by throwing a rock at the outside girder of the ramp. The impacts tended to create indentions in the coating rather than chipping it. Some zinc got stuck on the stone. The DFT in the indentations was about 40 μ m.

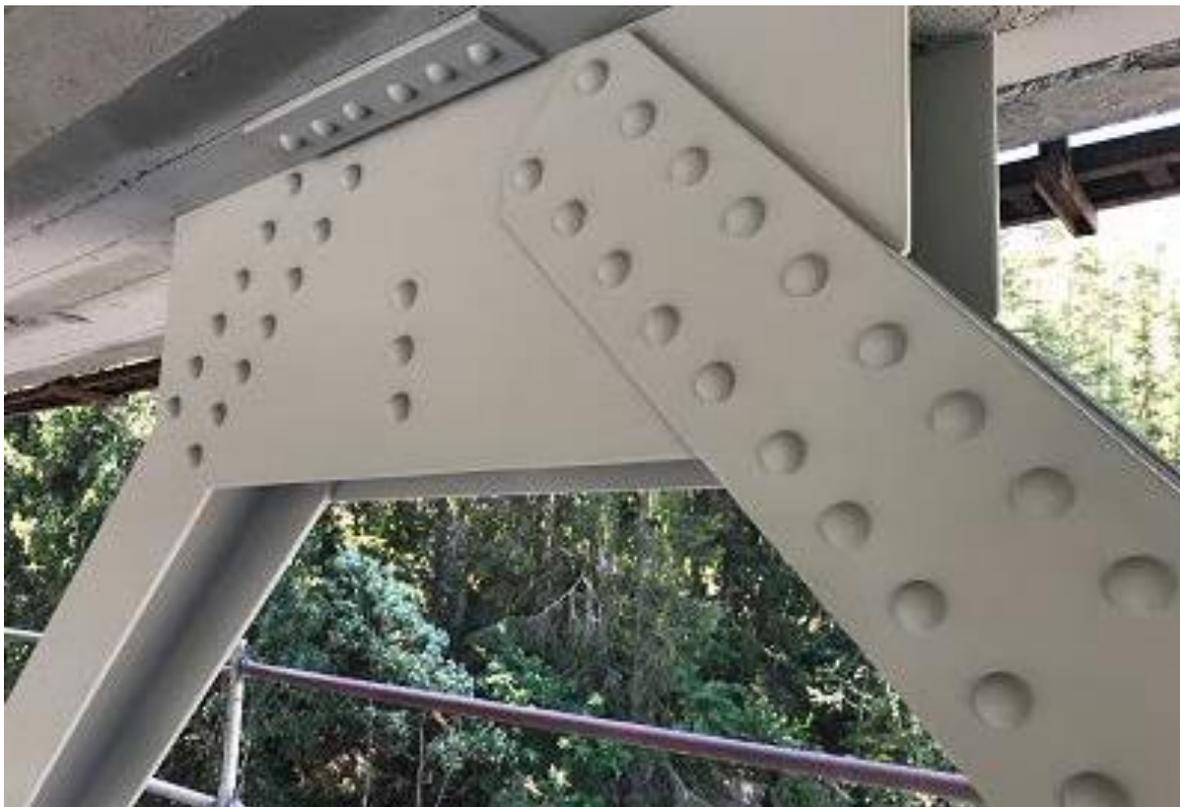
Figure 45. The coating refurbishments appeared good. All rivet heads had been painted by brush before a final layer of sprayed Zinga was applied. No sags, running or cracking could be found.

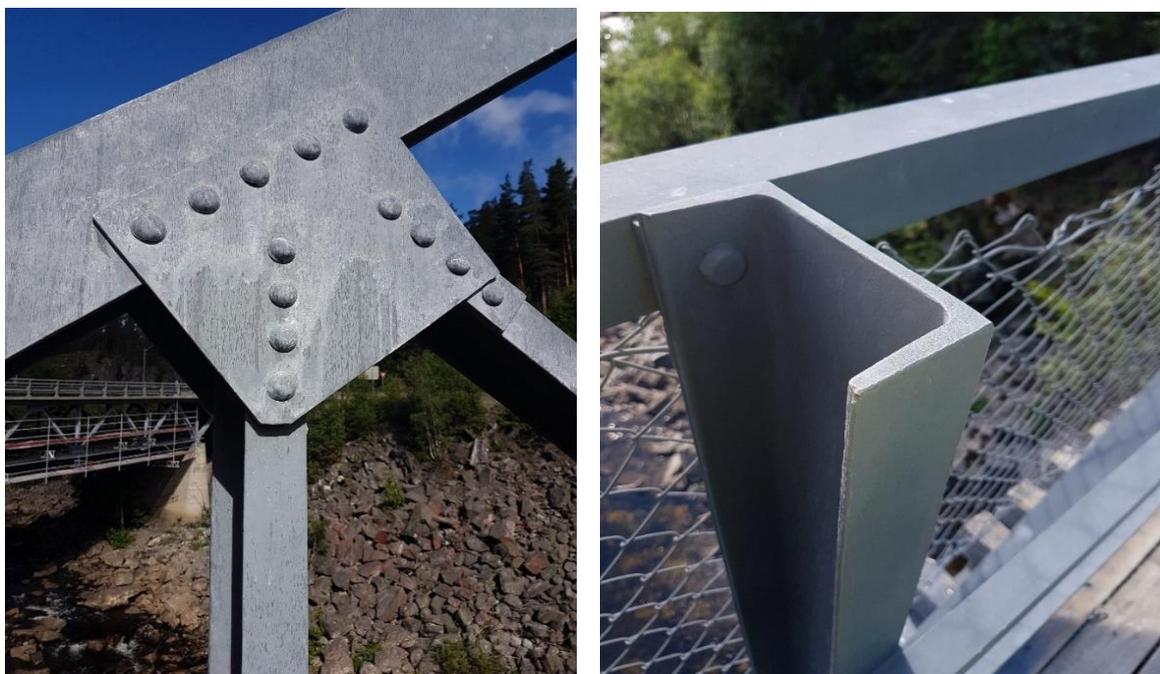
Figure 48. The steel beams of the structure have sharp edges. The design is not optimal for corrosion protection since there are many crevices and surfaces where dirt and debris can collect. No corrosion was observed.

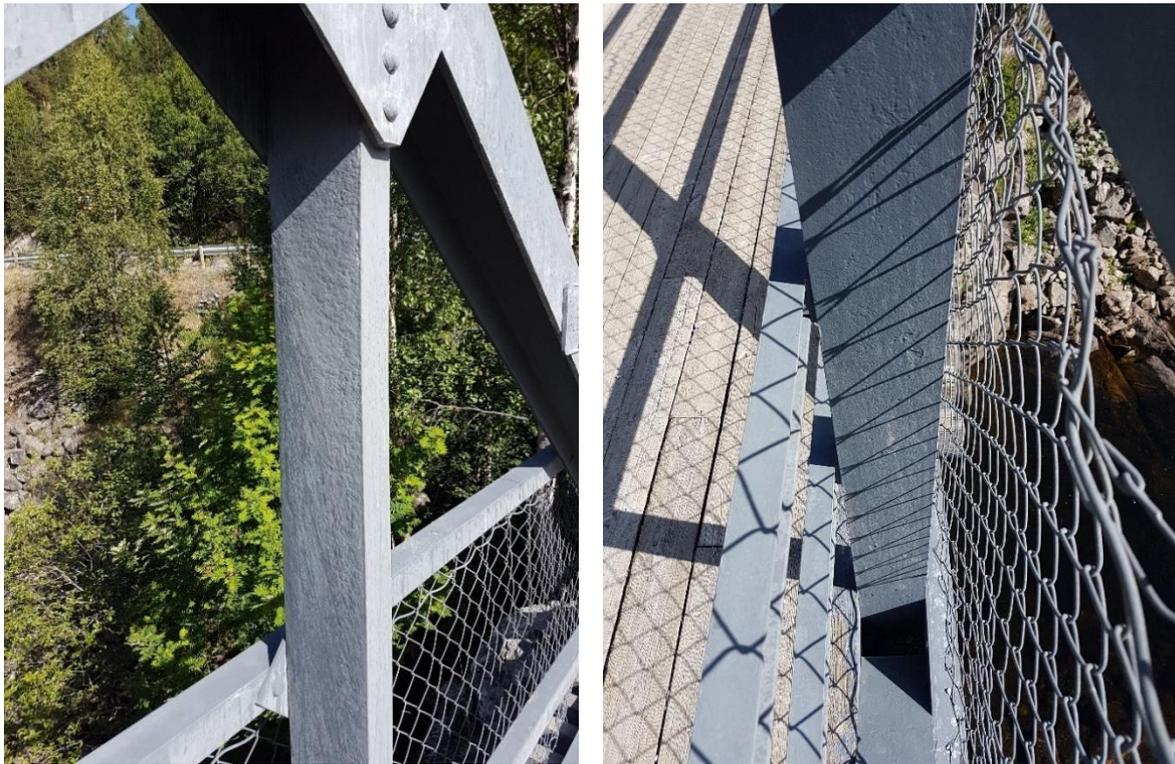
Figure 49. Surfaces with rough surface profile, probably a result from overcoating steel with rust grade C or D.

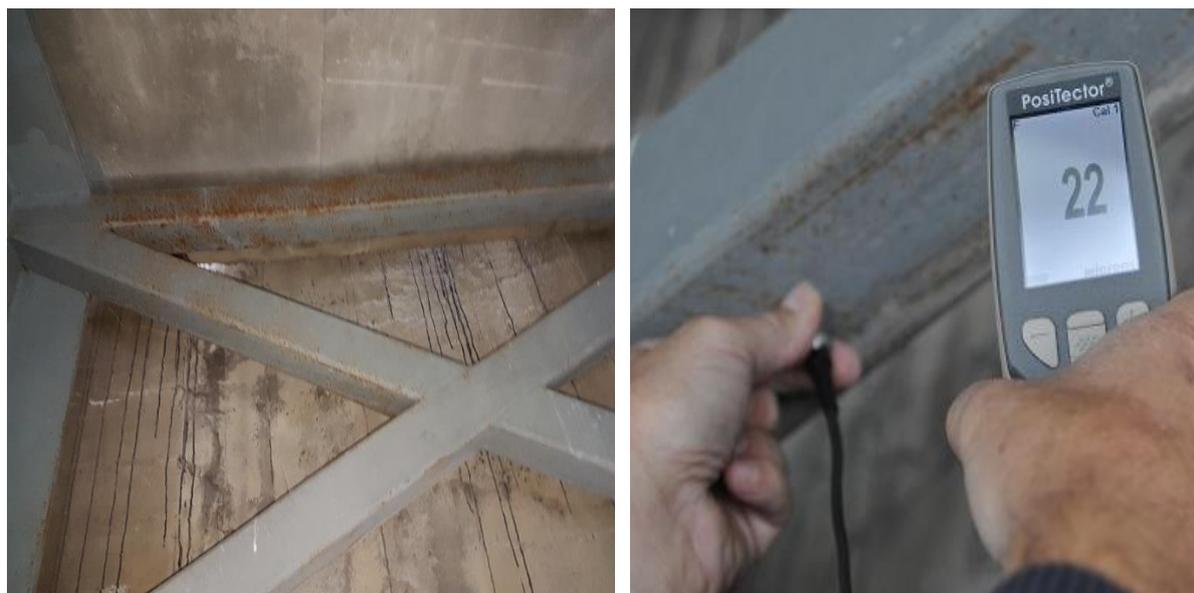
Figure 52. A few surfaces with red rust were found. To the left: the square steel beams were located under a gap in the roadway between the road and the concrete roadway. To the right: The DFT of the square beams was about 20µm thick. The breakdown mechanism of the coating appears to be a slow erosion from the outside and in, rather than a through blistering and flaking.

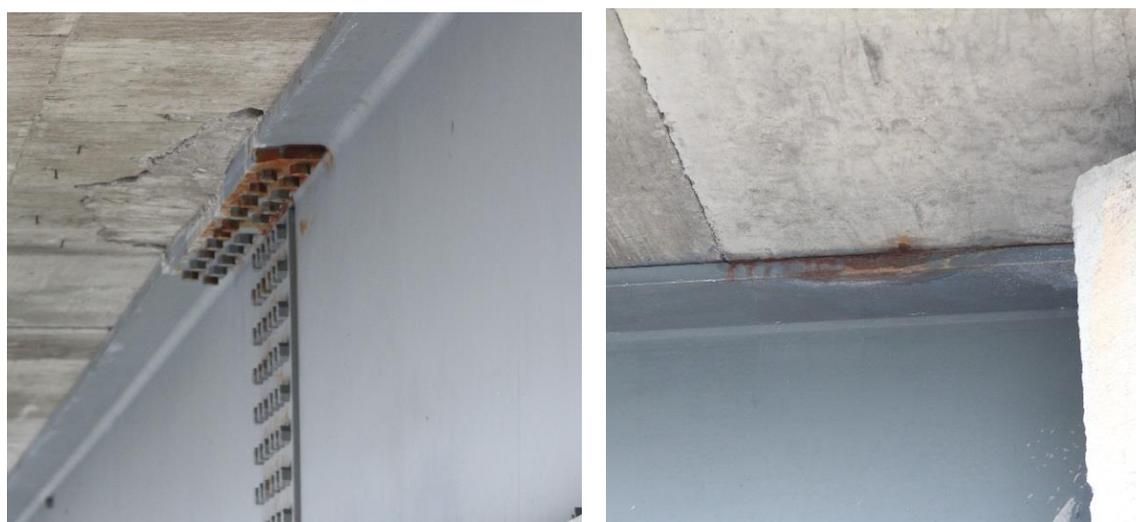
Figure 53. A few surfaces with red rust were observed. Unfortunately, these locations were inaccessible for DFT measurements at the time of inspection.

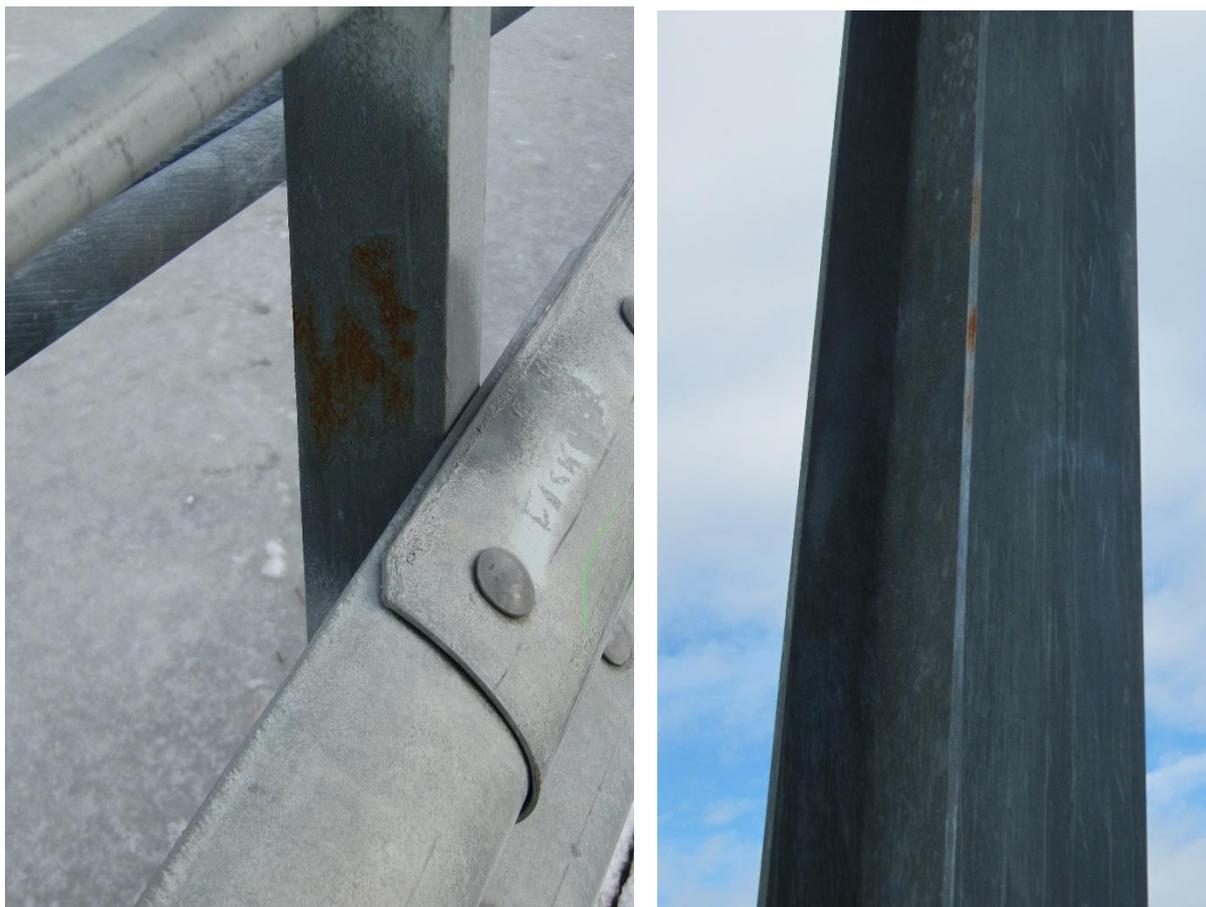
Figure 58. One or two spots with red rust could be found, these were most probably areas where the coating application for some reason had failed.

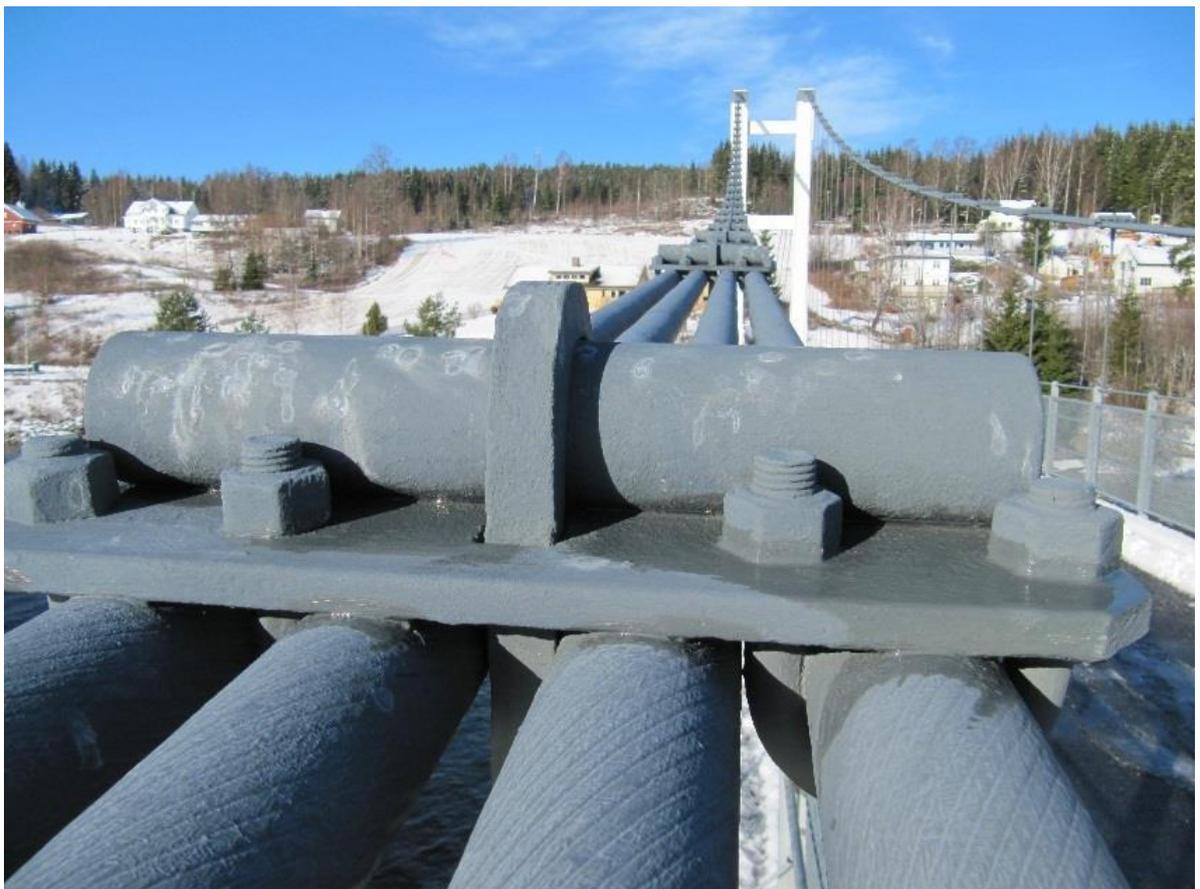
Figure 60. Close up picture of the cable linkages. These parts are not optimal to coat, there are a lot of crevices, sharp edges and areas where it is hard to get good coverage. No corrosion was observed.

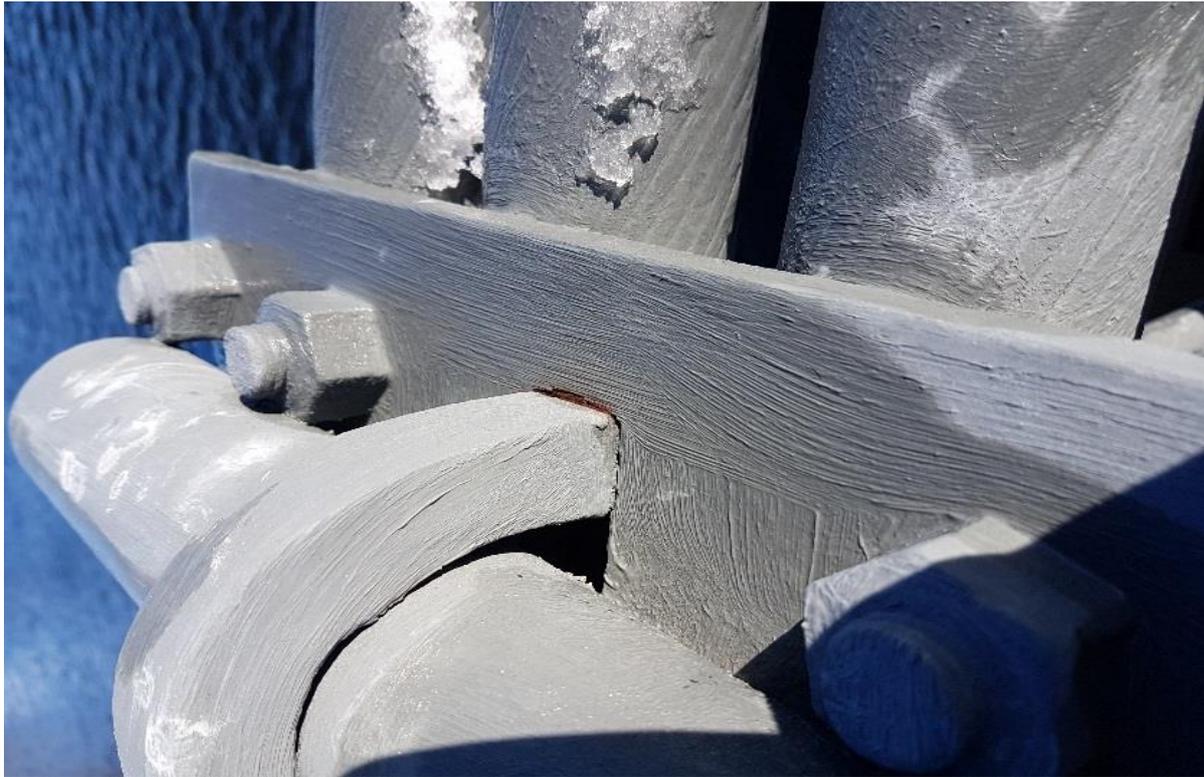
Figure 61. Clamp joining the cable bundles together. The coating has been applied with a brush, some red-rust had formed inside the crevice between the U-profile and the plate.

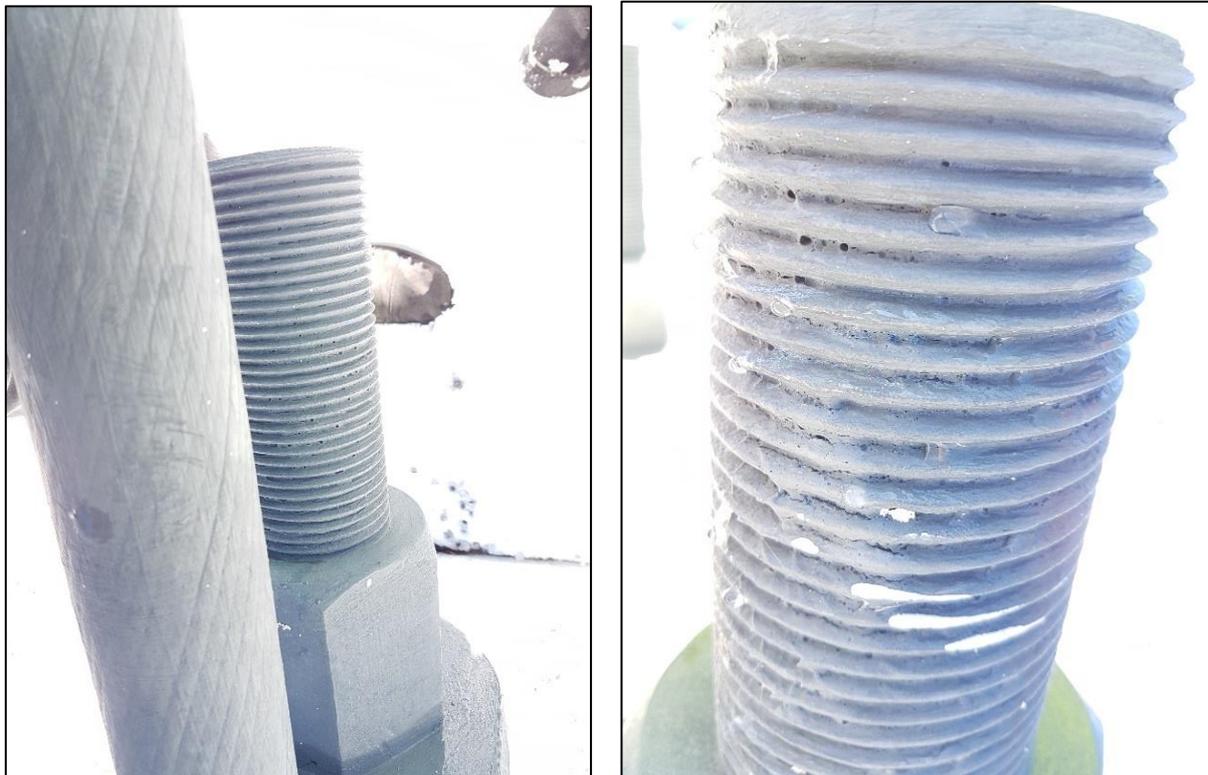
Figure 62. To the left: cable at the anchoring point. To the right: Coating on a bolt thread at the anchoring point, some pinholes were visible in the thread. There were however no signs of corrosion.

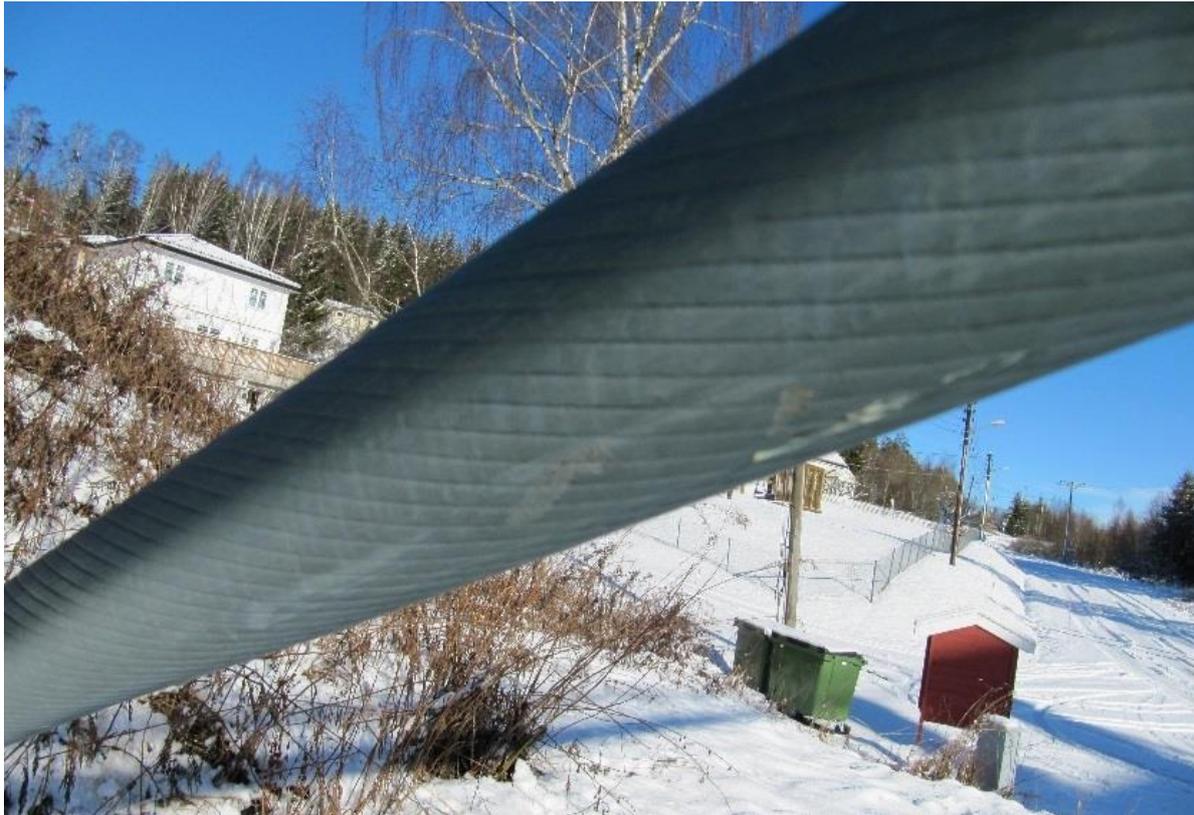
Figure 63. A cable near the anchoring fundament. No corrosion was observed on the part of the cables that were accessible during the inspection.

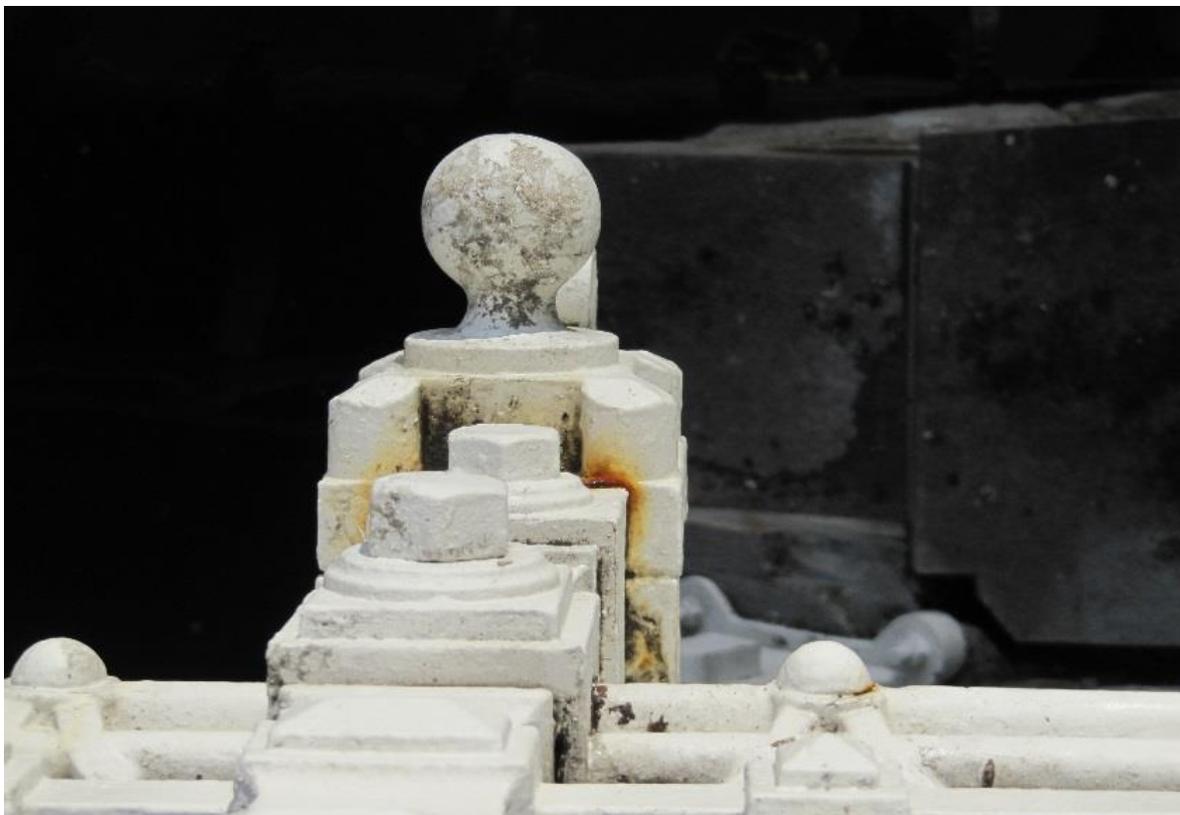
Figure 65. Joint between support arch and fencing post in cast iron. At some joints, discolorations from corroding steel inside crevices could be seen

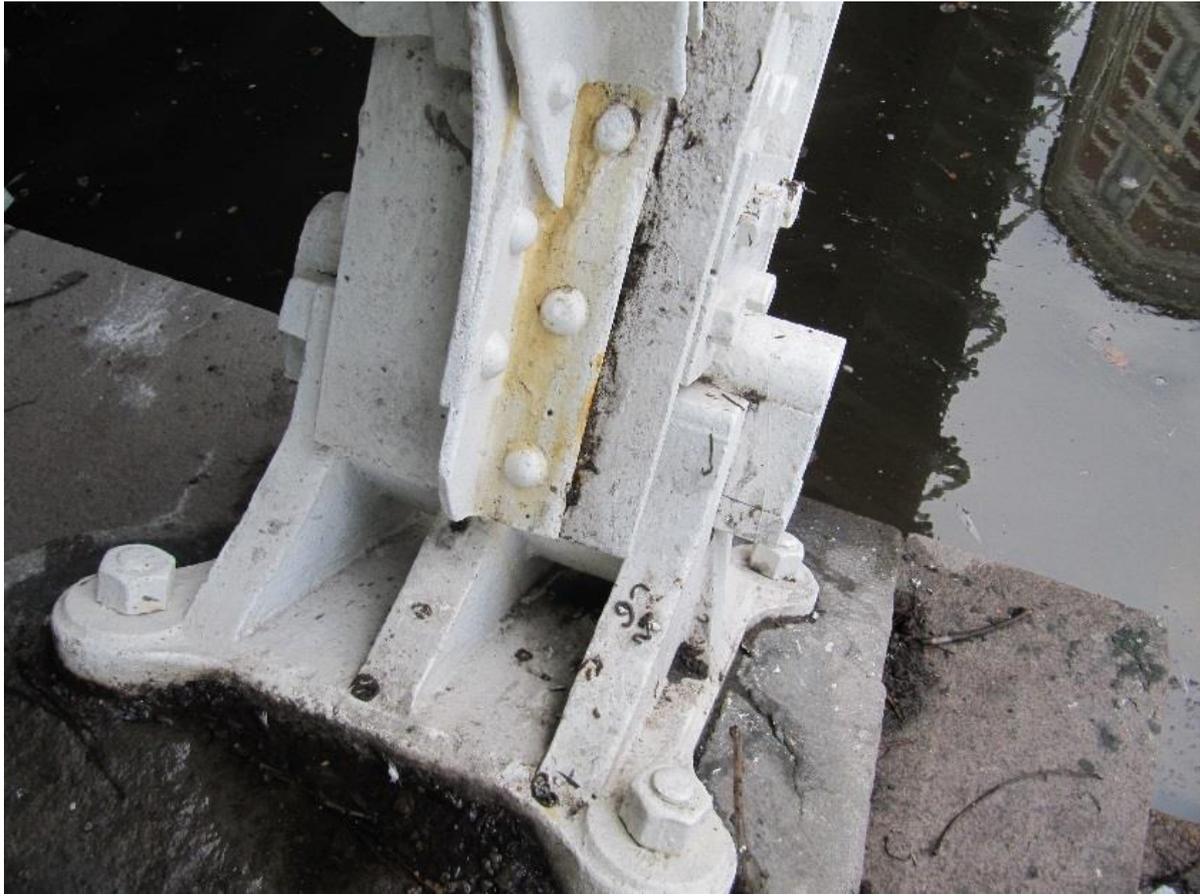
Figure 66. discoloration from crevice corrosion under rivets.

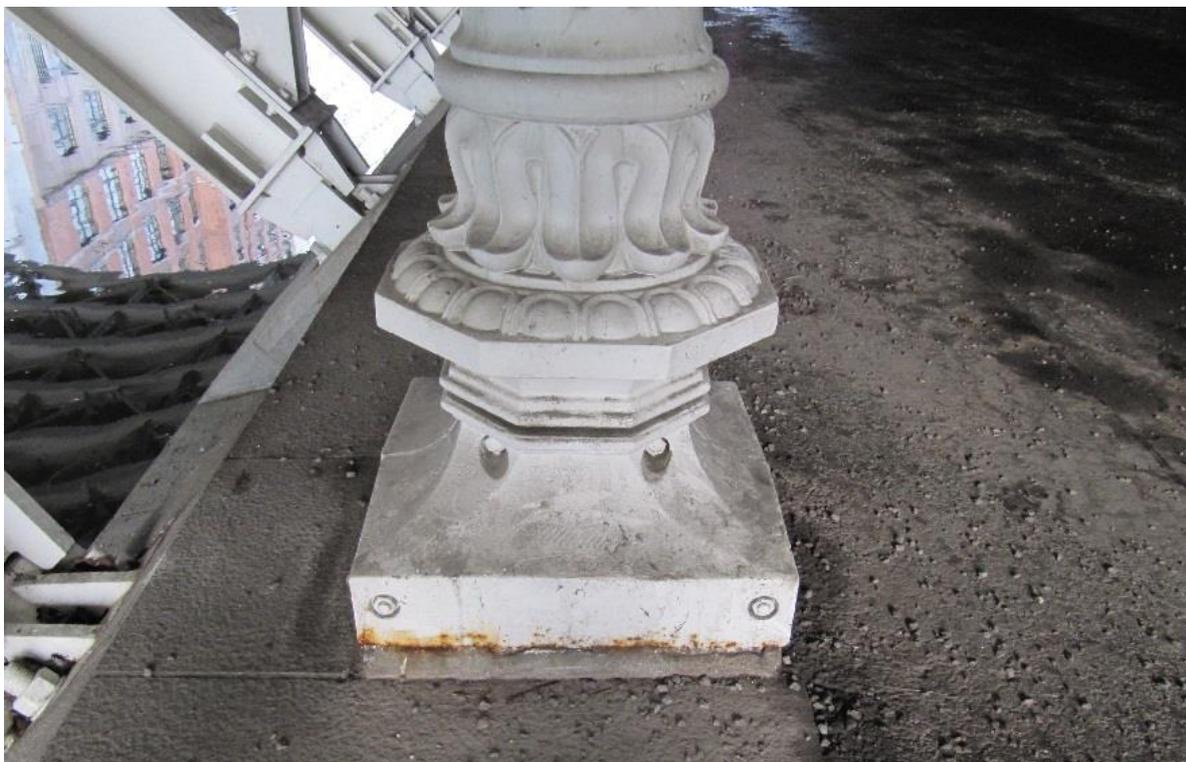
Figure 67. Some rust between the pavement and the cast iron pillars could be seen under the bridge.

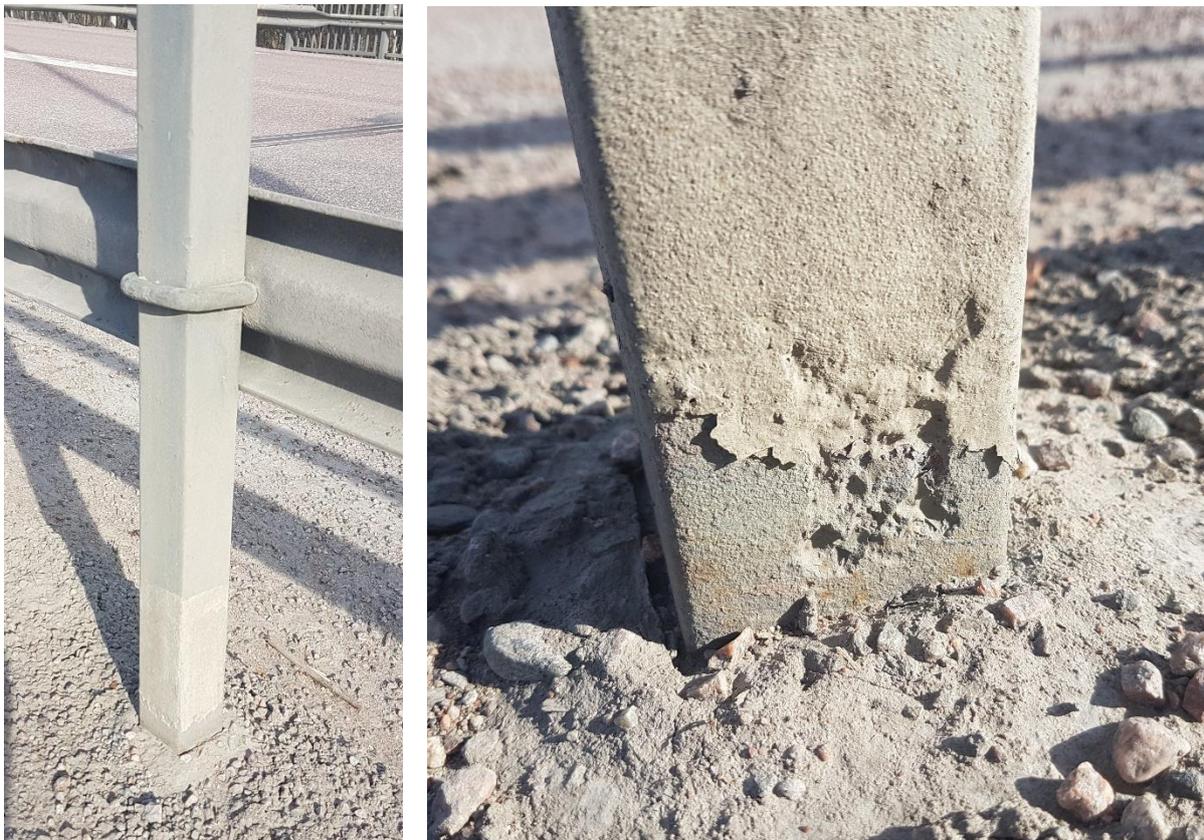
Figure 71. To the left: fencing pole with lower parts coated with epoxy and polyurethane. To the right: Fencing post with completely deteriorated coating, The TSZ under the coating was largely intact, although some spots of red rust had started to emerge.

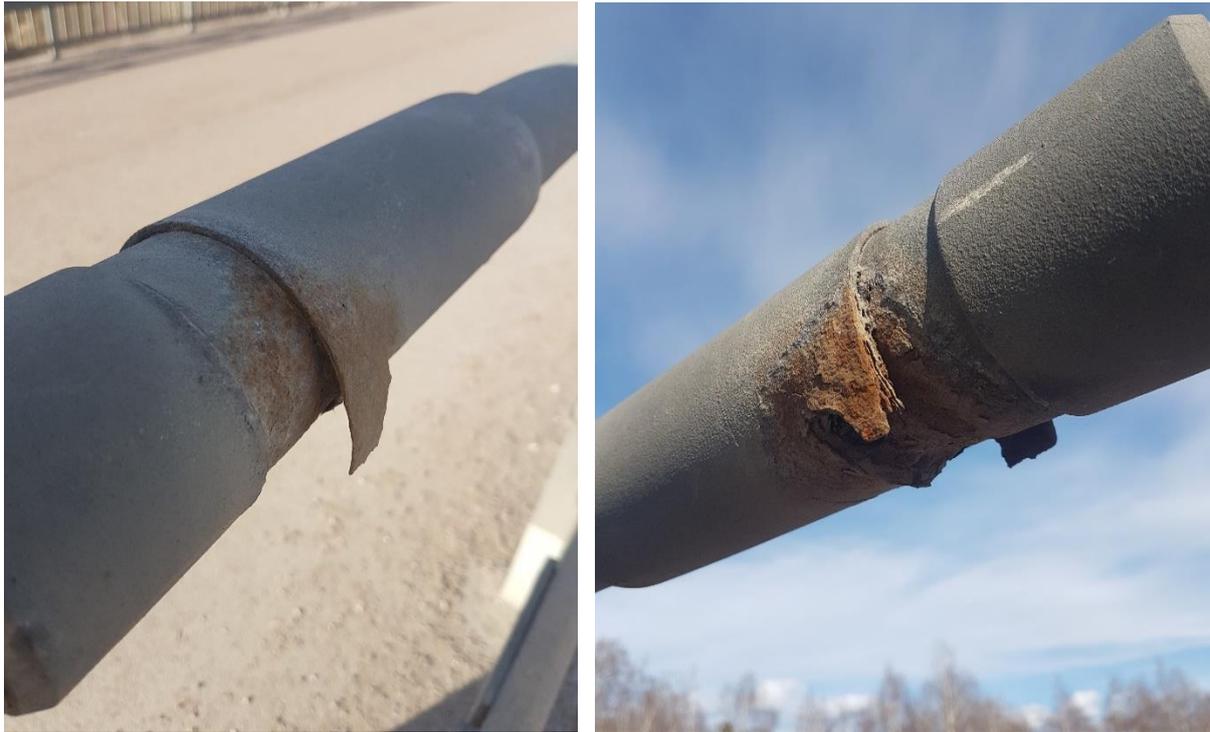
Figure 72. Two examples of crevice corrosion in the expansion joints of the handrail.

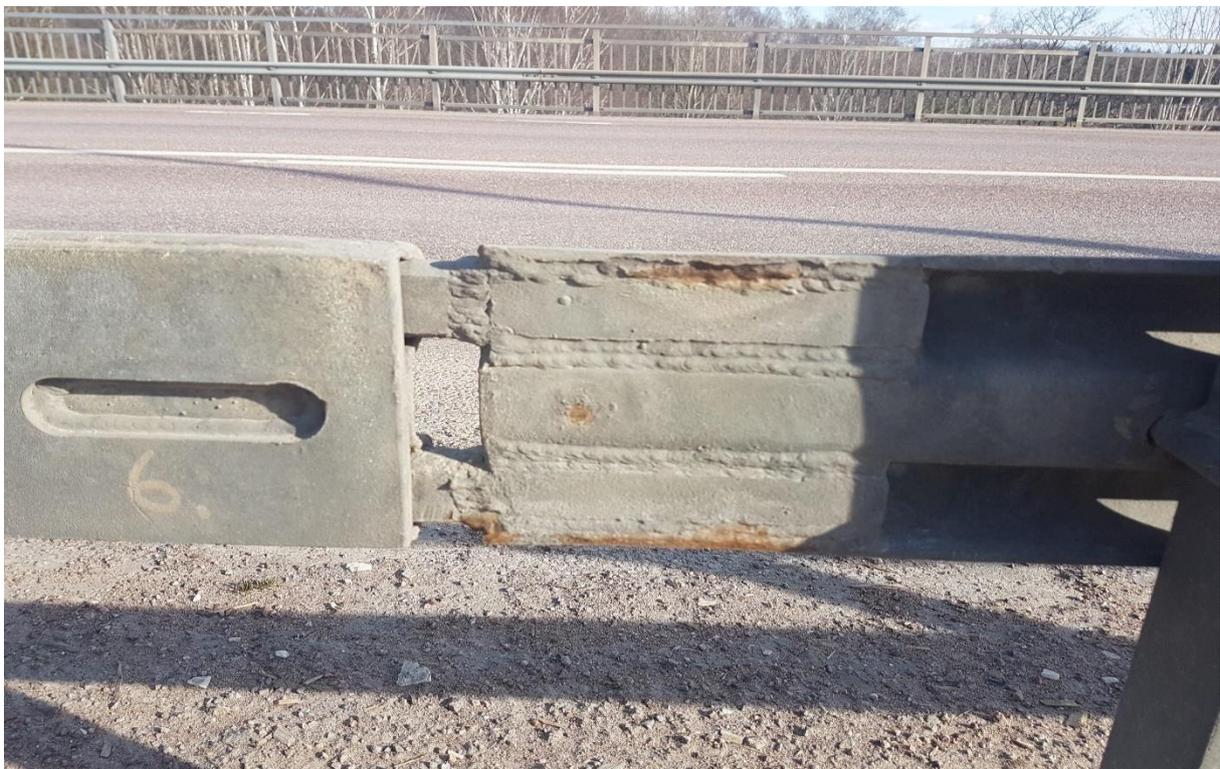
Figure 73. Apparently poorly prepared welds around the expansion joints

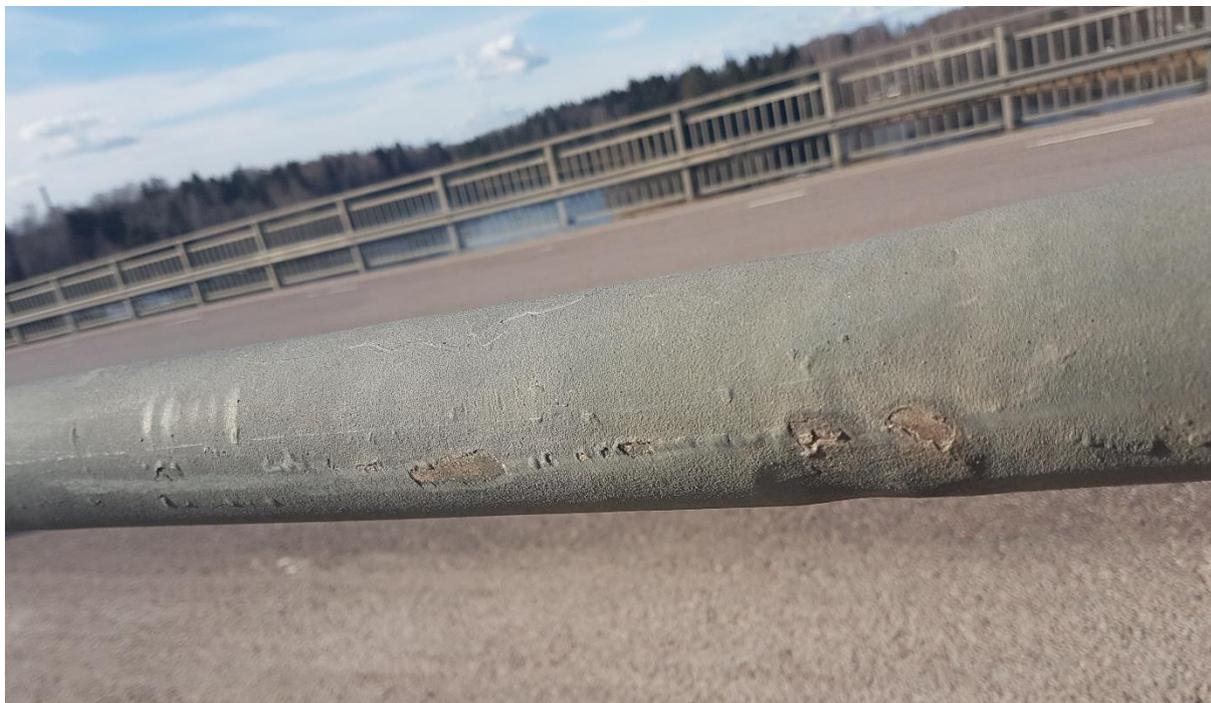
Figure 75. Mechanical damage on the handrail. Only limited rust creep from the damages was observed.

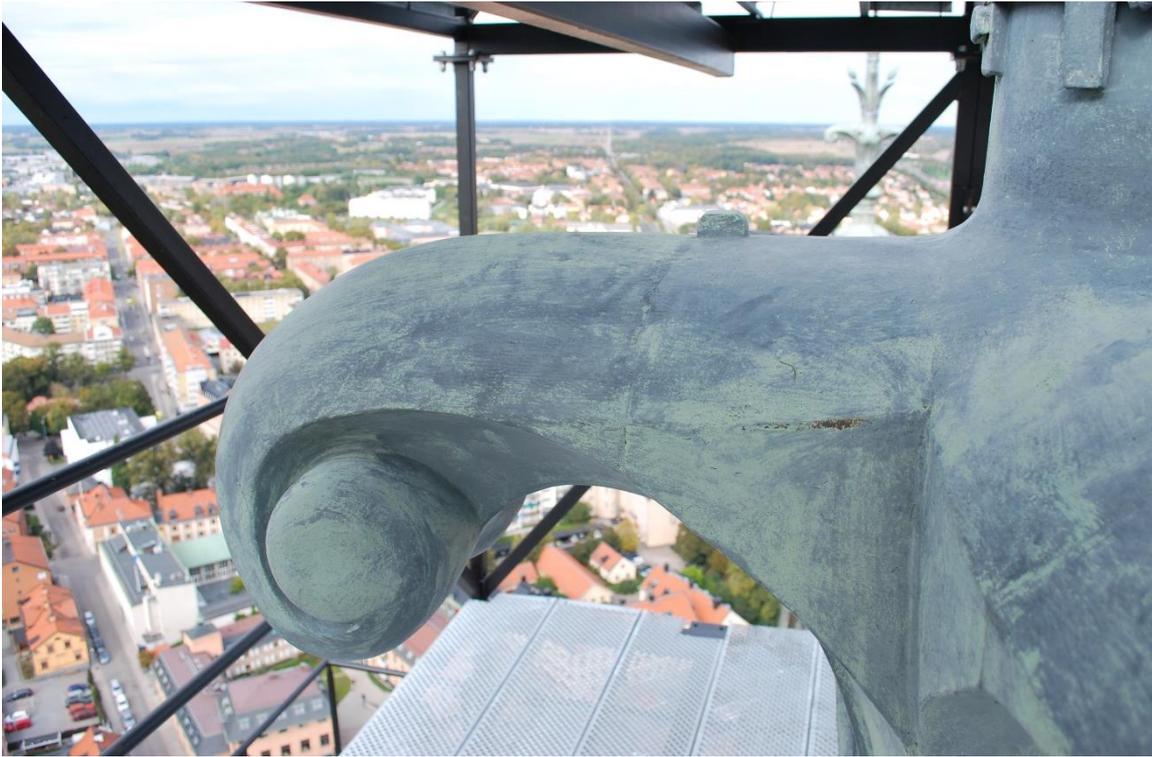
Figure 78. An example of an ornament in cast iron, largely an intact zinc coating, a small spot with under rust was visible. The grey chlorinated rubber has deteriorated completely.

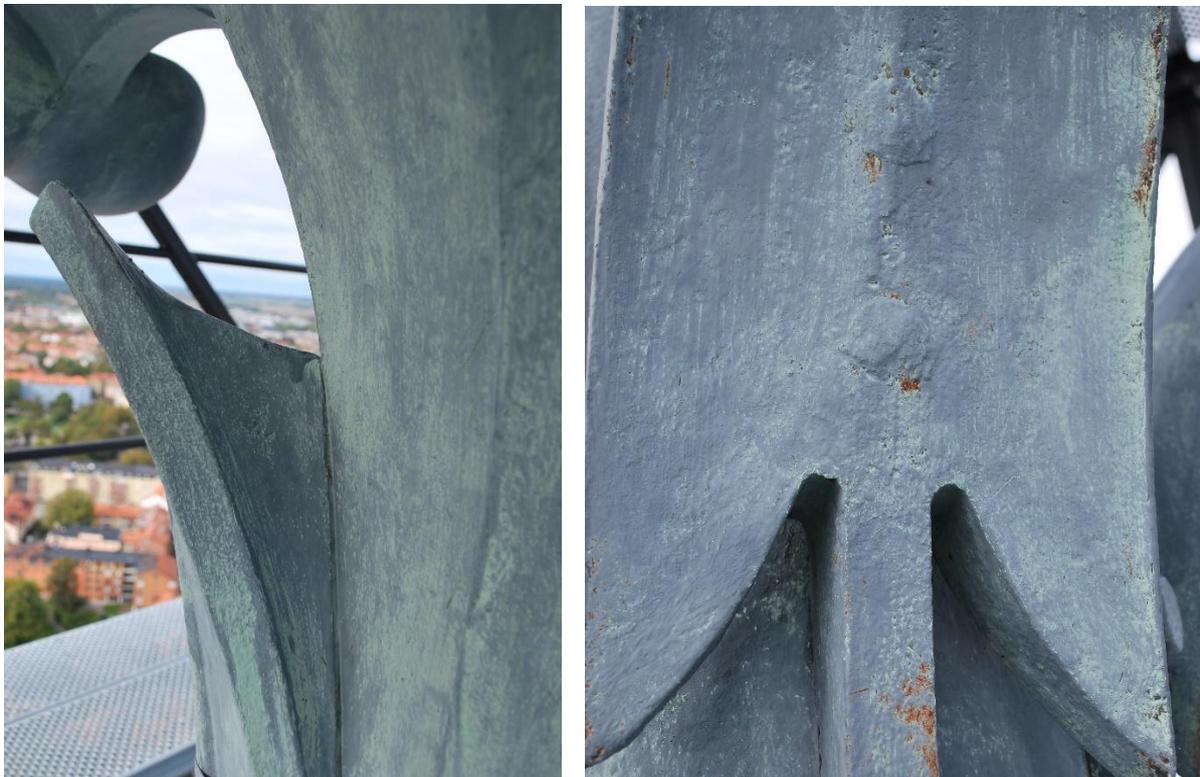
Figure 79. Cast iron ornaments, To the left: a crevice that has been successfully coated without any signs of corrosion. To the right: some under-rusting near edges and rivets/ bolts could be seen.

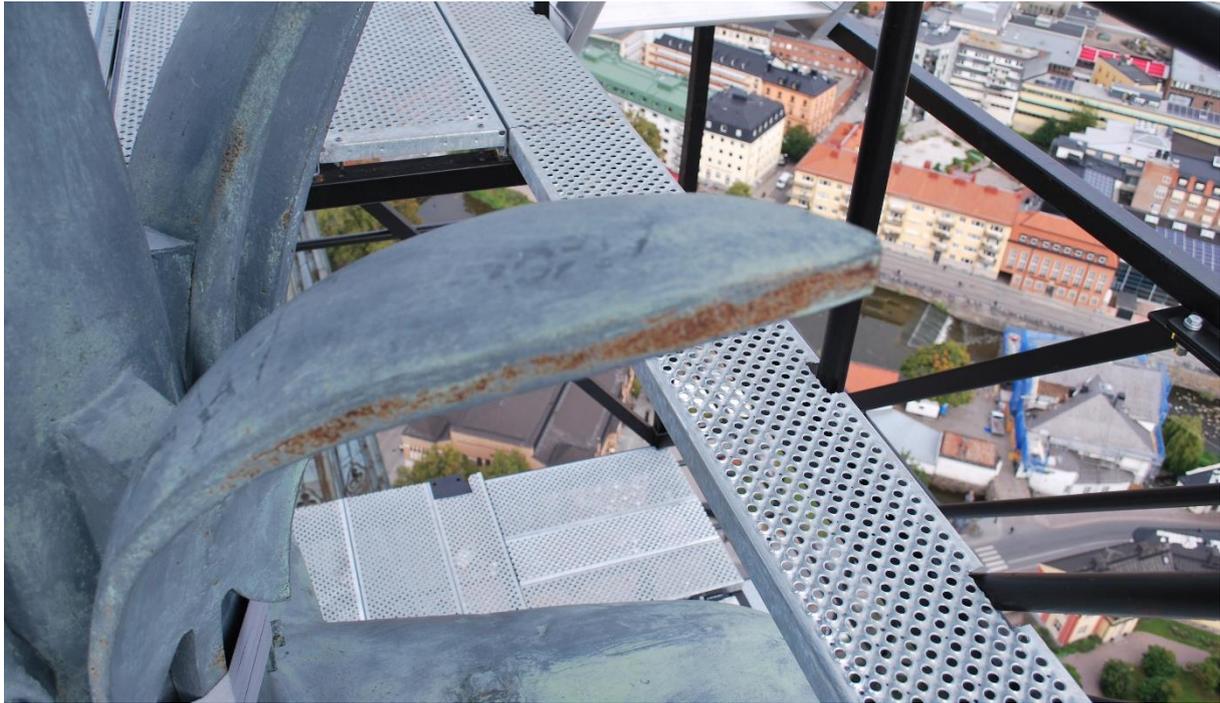
Figure 80. Under-rust on the edge of a cast iron ornament
