Inspection of reference objects coated with various zinc rich coatings

Björn Tidbeck, Bror Sederholm

Report number. 15660-1

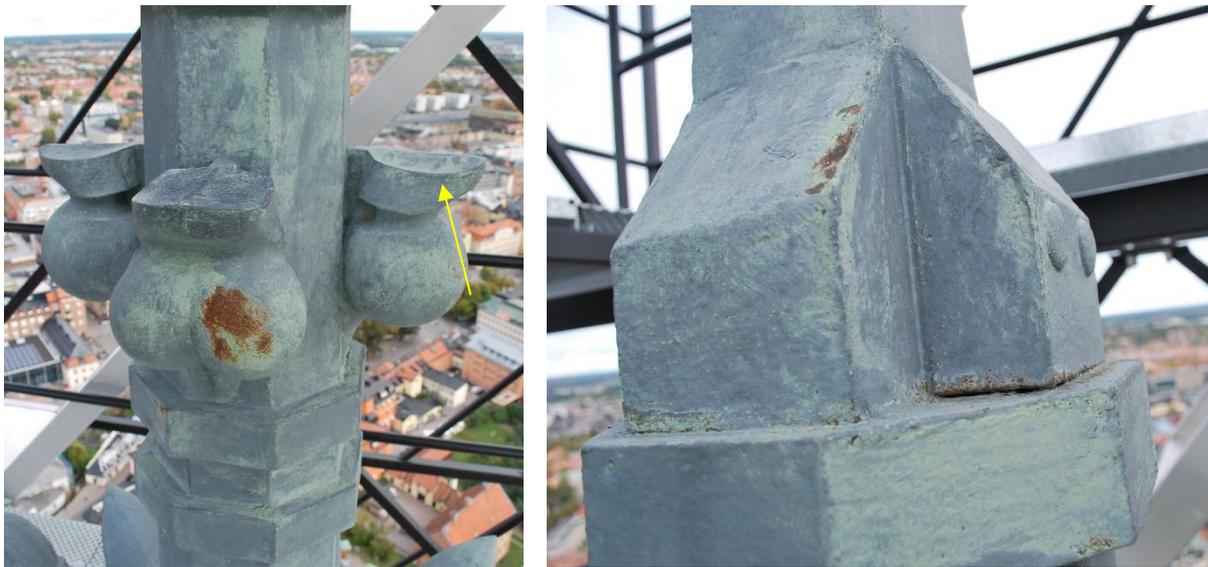
Figure 81. Cast iron ornament, to the left: apparent coating damage on the object before the coating was fully cured. The zinc was about 200 μm thick, the coating/ rust layer was about 20 μm thick. Notice the year 1974 painted on the right ornament. To the right: the foot of the cross. Some rust on the edges and in the crevice.

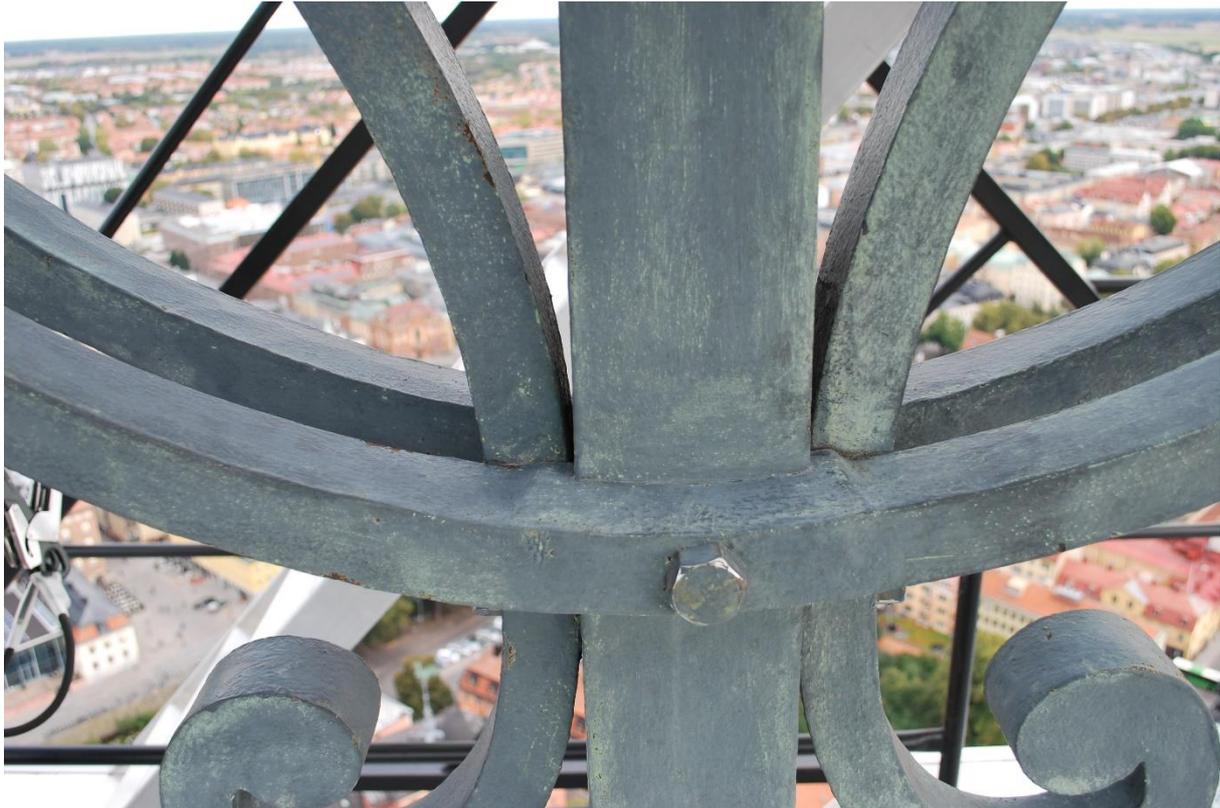
Figure 82. The top of the wrought iron cross, it appears as if the bolt holding the assembly together is made of stainless steel. Probably these parts have been disassembled so that the surfaces in the crevices could be coated, at some point during the early 1970's.

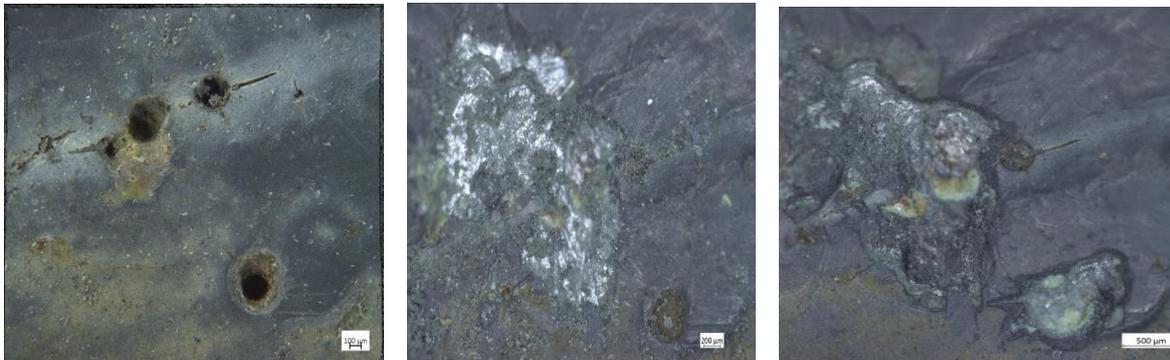
Figure 83. Some pinholes were found in the coating. To the left: pinholes as found. In the middle: The coating was scraped with the edge of a knife, revealing metallic zinc under the surface of the coating. To the right: the scraped surface reacted instantly with copper chloride to form black corrosion products, that indicate corrosion of the metallic zinc.

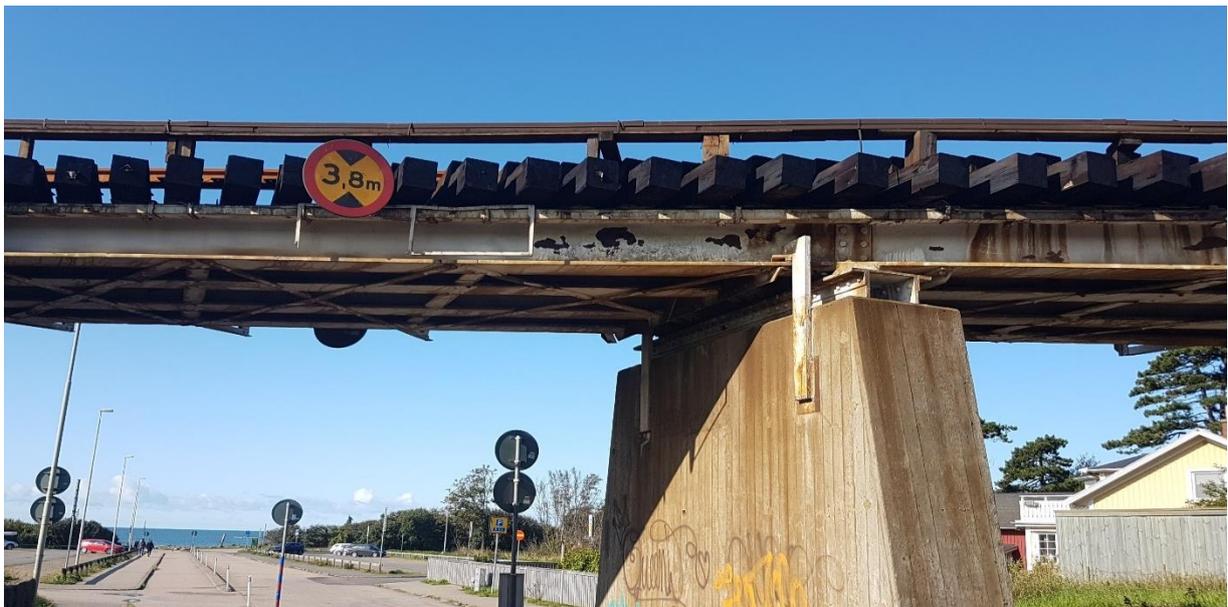
Figure 84. Overview of a railway bridge coated with Eon Coat, the bridge is located near the sea. The coating had started to flake on the main I-beams.

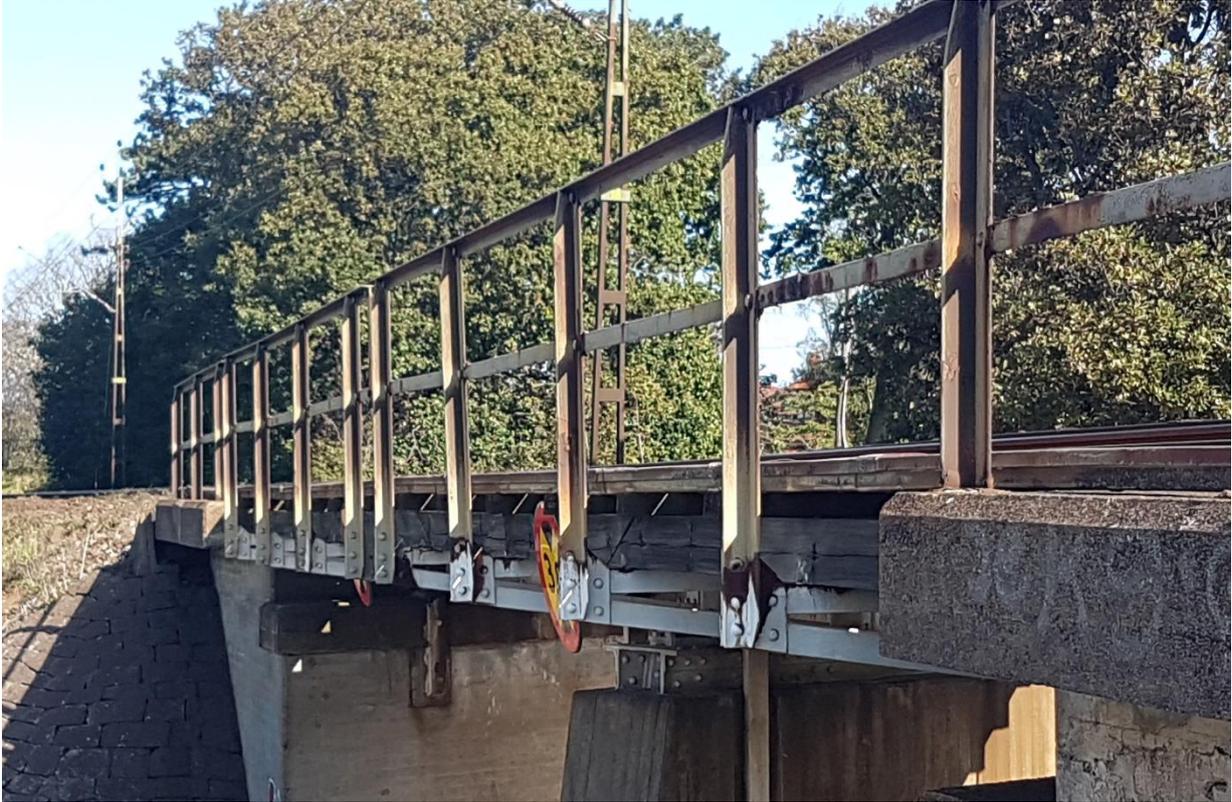
Figure 85. Corrosion in the joints between the bridge fencing and the support lattice. The picture is from the side facing the sea.

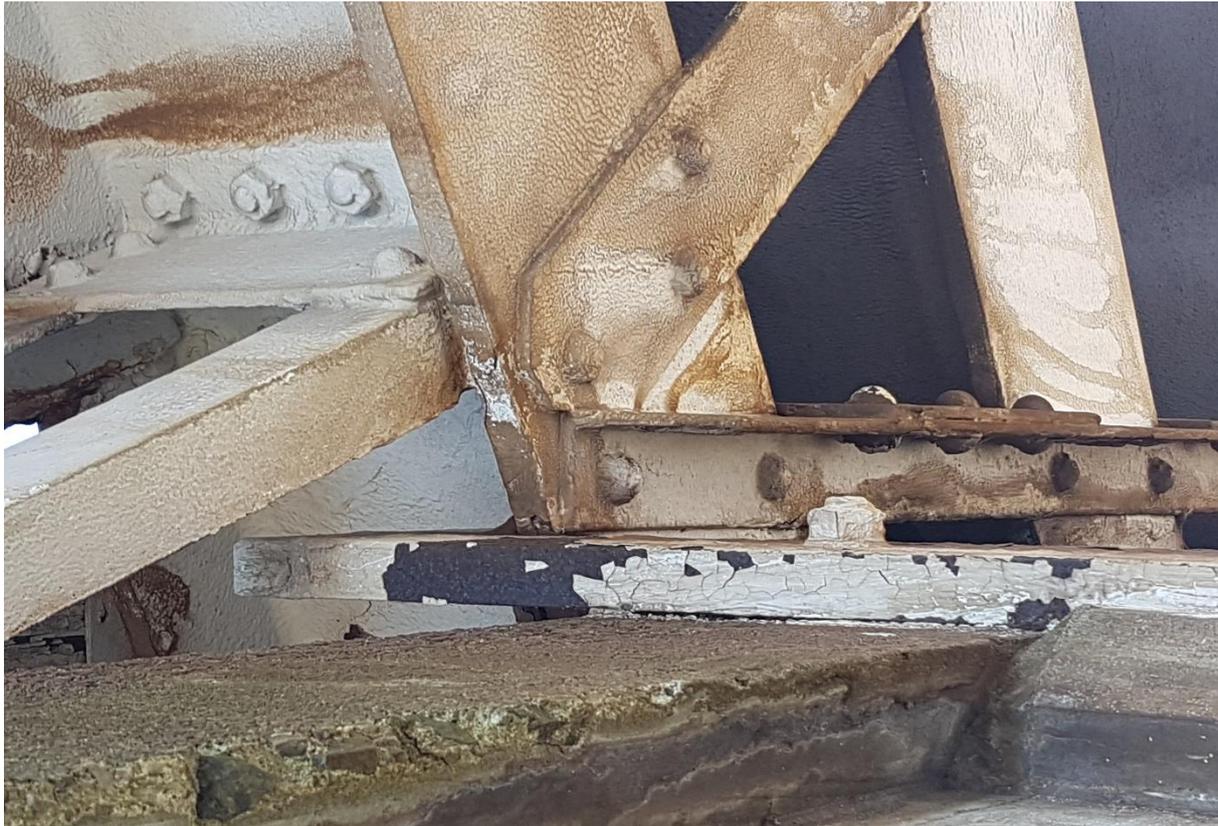
Figure 87. The coating was in some places very thick and had started to flake
