LIVAR – Livslängsoptimering av räler

David Franklin, Alexander Lundstjälk

Report number. 101407

Abstract

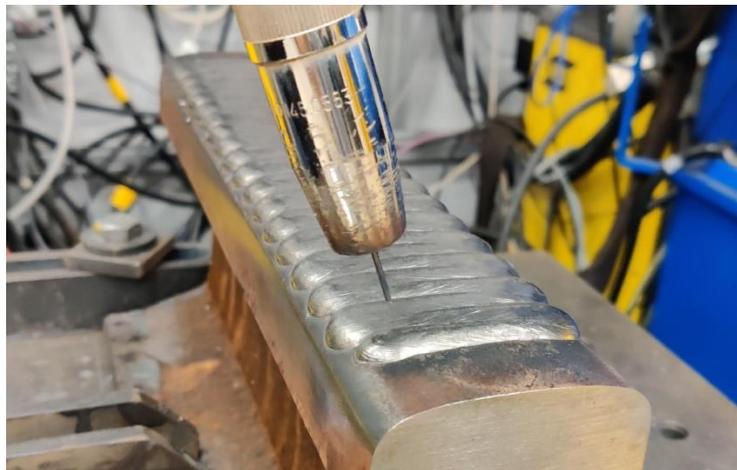
Figure 5, weld pattern

The weld pattern was done by welding traverse to the rail, see Figure 5. The time to weld the full length in one layer was approximately 15 minutes. Two layers were welded to achieve the same thickness of added material as is created with the ESC.

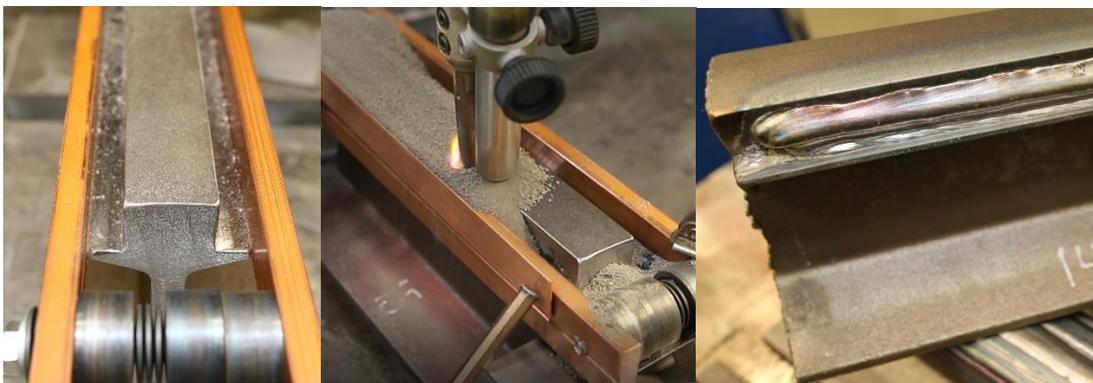
Figure 7, the setup for SAW welding.

ESAB's ICE Aristo 1000 AC SAW process was used with 3 wires. 2 warm/hot wires and 1 cold wire in the centre.

From the FCAW and ESC trials it was concluded that the focus of rail repair should be on the parts with highest level of wear, which is the inside of rails in curves. Therefore, a final test was performed: Welding the side of the rail where the most wear can be found. This is not possible with ESC due to the large melt pool and limitation to PA positioning of the weld head. These trials were performed on rail heads machined according to Figure 6 (dotted rectangle is removed material). The green curve shows the worst wear profile which may arise in a railway curve. The image also describes how the incident angle of the filler wires were pointing. The angle in travel direction is always 90 ° to the base plate. Cu-backings were used to control the melt and flux from overflow, see Figure 7.

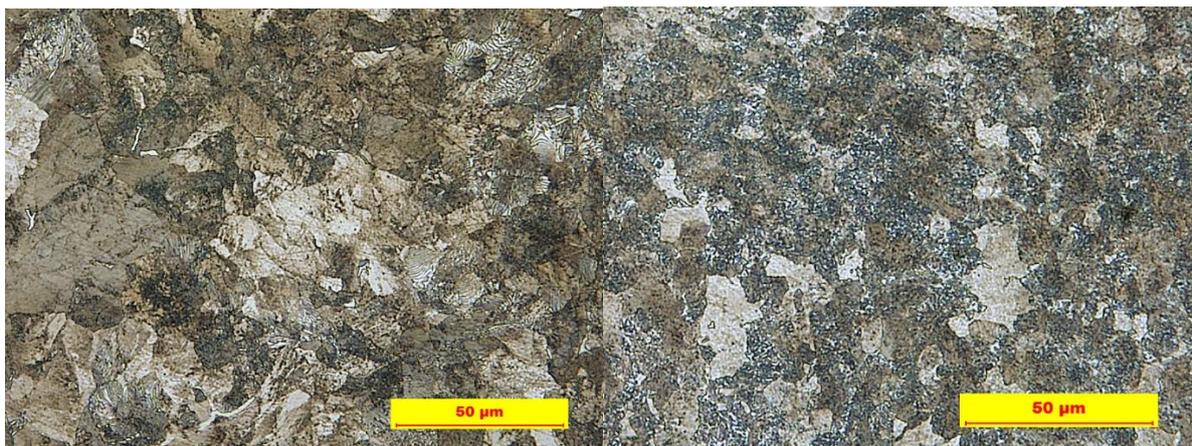
Figure 13, left, microstructure in the top of the HAZ, right the bottom of the HAZ.

The HAZ consists of mainly perlite. Close to the substrate, the perlite is very fine but gets coarser with more elements of bainite closer to layer 1, see Figure 13 and Figure 16. A drop in hardness can be observed as the bainite content decreases.

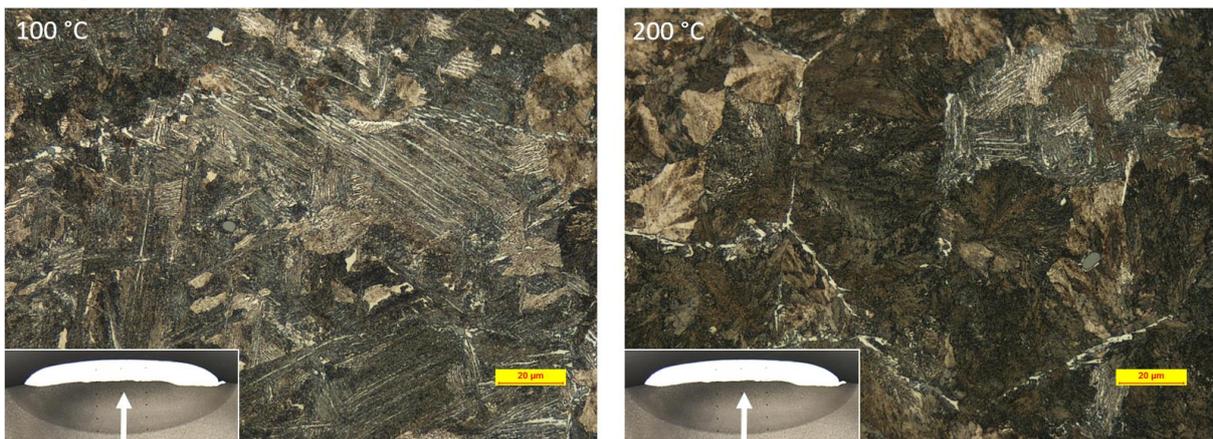
Figure 18: Microstructure of upper HAZ. Pre-heating temperature 100°C to the left and 200°C to the right. White arrow illustrates position of image.

The upper HAZ is also called the “Grain growth zone” and the microstructure is presented in Figure 18 (illustrated with arrows). In the left microstructure (Pre-heat 100°C) it is almost 100% bainitic structure with small amounts of grain boundary ferrite. Pre-heat 200°C shows more perlite and more grain boundary ferrite.

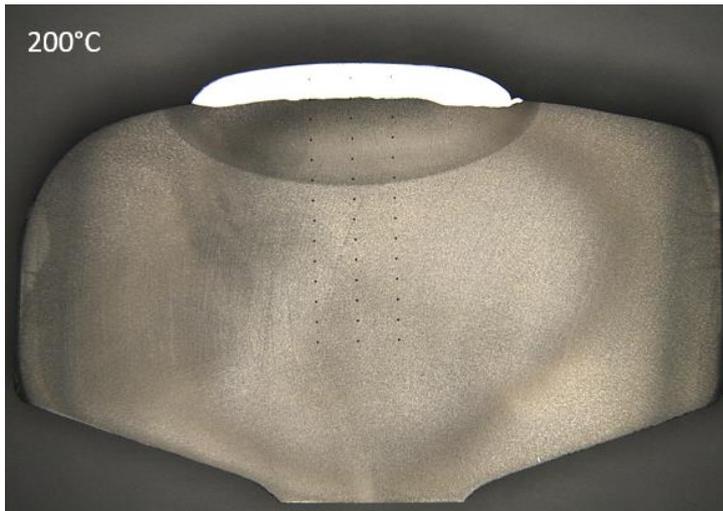
Figure 21: penetration profiles of SAW strip cladded railhead, pre-heated 200°C

The penetration profiles for the pre-heated rails at 100 °C and 200 °C were similar, and the 200 °C pre-heated illustrate a macro scale, see Figure 21.

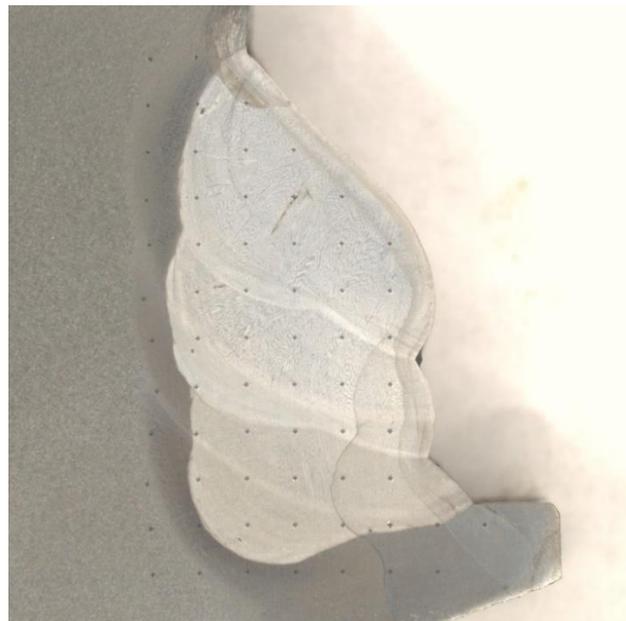
Figure 23, cross section of weld C1

The C1 was welded with three runs. A solidification crack can be seen Figure 23 . Three pores could be found in the root of the C1 weld, see Figure 24. The hardness mapping is presented in Figure 25. The high hardness is most likely due to martensite, similar as in C3.

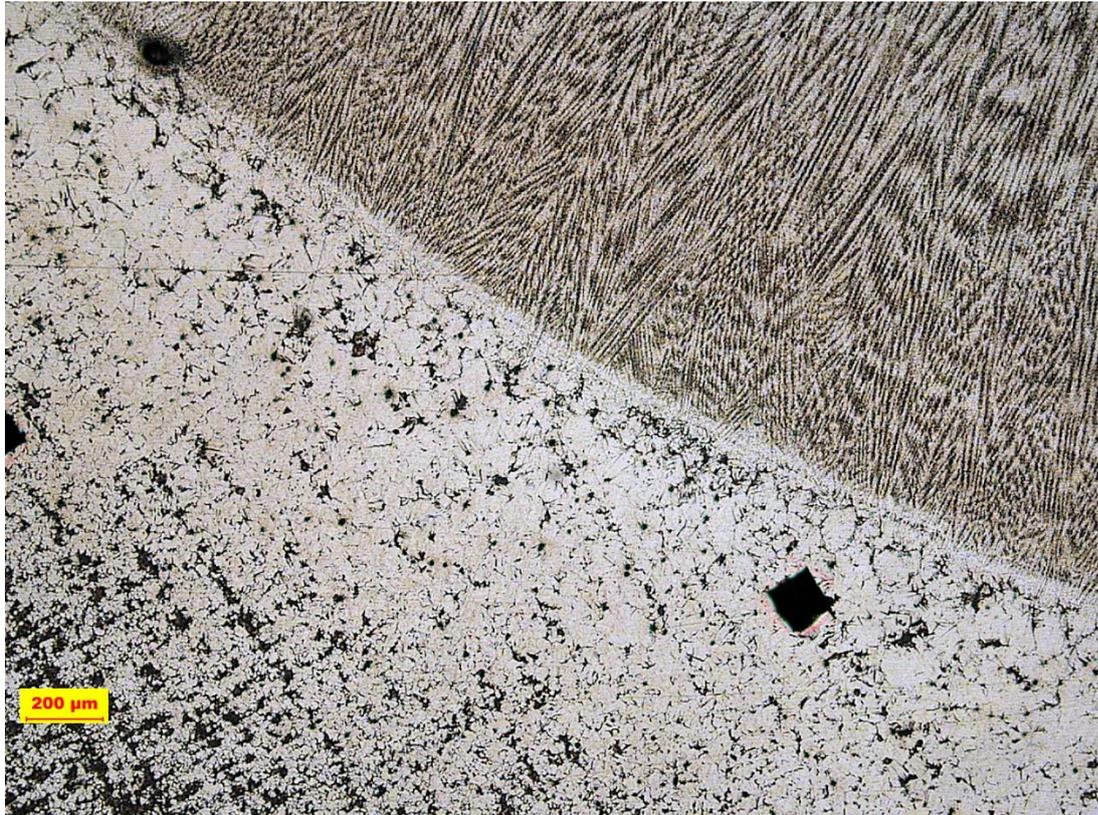
Figure 27: interface between base material and weld metal, with fusion line separating them. The hardness is 565HV10 in the hardness indentation.

The hardness of the HAZ is very high (565 HV10 in the hardness indentation in Figure 27), microstructure of the HAZ is martensitic as can be seen from Figure 28. There are possibly two regions of martensite visible as black and beige martensitic structures. Note that the etching is different between Figure 26 and Figure 27 which mixes the dark and white colours between the images.

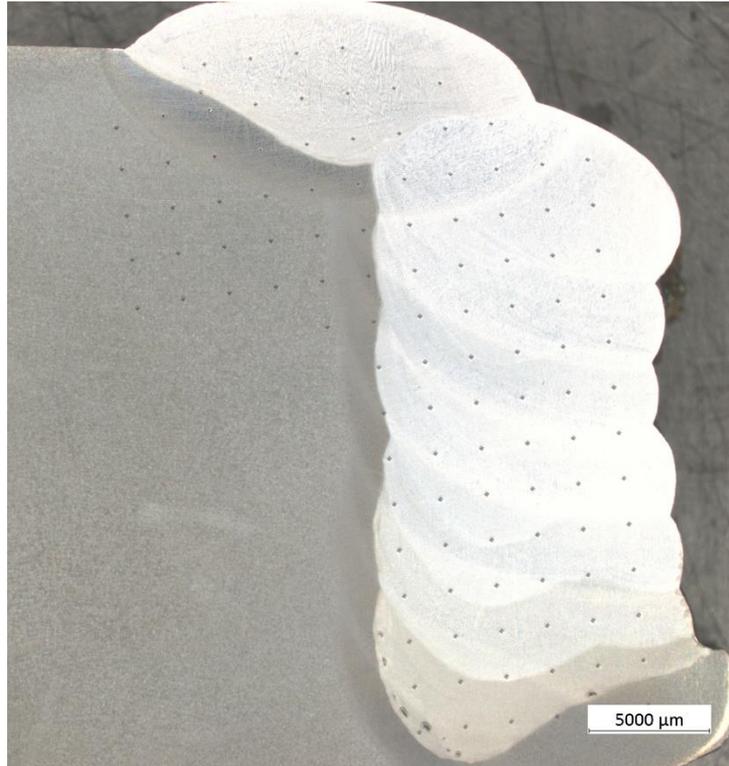
Figure 30, cross section of weld C3

C3 is welded with 8 passes (Figure 30) and has no cracks but a few pores visible in Figure 31. The overall hardness in C3 is low in the weld and HAZ because of the heat treatment of the following welds. The surface hardness is approximately 370-400 HV10 and the highest hardness 640 HV10 can be found in the boundary between the last weld pass and the rail head, see Figure 32. This hardness peak is likely a result of high cooling rate due to the positioning of the last weld pass.

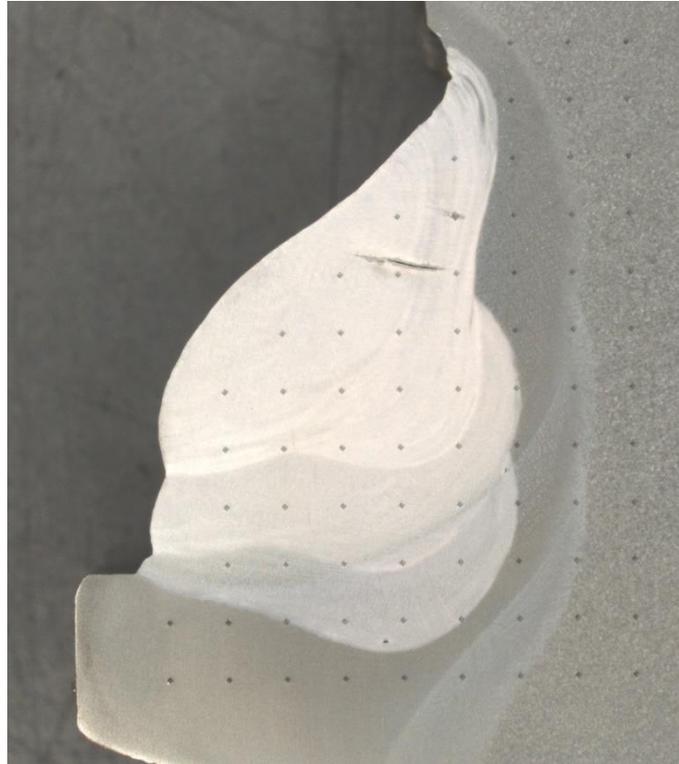
Figure 37, cross section of weld C5

The C5 weld was produced with three weld passes. A solidification crack is clearly visible in the last weld pass, see Figure 37. In the root of the first weld pores were found, see Figure 38.
