Evaluation of connected road surface monitoring

Thomas Lundberg and Peter Andrén
Maintenance and operations, VTI

Experiences from two activities

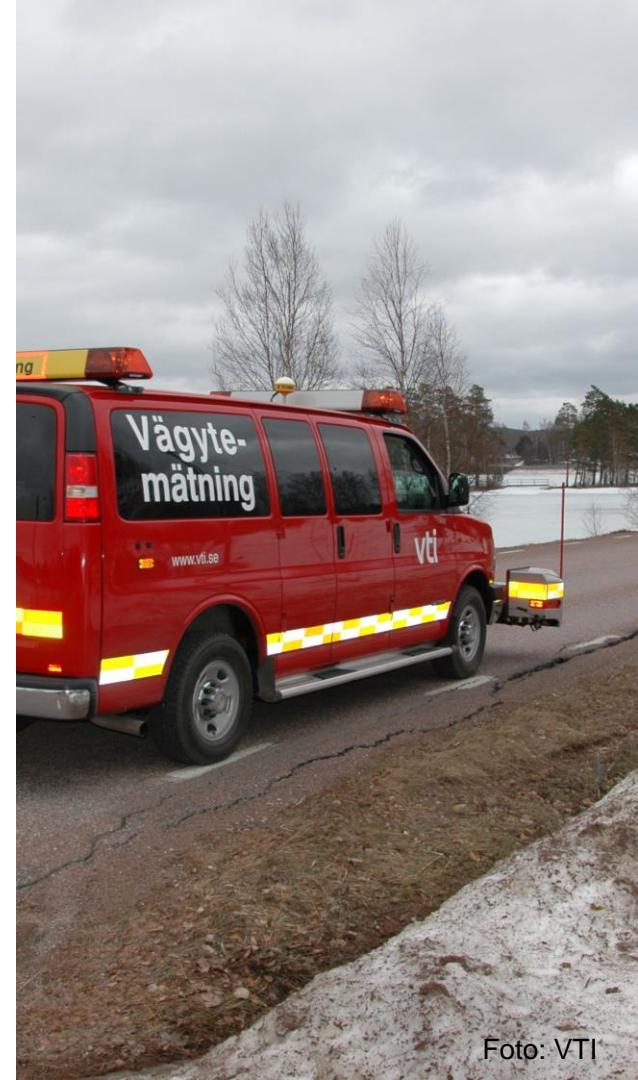
Activity 2 – Sections A-D

- A: Road W70, 82 km, normal road – rather good standard
- B: Road W1037, 12 km – uneven
- C: Road W1037, 9 km – very uneven
- D: Road E45, 24 km – partly good, partly bad (winter damages)

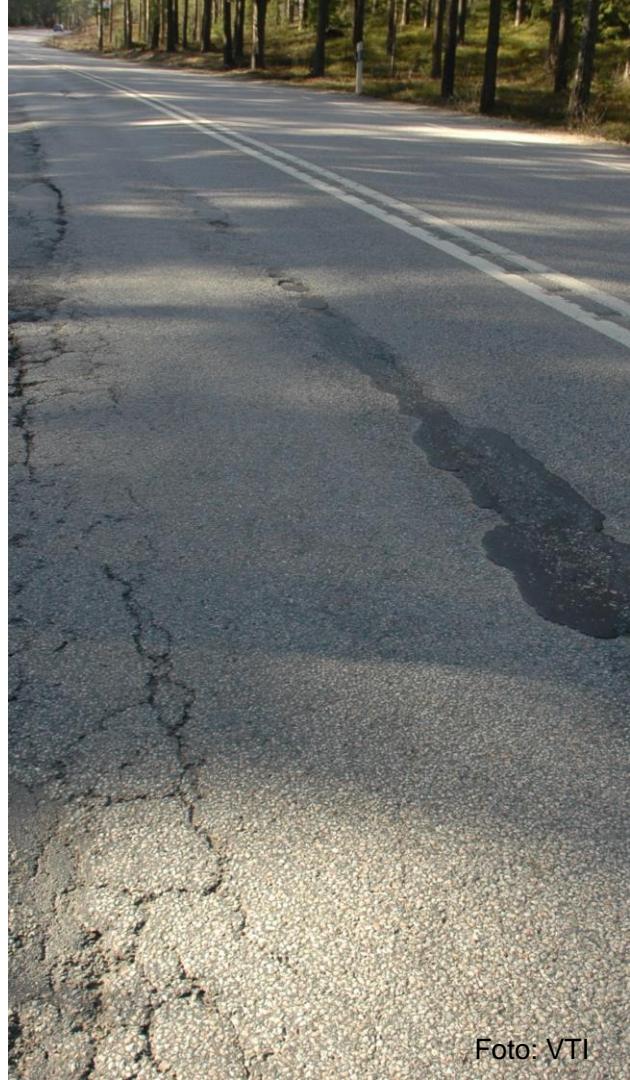
Evaluation method – Ranking, limit $\pm 15\%$

- Rank data from 0% to 100%.

Example: Reference ranked 80% - supplier data
"approved" with rank between 65% and 95%

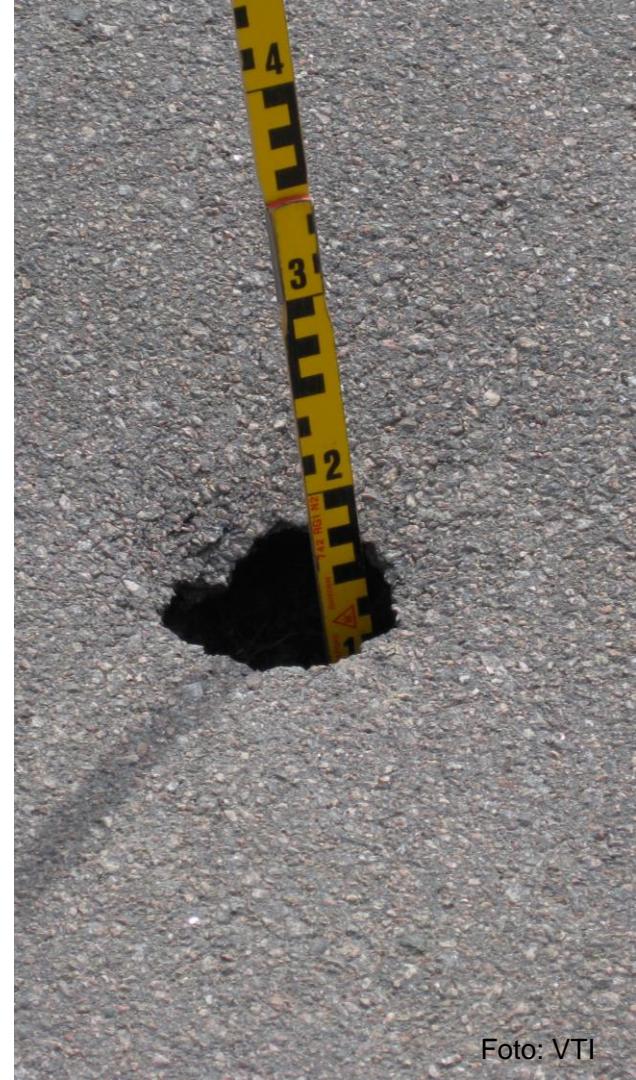
Evaluation method - Normalization

- Make the 10 and 90 percentiles for the supplier data the same as for the reference data.
- Use all available data (not per section).

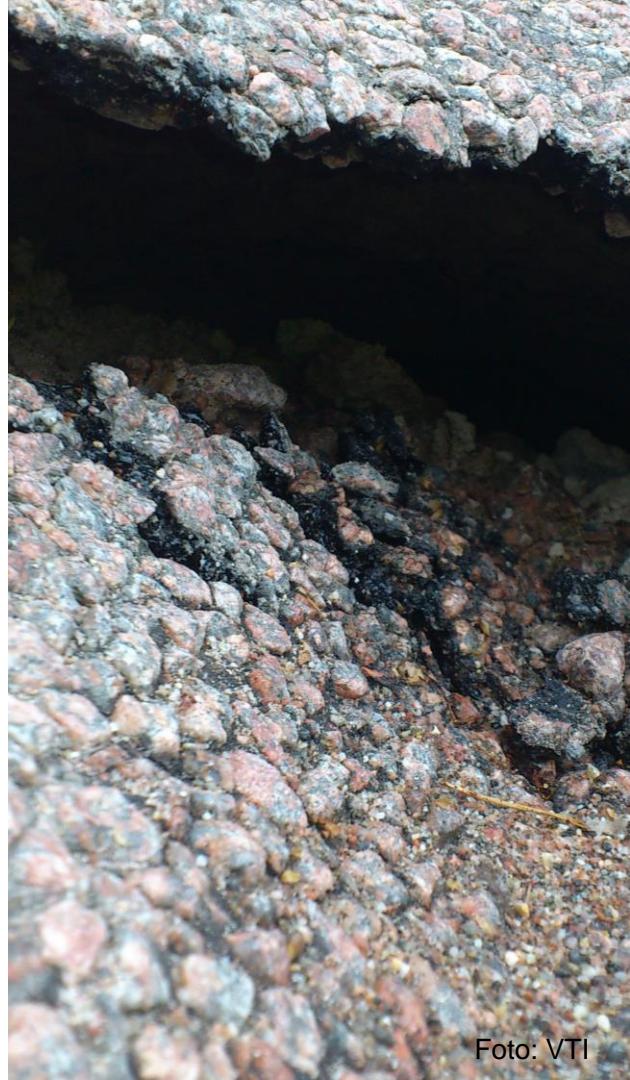
IRI --- Nira. 2023/09. Section A. Direction N.

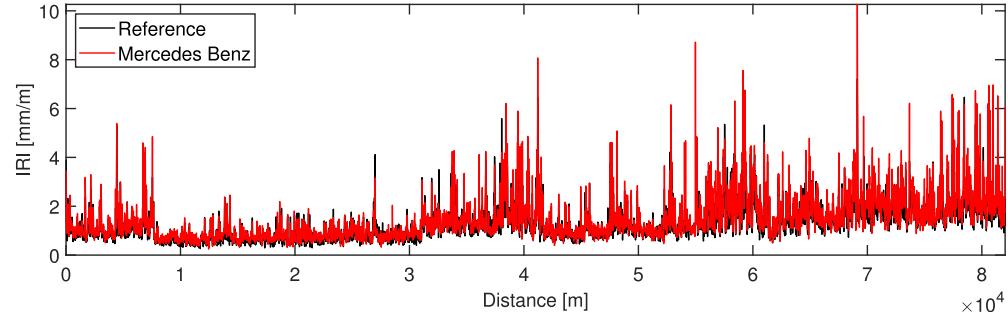
IRI --- Mercedes Benz. 2023/09. Section A. Direction N.

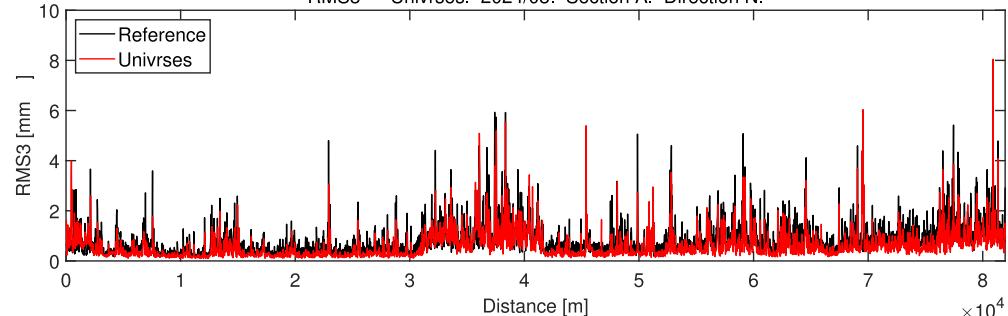
RMS3 --- Univrses. 2024/03. Section A. Direction N.

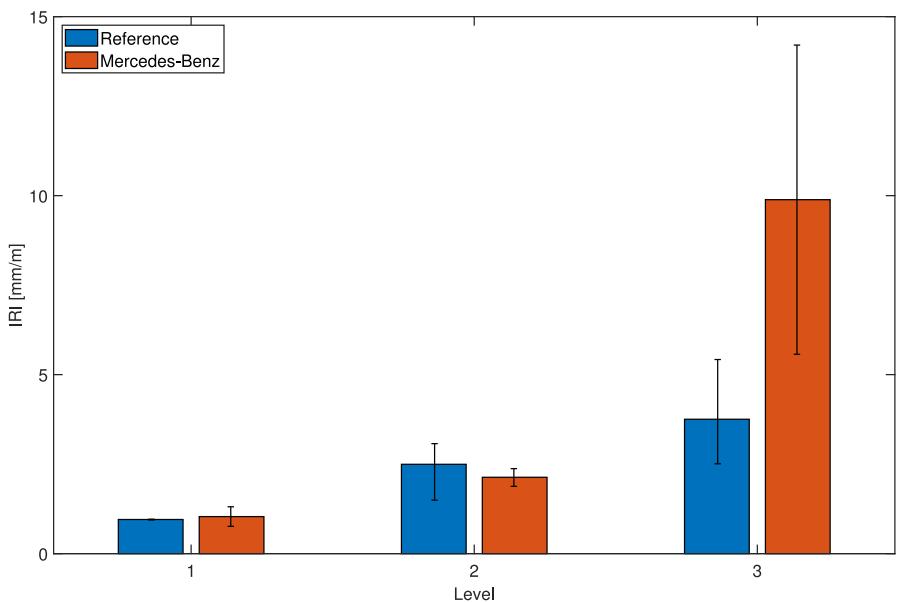
Mercedes Activity 3 (Waviness/IRI)

Level	MB	Ref
1	0.76	0.96
1	0.76	0.94
1	1.31	0.95
1	1.31	0.96
2	1.88	1.49
2	1.88	1.57
2	2.37	2.88
2	2.37	2.91
2	2.11	3.07
2	2.11	3.01
2	2.20	2.54
3	5.57	2.58
3	5.57	2.51
3	14.21	4.50
3	14.21	5.42

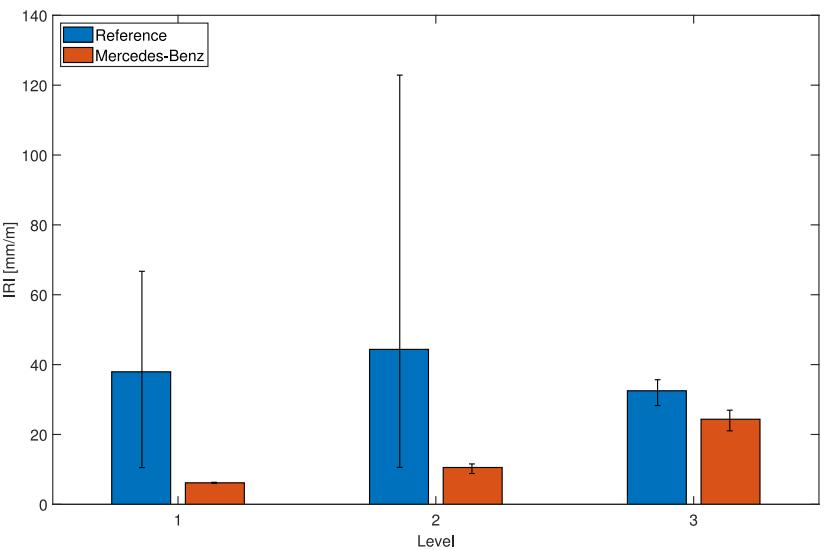
Mercedes Activity 3 (Surface Events/Local Roughness)

Level	MB	Ref
1	6.31	10.64
1	6.31	10.53
1	6.00	63.88
1	6.00	66.71
2	8.82	19.87
2	8.82	20.28
2	11.57	21.47
2	11.57	10.57
2	10.82	28.16
2	10.82	18.97
2	10.98	112.67
2	10.98	122.87
3	24.05	35.32
3	24.05	35.67
3	21.04	28.28
3	21.04	29.12
3	24.11	34.60
3	24.11	34.97
3	26.95	32.18
3	26.95	30.72
3	26.95	31.72

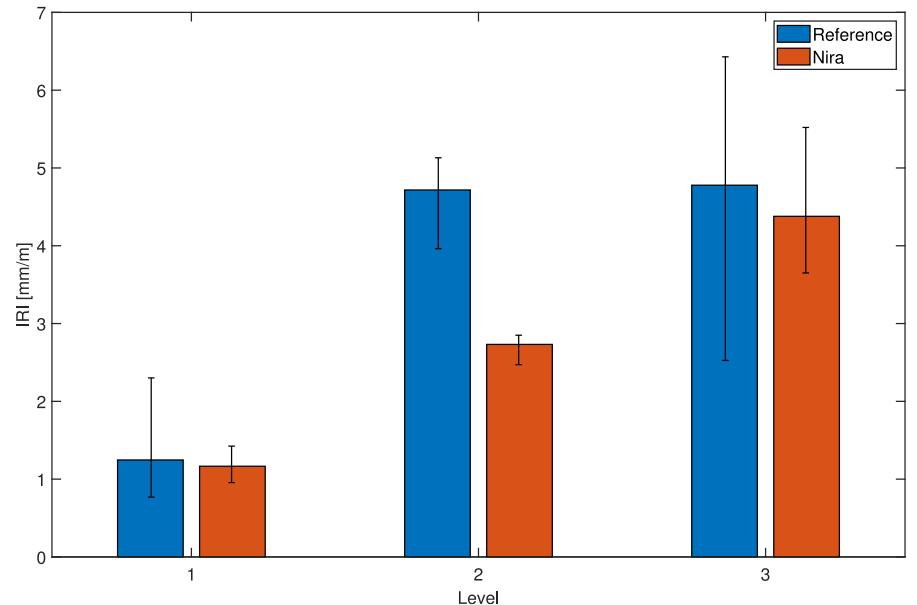
Nira Activity 3: IRI

Level	Nira	Ref
1	1.42	2.30
1	1.42	1.95
1	1.12	0.82
1	1.12	0.83
1	0.96	0.80
1	0.96	0.77
2	2.85	4.93
2	2.85	5.02
2	2.85	4.96
2	2.47	3.97
2	2.47	3.96
2	2.81	5.05
2	2.81	5.13
3	3.65	2.53
3	3.65	2.57
3	5.52	5.87
3	5.52	5.85
3	4.44	6.43
3	4.44	6.06
3	3.91	4.30
3	3.91	4.62

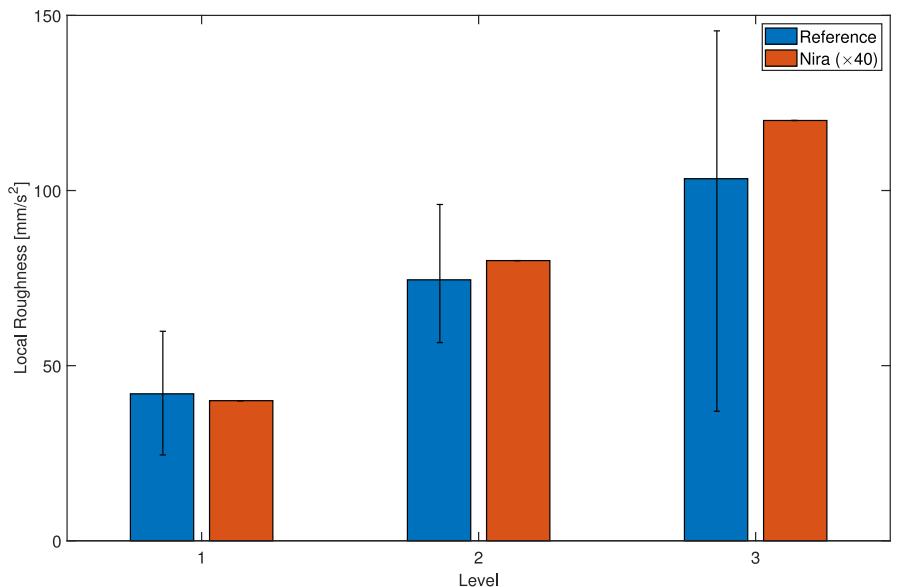
Nira Activity 3: Anomalies/Local Roughness

Level	Nira	Ref
1	1	24.50
1	1	24.50
1	1	59.82
1	1	59.03
2	2	83.15
2	2	82.87
2	2	78.63
2	2	76.35
2	2	60.09
2	2	96.02
2	2	56.58
2	2	62.39
3	3	138.22
3	3	145.58
3	3	102.04
3	3	122.06
3	3	36.99
3	3	57.69
3	3	108.38
3	3	116.06

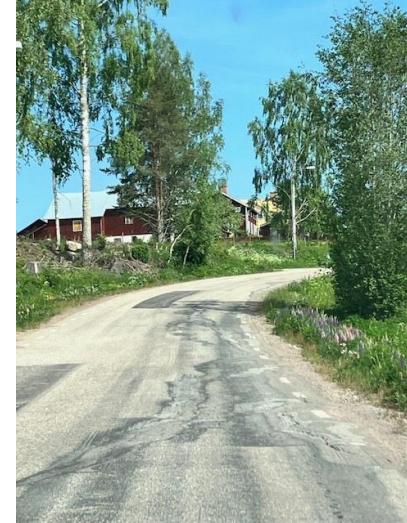
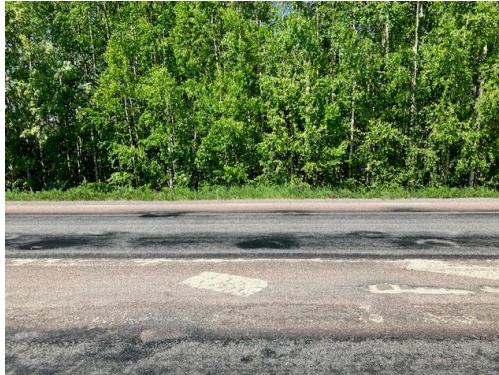
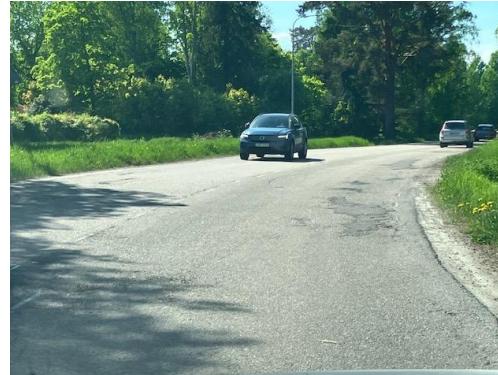
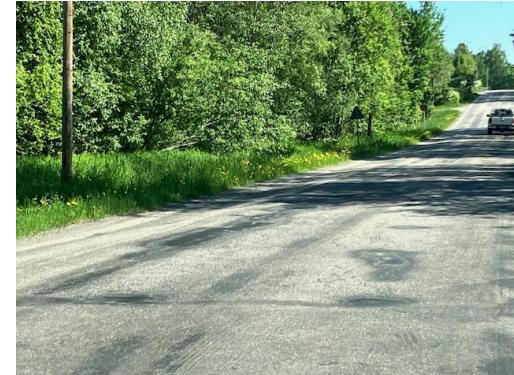
Univrses results – Damage level 3

- Result visual inspection, rating 2, 3, 1, 1
 - Frost cracks and load-bearing damage
 - Edge slump and cracks, generally uneven
 - Old brittle pavement, raveling, poor older repairs
 - Repaired cracks and potholes

- Overall good results
- Univrses damage level three was visually classified as worst condition
- One section in damage level 2 without visual damage

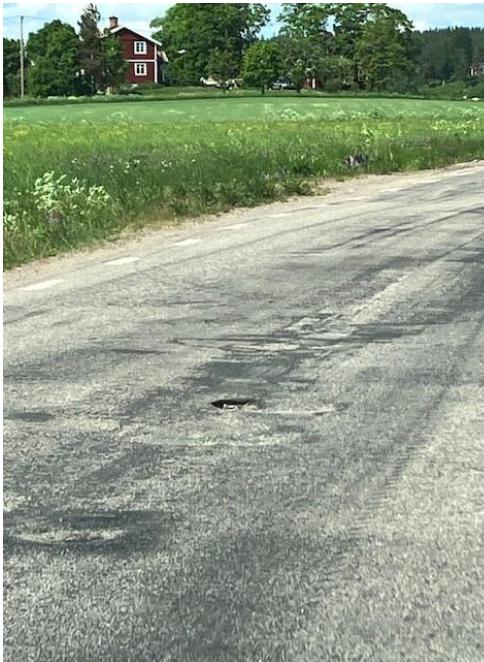
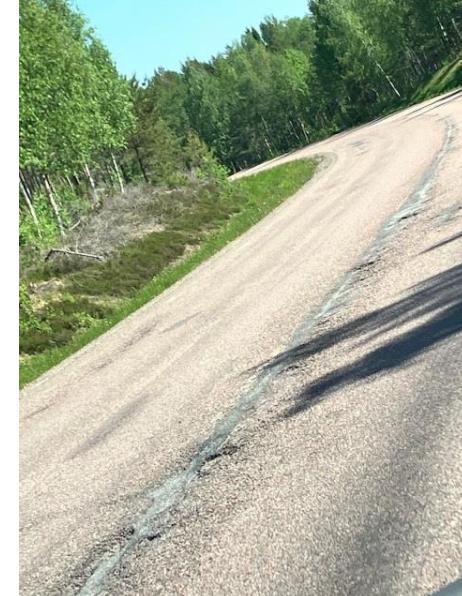
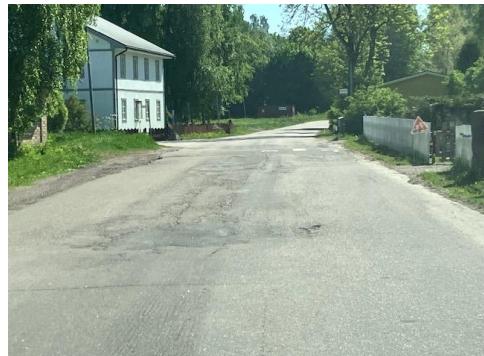
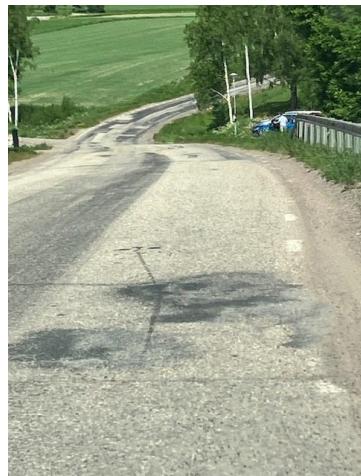
Univrses results – Pothole level 3

- Result visual inspection, rating 1, 2, 1, 1
 - Raveling, old paving
 - Potholes in the middle of the road
 - Potholes in the middle of the road
 - Potholes, poor elderly repair

- Overall ok results
- Not always potholes detected at the sections
- Univrses pothole level 3 had potholes in three out of four sections
- Some sections were affected by road repair
