## **International Journal of Forest Engineering**

# Stabilization through improved drainage using stone mattresses

## Dina Kuttah & Johan Persson

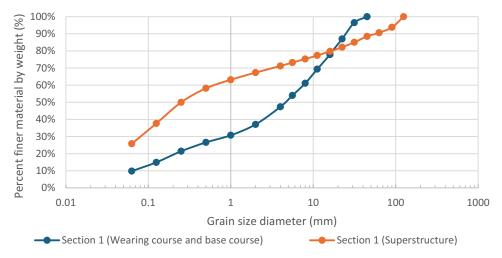
Figure 1. Grain size distribution of wear and base layers and superstructure material for section 1.

For the wearing and base course of section 1, Figure 1 shows that approximately 10% of the particles pass through a 0.063 mm sieve, 37% are finer than 2 mm and 100% pass through a 45 mm sieve. For the overall superstructure material of section 1, Figure 1 shows that approximately 25% of the particles pass through the 0.063 mm sieve, 67% are finer than 2 mm and 100% pass through the 125 mm sieve.

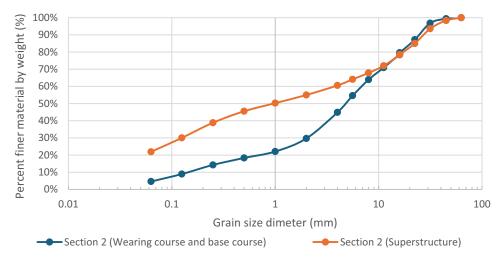
Figure 2. Grain size distribution of the wear and base layers and superstructure material for section 2.

The analysis for the wearing and base course of section 2, see Figure 2, shows that 5% of the particles pass through the 0.063 mm sieve, 30% are finer than 2 mm and all 100% pass through the 63 mm sieve.

Figure 2 also shows that for the overall superstructure material for section 2, approximately 22% pass through the 0.063 mm sieve, 55% are finer than 2 mm and all 100% pass through the 63 mm sieve.

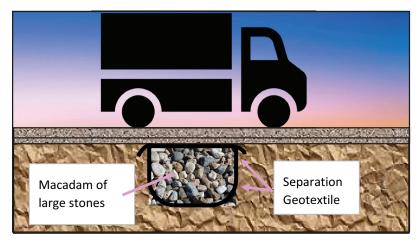
Figure 3. Forest road construction with stone mattresses.

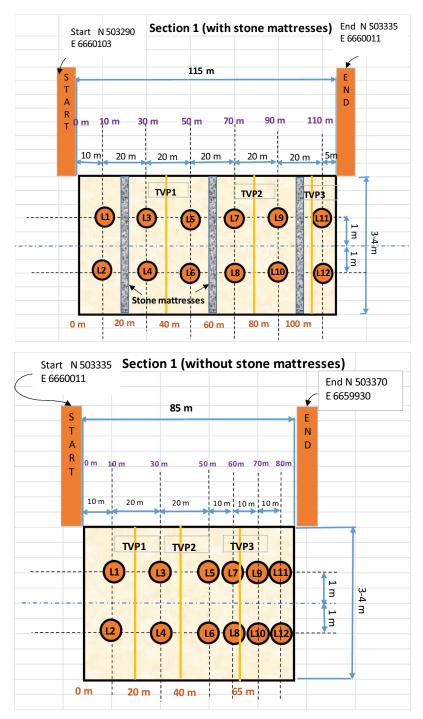
Figure 5. Test points and measurement layout for the two tested parts of section 1 with and without the drainage system (stone mattresses).

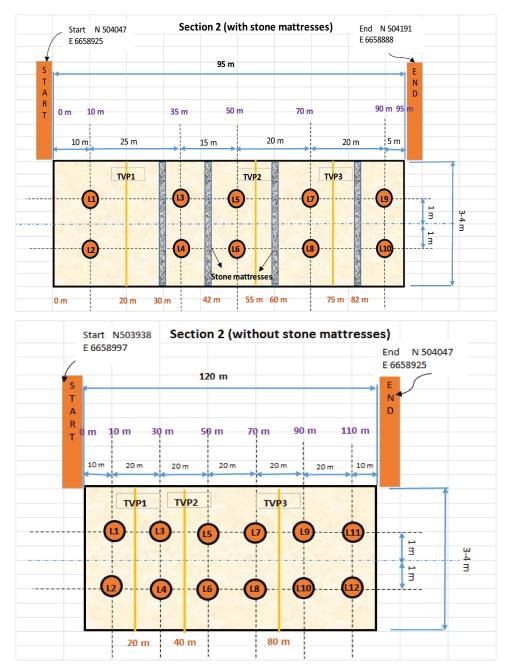
Figure 6. Test points and measurement layout for the two tested parts of section 2 with and without the drainage system (stone mattresses).

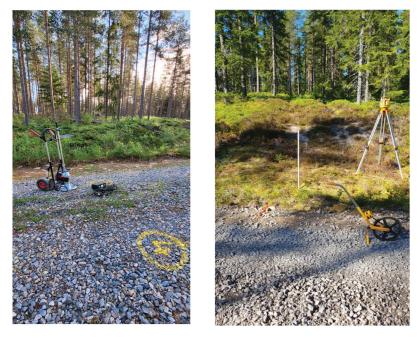
Figure 7. The post-construction measurements before and after traffic and weather impacts of the road sections. Photos: Andreas Waldemarson, VTI.

The initial measurements on the test sections were taken shortly after the roads were completed, see Figure 7. The final measurements were taken after more than a year, when the road sections had been exposed to weather and traffic loads for several months, as well as a the traffic simulation. The initial and final measurements serve as reference points to assess road performance and identify any problems before and after the road sections were affected by external factors. The results of the initial and final tests are presented in the following section.

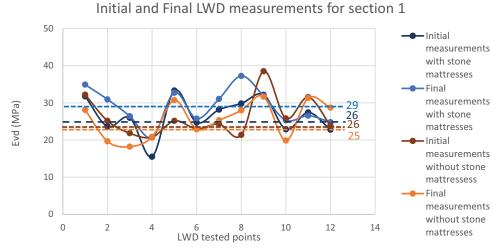
Figure 8. The Evd values from the initial and final LWD measurements for the tested road section 1.

Figures 8 and 9 show the initial and final measurements of the dynamic deformation modulus (Evd) obtained using LWD for road sections 1 and 2 with and without stone mattresses. The dotted lines with corresponding Evd values represent the average Evd (MPa) for each section and measurement occasion.

The LWD test results for the sections with stone mattresses showed an improvement in bearing capacity compared to the

traditional design without stone mattresses. For section 1 with stone mattresses, the percentage change in average Evd (MPa) between the initial and final measurements was approximately 11%. However, for section 1 without stone mattresses, the same calculation showed a change of approximately -1%. This indicates that the dynamic deformation modulus (Evd) was 12% higher on stabilized road surfaces compared to unstabilized ones, based on the difference between initial and final measurements. This improvement was observed despite the relatively large distance of about 40 meters between each stone mattress.

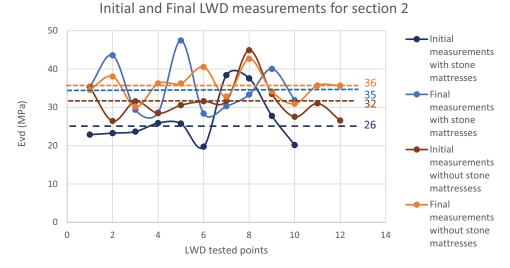
Figure 9. The Evd values from the initial and final LWD measurements for the tested road section 2.

For section 2, the percentage change in average Evd (MPa) between the initial and final measurements was approximately 37%, whereas for section 1 without stone mattresses, the change was approximately 14%. This means that the dynamic deformation modulus (Evd) was 23% higher on stabilized road surfaces compared to unstabilized ones, based on the difference between initial and final measurements. This greater improvement can be attributed to the denser placement of the stone mattresses, which were spaced 25 meters apart. The water content measured alongside the LWD readings showed a significant increase, with final measurements being two to three times higher than the initial readings across all sections (i.e. section 1 with and without stone mattresses), primarily due to the rainy period during the final

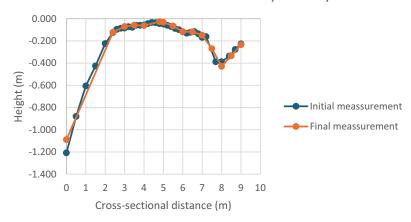
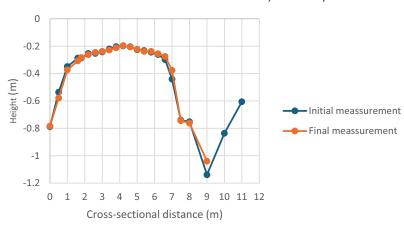
Figure 10. Initial and final profile measurements for road section 1 with stone mattresses.

The three profiles in Figure 10 for section 1 with stone mattresses show that no significant rutting has occurred in the wheel paths on this section.

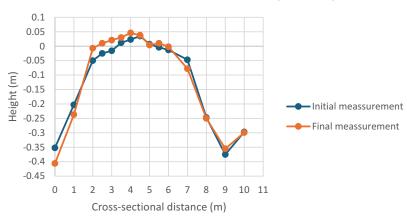
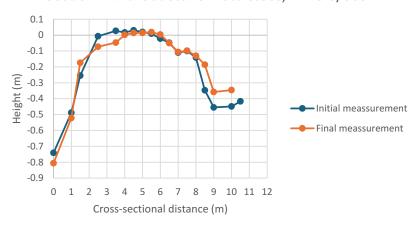
Figure 11. Initial and final profile measurements for road section 1 without stone mattresses.

In contrast, for section 1 without stone mattresses, Figure 11 shows that there is some noticeable rutting in the wheel paths for profiles 1 and 2, while no noticeable rutting is observed in the wheel paths for profile 3.

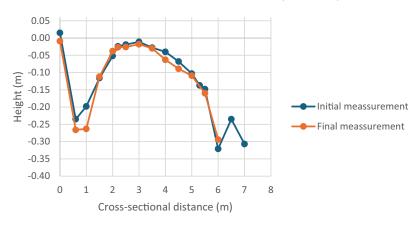
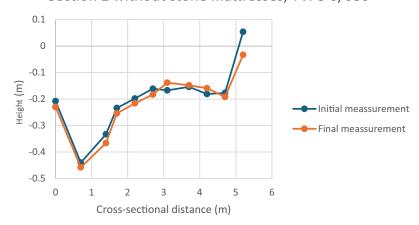
Figure 13. Initial and final profile measurements for road section 2 without stone mattresses.

Figure 13 shows some noticeable rutting in the wheel paths for profile 1, while there is no noticeable rutting in the wheel paths for profiles 2 and 3 on section 2, without stone

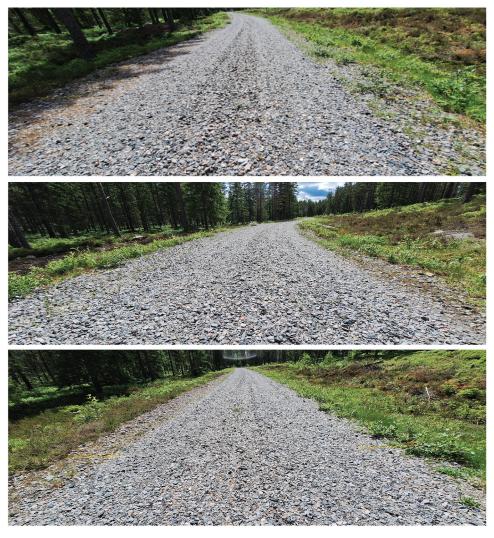
Figure 14. Visual inspection of section 1 (with stone mattresses) in Grängesberg. Photos: Andreas Waldemarson, VTI.

There were no potholes on section 1, which was surfaced with stone mattresses. There were visual signs of rutting in the wheel paths. The loose gravel was pressed

into the road, which clearly showed where the traffic had gone, although the ruts were not very deep. As for the dust, it was difficult to judge due to the dampness of the road surface, but the loose stones were dry. There was a lot of loose gravel all over the road surface, particularly at the edges of the road, as clearly shown in the photographs, see Figure 14.

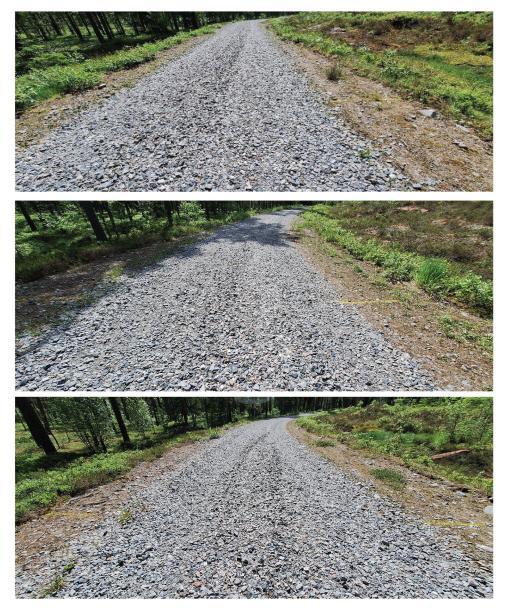
Figure 15. Visual inspection of section 1 (without stone mattresses) in Grängesberg. Photos: Andreas Waldemarson, VTI.

Loose gravel was observed along both the section 1 road edges and the centerline, with the gravel being more compacted within the wheel tracks. The old markings from the initial measurements (over a year ago) were still visible despite the loose gravel, see Figure 15.

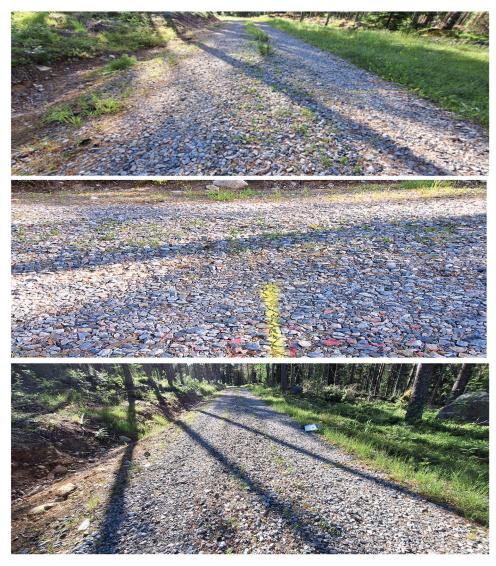
Figure 16. Visual inspection of section 2 (with stone mattresses) in Grängesberg. Photos: Andreas Waldemarson, VTI.

The old markings from the initial measurements were still there despite the loose gravel. This section was narrower and had some grass in the middle of the road, see Figure 16.

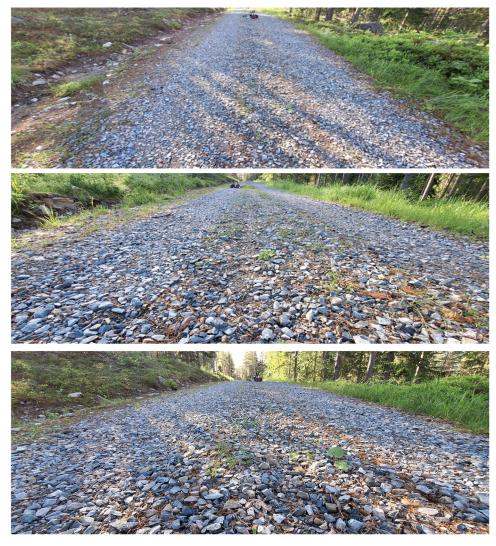
Figure 17. Visual inspection of section 2 (without stone mattresses) in Grängesberg. Photos: Andreas Waldemarson, VTI.

No rutting was noted, and no potholes were found. Where there were ruts, the loose material tended to collect at the edges of the road, making the ruts appear larger. Dusting was difficult to assess with a wet surface and dry loose stones. There was loose gravel both at the edges and in the centerline of the road, and the loose gravel was more compressed in the ruts. The old markings from the initial measurements were still visible despite the loose gravel and this section was narrower with some grass along the centerline of the road, see Figure 17.
