Inspection of reference objects coated with various zinc rich coatings

Björn Tidbeck, Bror Sederholm

Report number. 15660-1

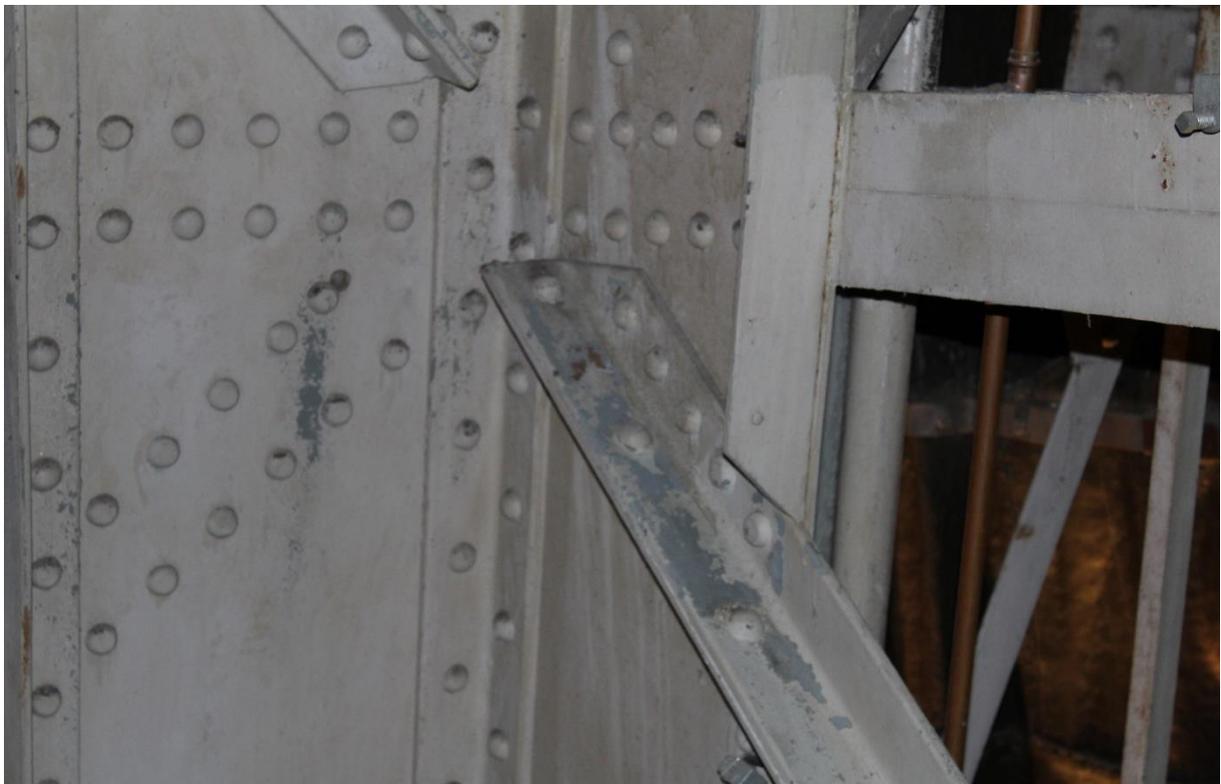
The inside air of the statue was controlled by an air conditioning system that was installed 2012. Before 2012 the statue was not open to the public and the air inside was not conditioned. The topcoating had started to flake and peel off from the zinc silicate. However, the supporting steel structure was virtually free from corrosion and the underlying zinc silicate was intact. The general film thickness of the zinc silicate was about 60-90 μm . In some places excessive amounts of coating had been applied, certain areas had been coated to a DFT in excess of 400 μm without any signs of mudcracking.

Figure 3. Supporting steel structure with rivets, the top coat (light gray in the picture) was flaking and peeling off from the underlying silicate (blueish gray in the picture).

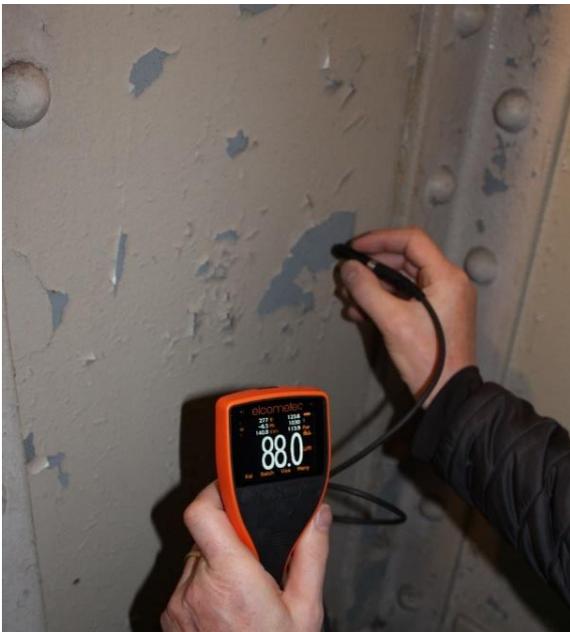
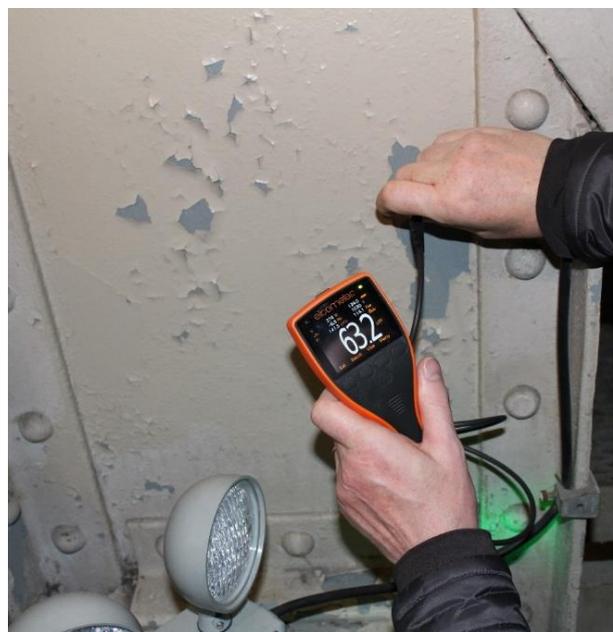
Figure 5. Generally, the film thickness of the silicate coating was between 60-90 μm .

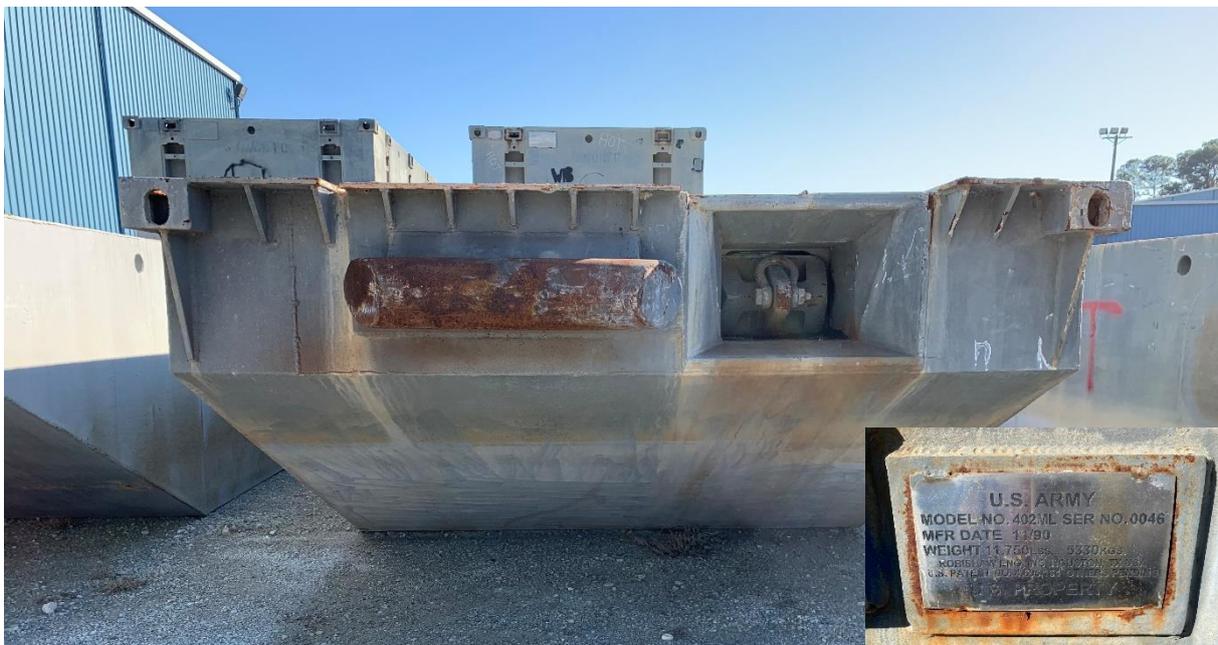
Figure 8. Unit 0046 with an engraved sign with manufacturing month. This unit was manufactured 29 years ago. The chamfered part of these units is used to drive the modular system onto the seashore

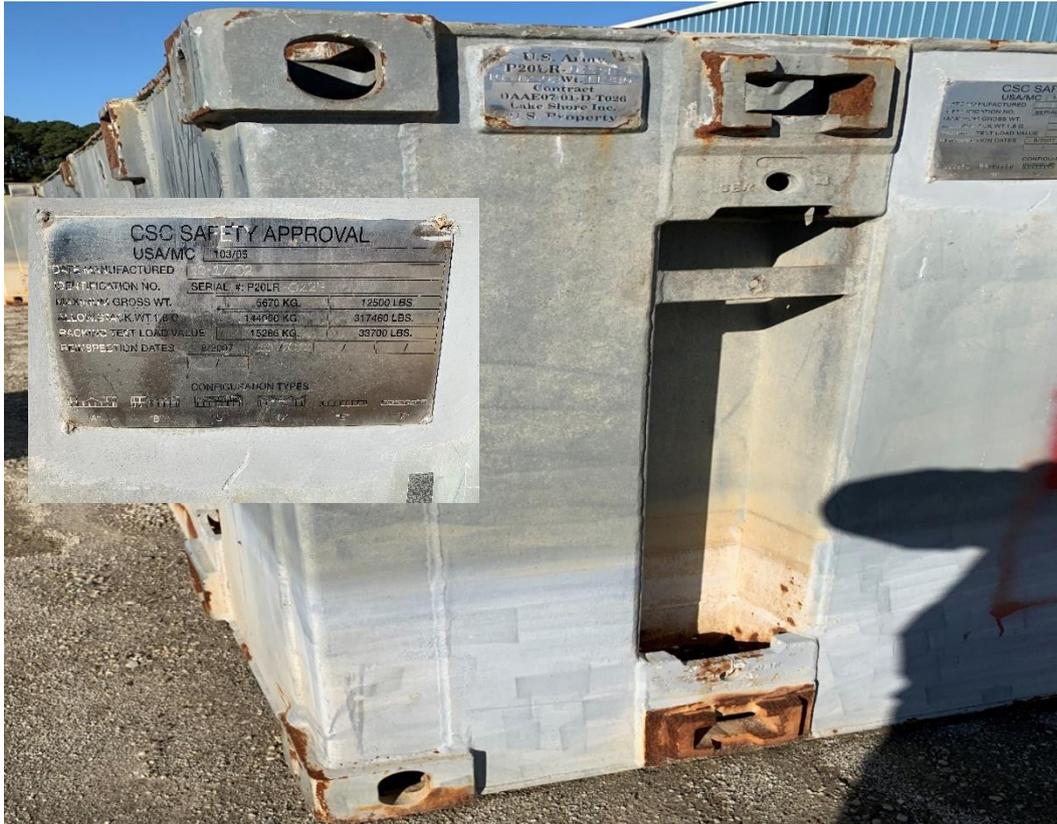
Figure 9. Unit O224 with an engraved sign with manufacturing date. This unit was manufactured 17 years ago.

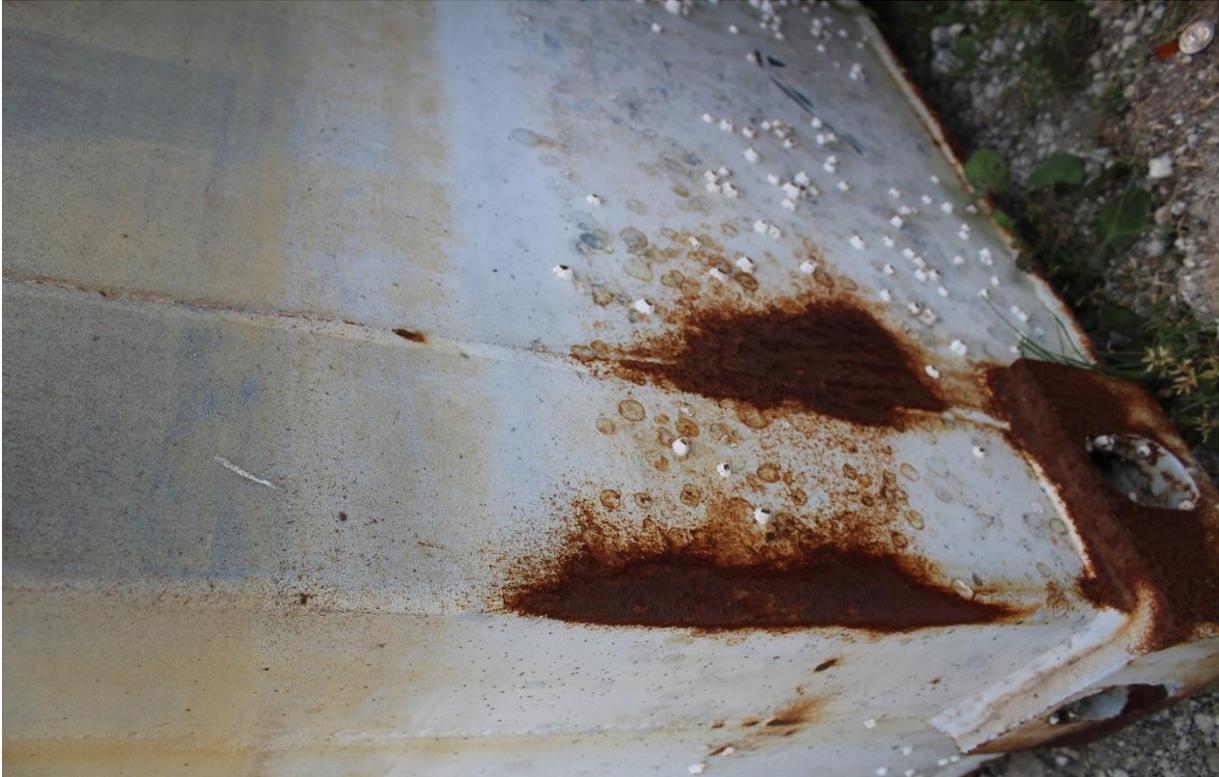
Figure 16. Unit P40 552, DFT was about 90 μ m above the waterline, DFT was about 30 μ m below the water line. The antifouling action could possibly be explained by leaching zinc salts. A change of colour in the coating below the water line suggests that all the zinc has been depleted and left a thin silicate coating where the barnacles can grow.

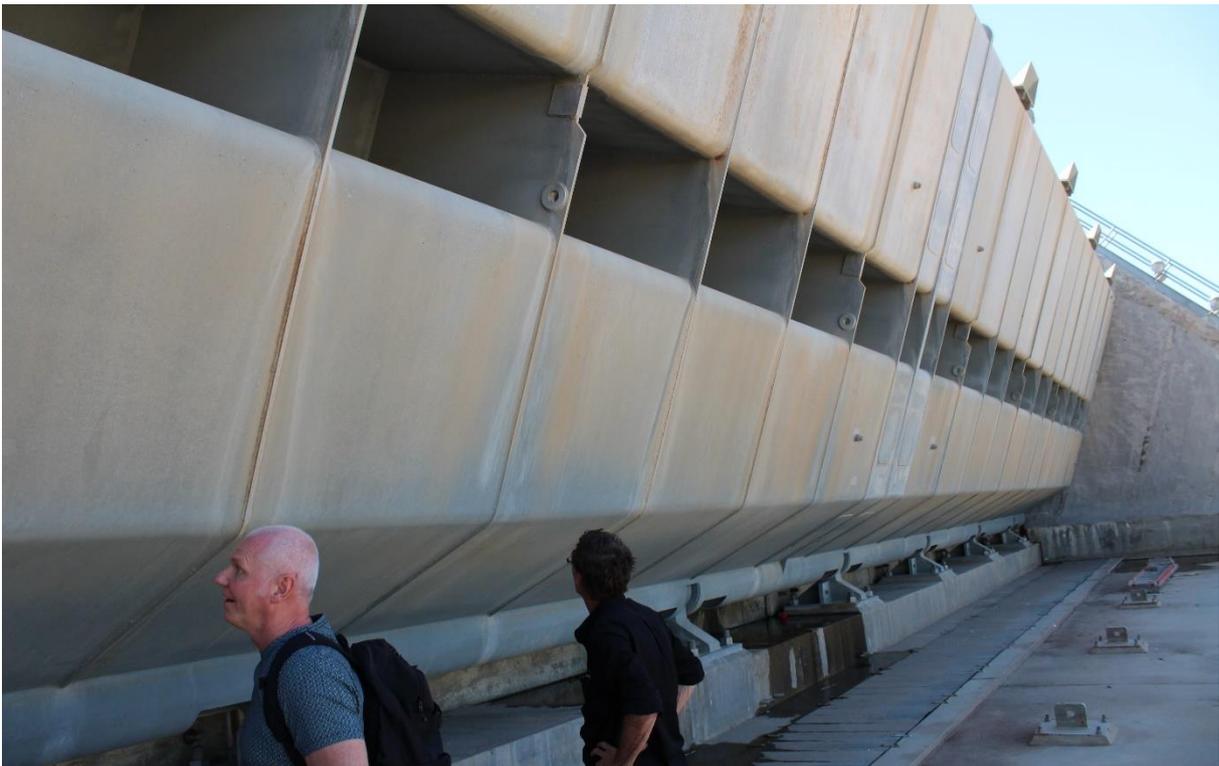
Figure 27. Overview of one out of eight dam gates. The brownish surfaces in the pictures are not rust but have been fouled by running water or dirt from the surroundings.

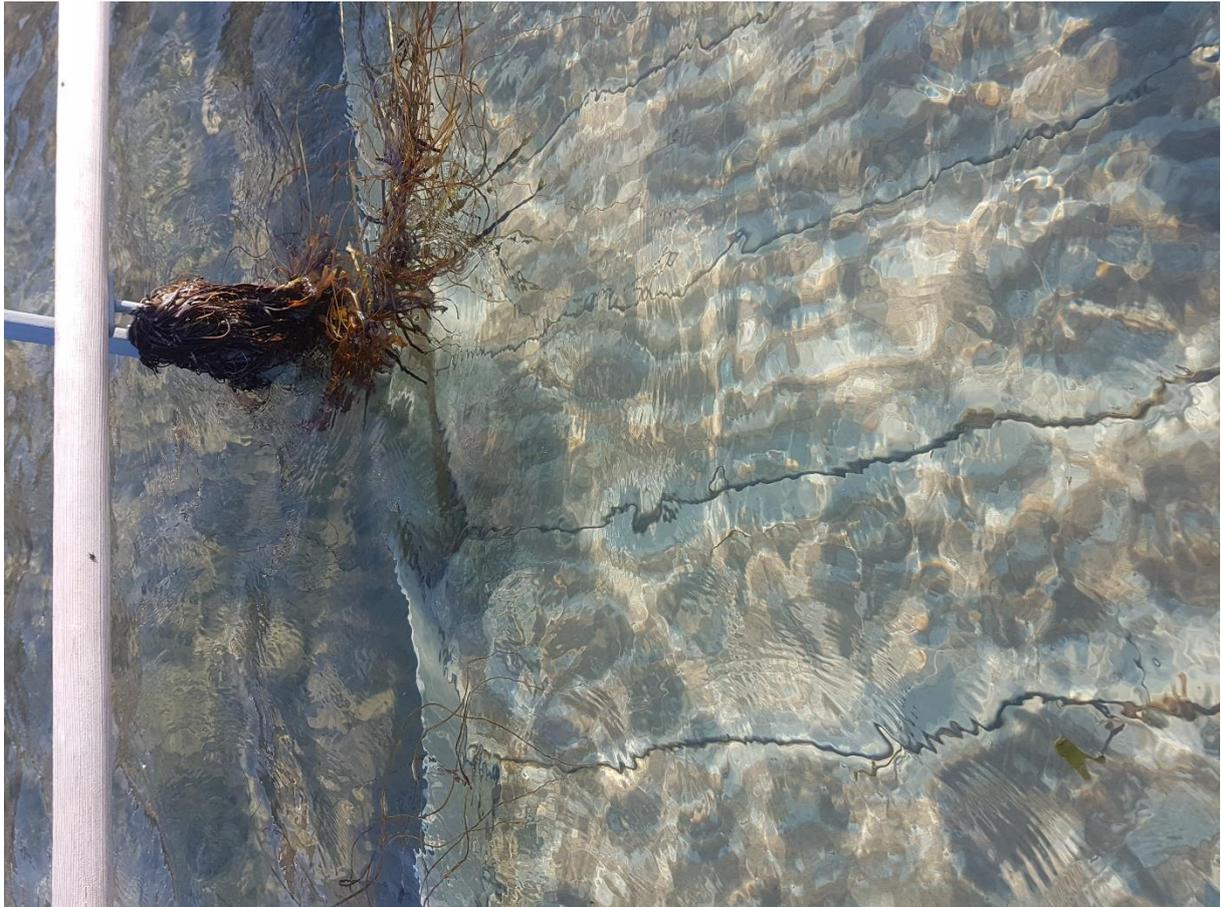
Figure 35. The ramp can become covered by sand. The lower part of the ramp is subjected to constant abrasion by beach sand moving with the waves.

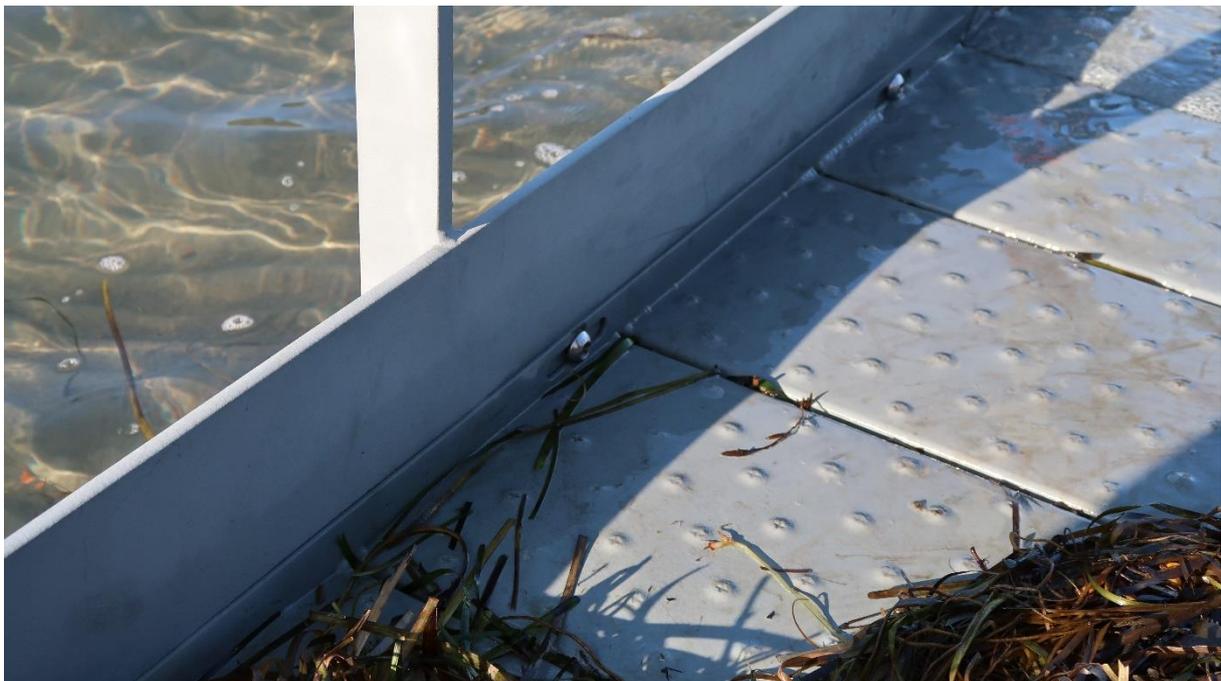
Figure 36. Close up of the ramp floor: there are lots of crevices and the design is not ideal for coating work.

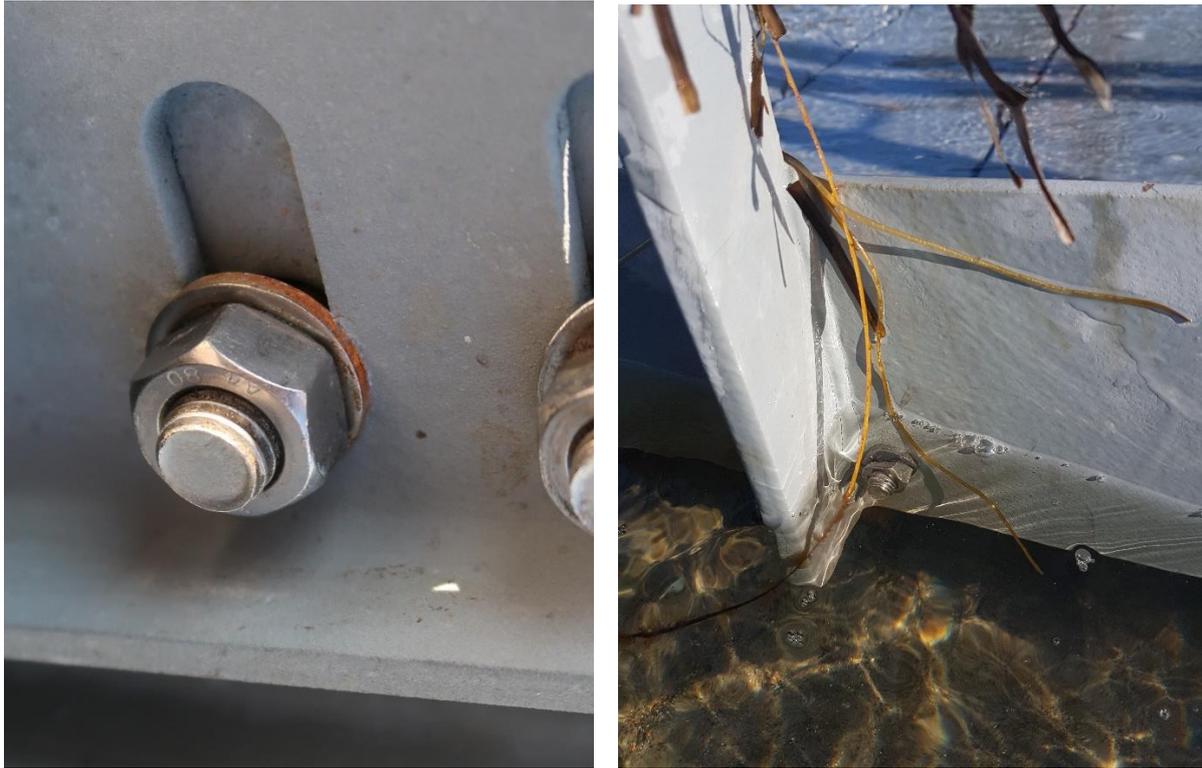
Figure 37. The ramp has been assembled with stainless steel bolts.

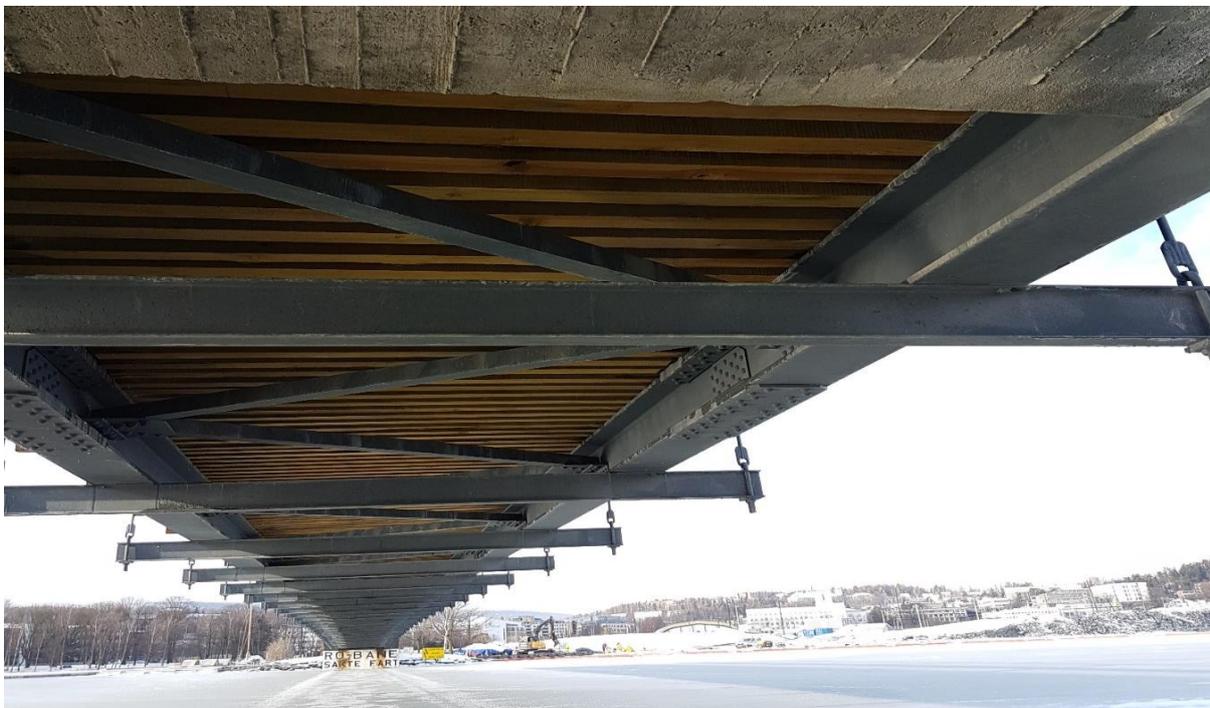
Figure 55. The underside of the bridge. Steel beam girders with support lattice and hanger beams. The distance from the steel structure to the salty water is about 2,5 meters. As there are many crevices and sharp edges on the steel beams, the structure is not optimal for coating

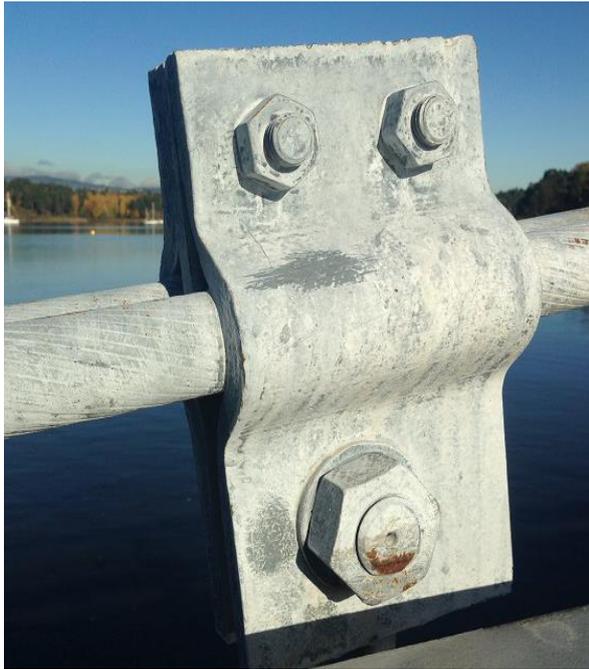
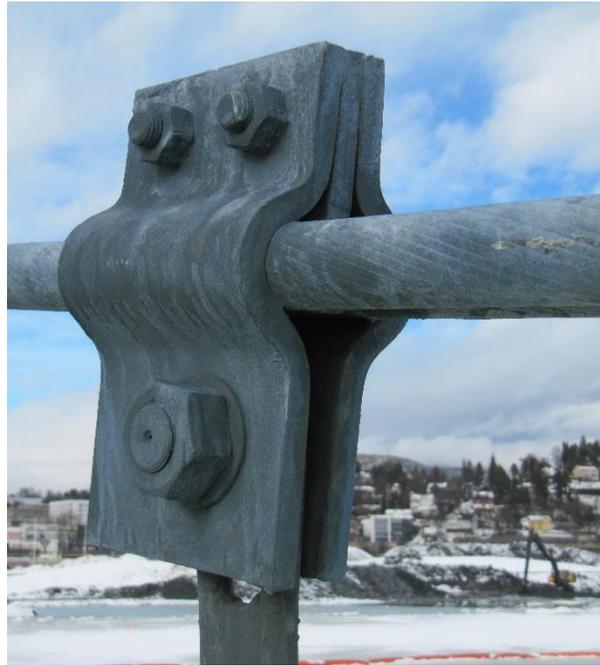
Figure 56. To the left: archive picture from 2014 after 29 years in service. To the right: stay cable attachment in 2017, three years after refurbishment

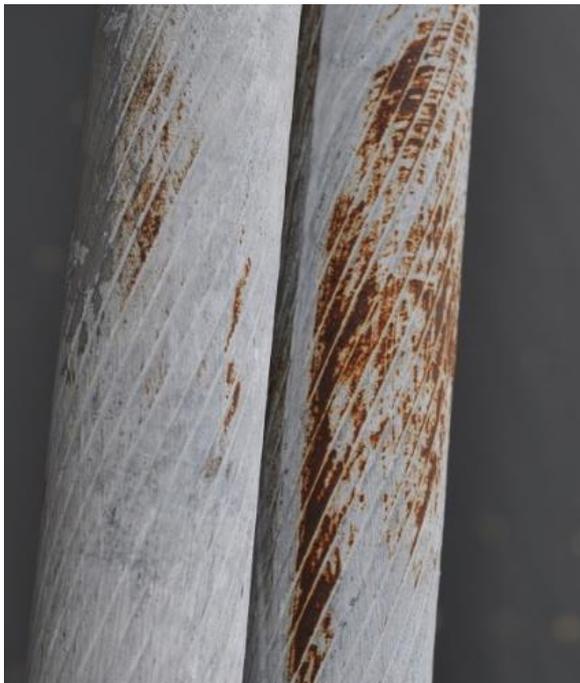
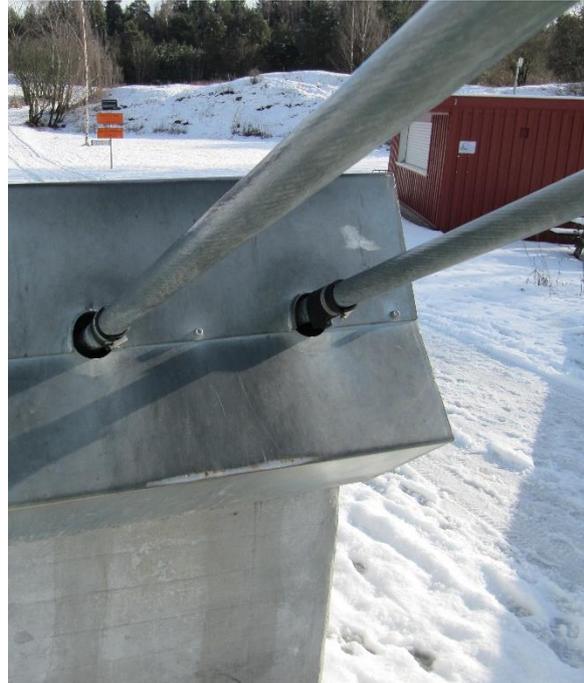
Figure 57. To the left: archive picture of a stay cable after 29 years in service. To the right: Stay cable in 2017, three years after the refurbishment.

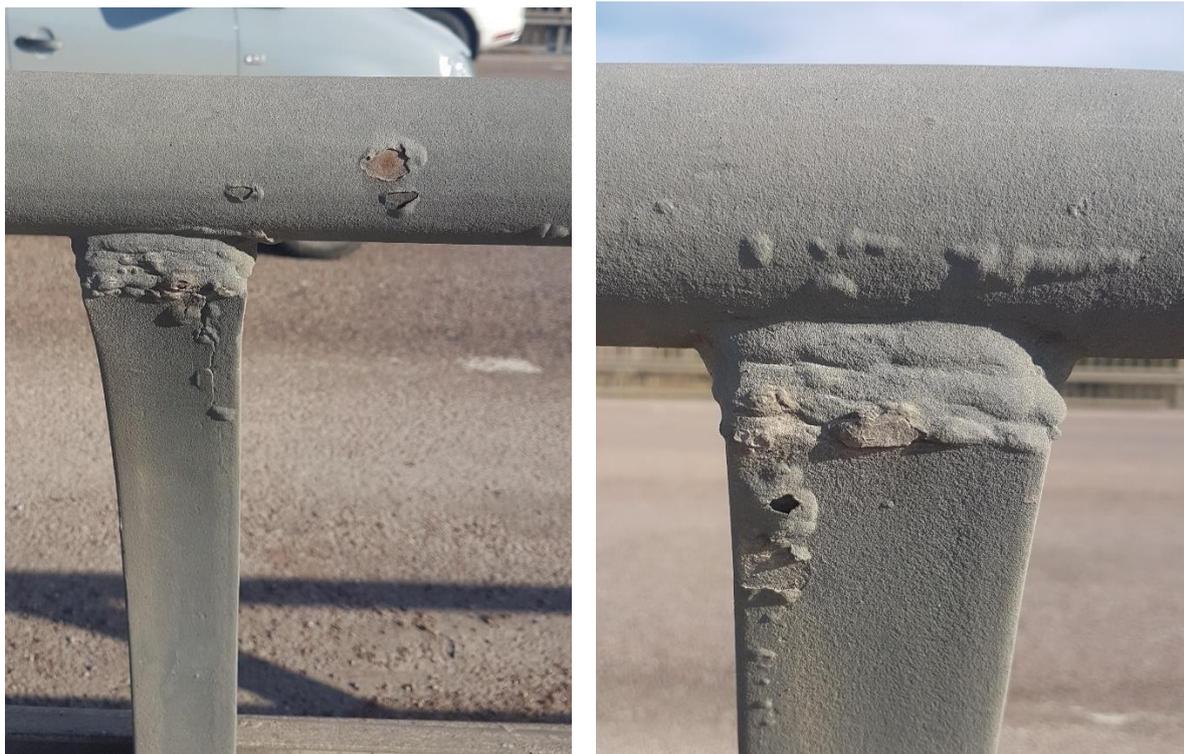
Figure 74. The welds between the fencing poles and the handrail was not optimally prepared. On a few poles some blistering and flaking of the TSZ could be seen.

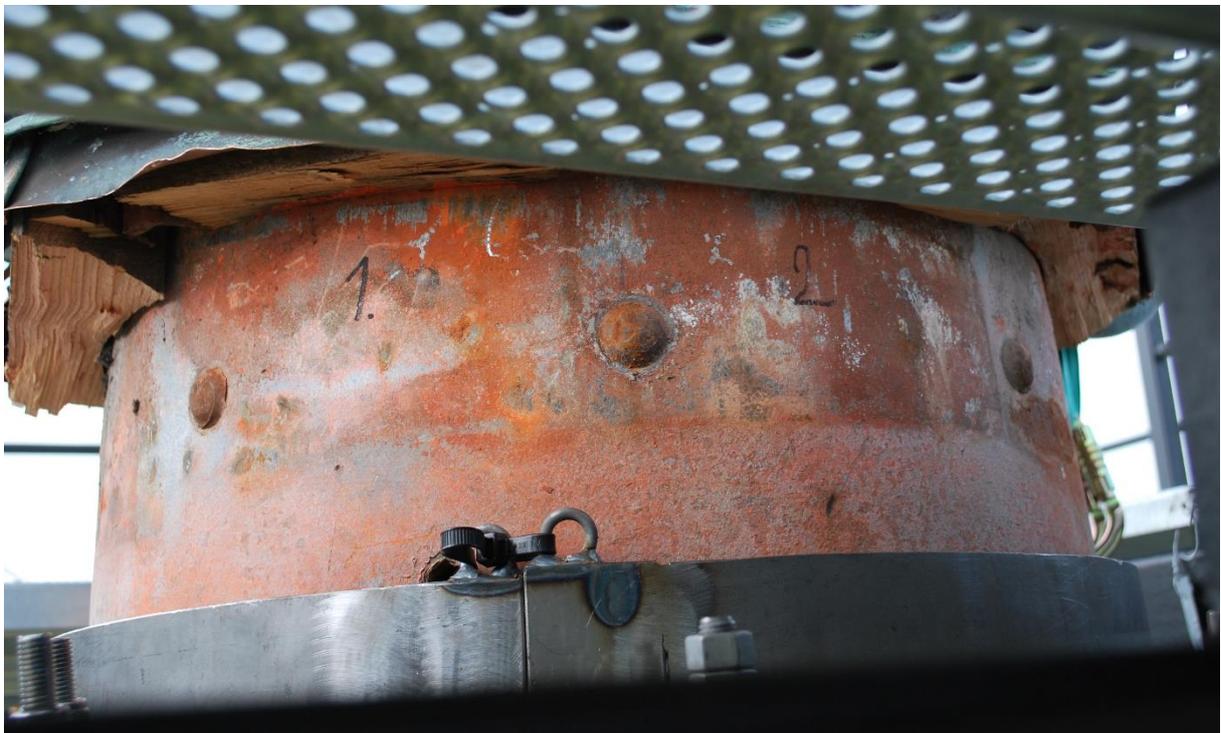
Figure 77. The top of the spire is constructed around a steel cone made from galvanised sheet metal, on the outside it has been painted with red lead linseed oil.

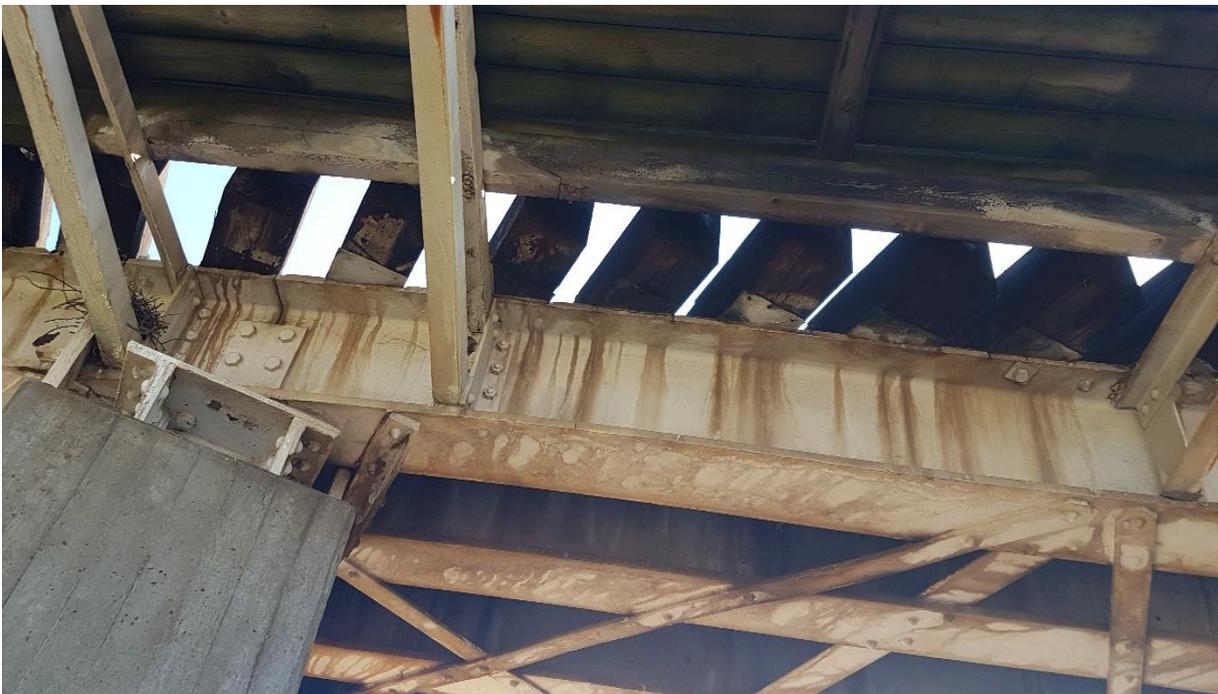
Figure 86. The brown color is not coming from corrosion but from the wooden sleepers of the train tracks.
